Manhole Inspection Report

Date:	04/19/2018	Weather:		Coding:	RZMACP
MH#:	M-708-145	Owner:	NA	Len. Surveyed:	6.3
P.O.#:		Surveyor:	John Kuglmaier	Rim to Invert:	7.1
Customer:		Cert. #:	U-1215-07002349	Wall Material:	Concrete (reinforced)

Street:	Intersection of Lake St. and Grand Is	Project:	Hobart, IN
City:	Hobart, IN	GPS Northing:	2905707.276
Location:		GPS Easting:	2905707.276
Drain Area:	Southwest	GPS Accuracy:	Sub-Meter
Cover Shape:	Circular	Evidence of Surcharge:	No
Cover Size:	22.5	Potential for Runoff:	None
Comments:

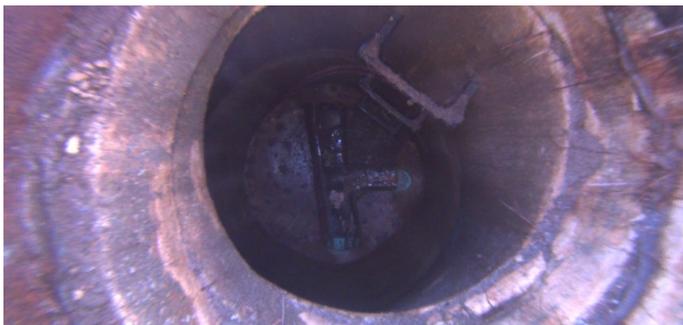
Code: **MGP**
Description: **General Photo**

Distance (ft): **.0**
Structural Grade: **0**
O&M Grade: **0**
Clock Start/From:
Clock To:
1st Value:
2nd Value:
Value Percent:
Step: **NO**
Remarks:

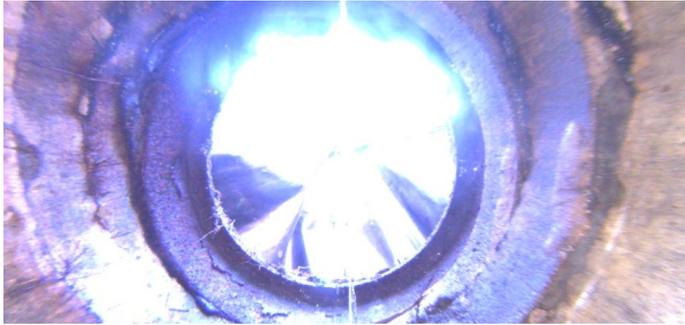
Code: **MGP**
Description: **General Photo**

Distance (ft): **2.5**
Structural Grade: **0**
O&M Grade: **0**
Clock Start/From:
Clock To:
1st Value:
2nd Value:
Value Percent:
Step: **NO**
Remarks:

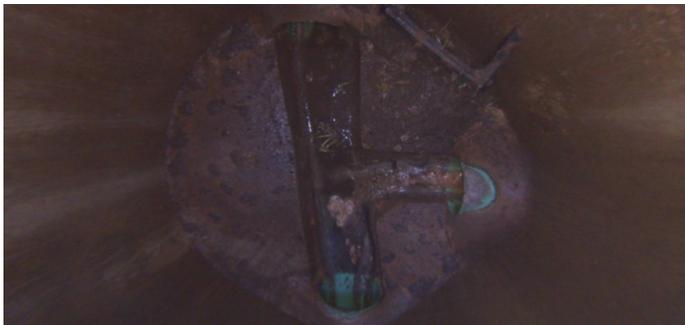
Code: **DAZ**
Description: **Deposits Attached Other**

Distance (ft): **3.4**
Structural Grade: **0**
O&M Grade: **2**
Clock Start/From: **12**
Clock To: **12**
1st Value:
2nd Value:
Value Percent: **5.000**
Step: **NO**
Remarks: **Mixed materials**

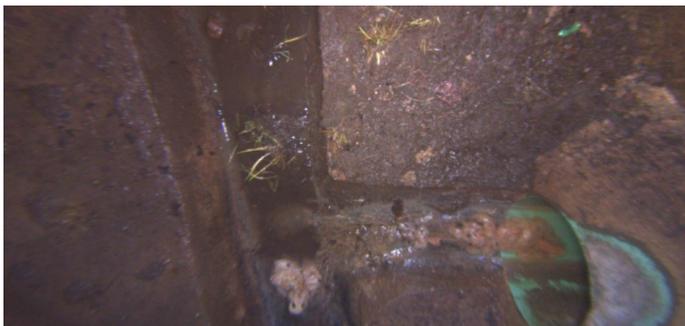
Code: **MGO**
Description: **General Observation**

Distance (ft): **5.3**
Structural Grade: **0**
O&M Grade: **0**
Clock Start/From:
Clock To:
1st Value:
2nd Value:
Value Percent:
Step: **NO**
Remarks: **Ins. Comp.**
