# Manhole Inspection Report

Date:	<b>09/20/2022</b>	Weather:		Coding:	<b>RZMACP</b>
MH#:	<b>M-708-148</b>	Owner:	<b>NA</b>	Len. Surveyed:	<b>4.2</b>
P.O.#:		Surveyor:	<b>Jen Costello</b>	Rim to Invert:	<b>5.2</b>
Customer:		Cert. #:	<b>U-907-5518</b>	Wall Material:	<b>Concrete (cast in place)</b>

Street:	<b>Lake St. 219' North of Coral Cove.</b>	Project:	<b>Hobart, IN</b>
City:	<b>Hobart, IN</b>	GPS Northing:	<b>2282243.378</b>
Location:	<b>Local Rural Streets</b>	GPS Easting:	<b>2905544.341</b>
Drain Area:	<b>Southwest</b>	GPS Accuracy:	<b>Sub-Meter</b>
Cover Shape:	<b>Circular</b>	Evidence of Surcharge:	<b>No</b>
Cover Size:	<b>24.0</b>	Potential for Runoff:	<b>None</b>
Comments:

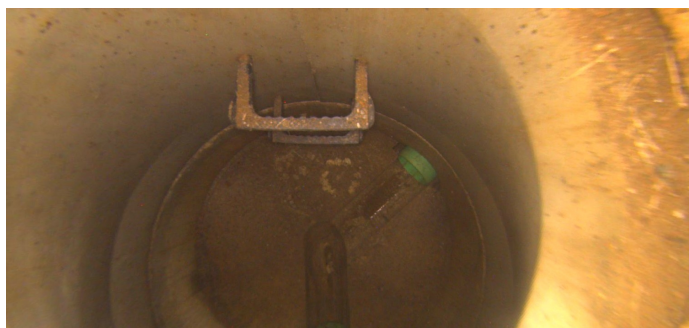
Code: **MGO**  
Description: **General Observation**

Distance (ft): **.0**  
Structural Grade: **0**  
O&M Grade: **0**  
Clock Start/From:  
Clock To:  
1st Value:  
2nd Value:  
Value Percent:  
Step: **NO**  
Remarks: **access mh**

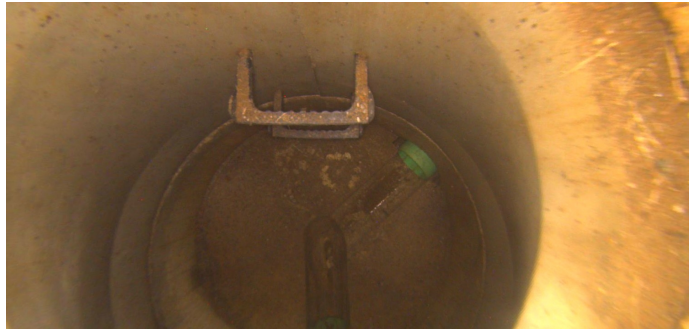
Code: **SRI**  
Description: **Surface Roughness Increased**

Distance (ft): **.0**  
Structural Grade: **1**  
O&M Grade: **0**  
Clock Start/From: **12**  
Clock To: **12**  
1st Value:  
2nd Value:  
Value Percent:  
Step: **NO**  
Remarks:

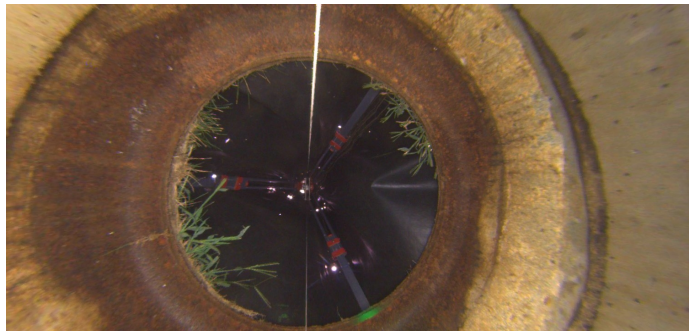
Code: **MGO**  
Description: **General Observation**

Distance (ft): **1.6**  
Structural Grade: **0**  
O&M Grade: **0**  
Clock Start/From:  
Clock To:  
1st Value:  
2nd Value:  
Value Percent:  
Step: **NO**  
Remarks: **underside of frame**

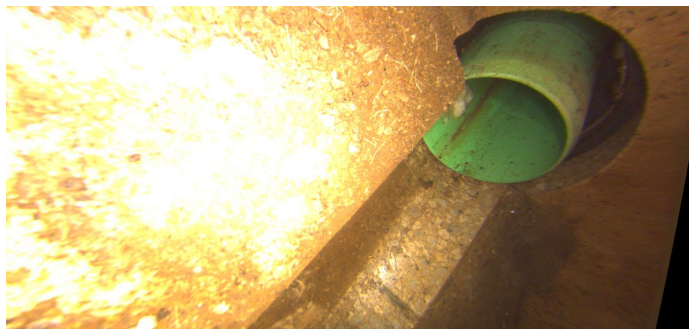
Code: **DSF**  
Description: **Deposits Settled Fine**

Distance (ft): **4.2**  
Structural Grade: **0**  
O&M Grade: **2**  
Clock Start/From: **12**  
Clock To: **12**  
1st Value:  
2nd Value:  
Value Percent: **5.000**  
Step: **NO**  
Remarks:

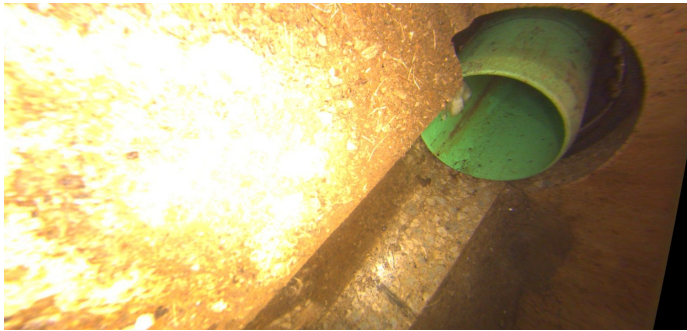
Code:	<b>SRI</b>
Description:	<b>Surface Roughness Increased</b>
Distance (ft):	<b>4.2</b>
Structural Grade:	<b>1</b>
O&M Grade:	<b>0</b>
Clock Start/From:	<b>12</b>
Clock To:	<b>12</b>
1st Value:	
2nd Value:	
Value Percent:	
Step:	<b>NO</b>
Remarks:

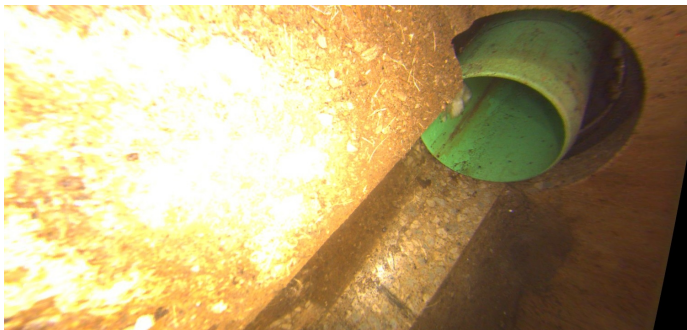
Code:	<b>MGO</b>
Description:	<b>General Observation</b>
Distance (ft):	<b>4.2</b>
Structural Grade:	<b>0</b>
O&M Grade:	<b>0</b>
Clock Start/From:	
Clock To:	
1st Value:	
2nd Value:	
Value Percent:	
Step:	<b>NO</b>
Remarks:	<b>end of survey</b>
