Manhole Inspection Report

Date:	04/19/2018	Weather:		Coding:	RZMACP
MH#:	M-708-150	Owner:	NA	Len. Surveyed:	4.1
P.O.#:		Surveyor:	John Kuglmaier	Rim to Invert:	4.6
Customer:		Cert. #:	U-1215-07002349	Wall Material:	Concrete (reinforced)

Street:	West of Lake St. North of Coral Cove	Project:	Hobart, IN
City:	Hobart, IN	GPS Northing:	2905498.96
Location:		GPS Easting:	2905498.96
Drain Area:	Southwest	GPS Accuracy:	Sub-Meter
Cover Shape:	Circular	Evidence of Surcharge:	No
Cover Size:	22.5	Potential for Runoff:	None
Comments:

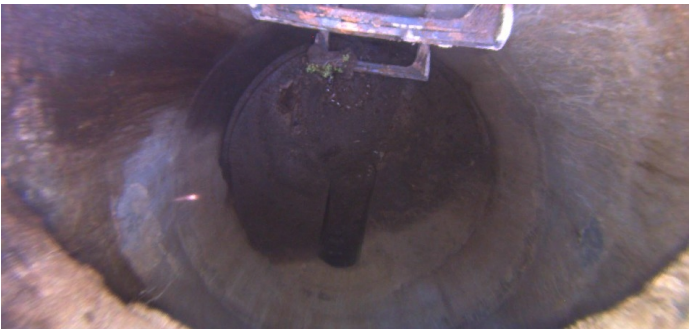
Code: **MGP**
Description: **General Photo**

Distance (ft): **.0**
Structural Grade: **0**
O&M Grade: **0**
Clock Start/From:
Clock To:
1st Value:
2nd Value:
Value Percent:
Step: **NO**
Remarks:

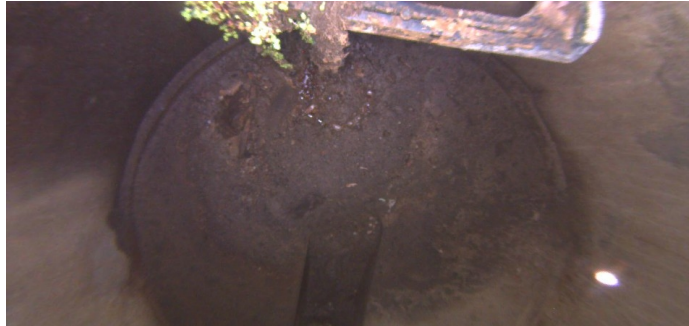
Code: **DSF**
Description: **Deposits Settled Fine**

Distance (ft): **2.0**
Structural Grade: **0**
O&M Grade: **2**
Clock Start/From: **9**
Clock To: **3**
1st Value:
2nd Value:
Value Percent: **5.000**
Step: **NO**
Remarks:

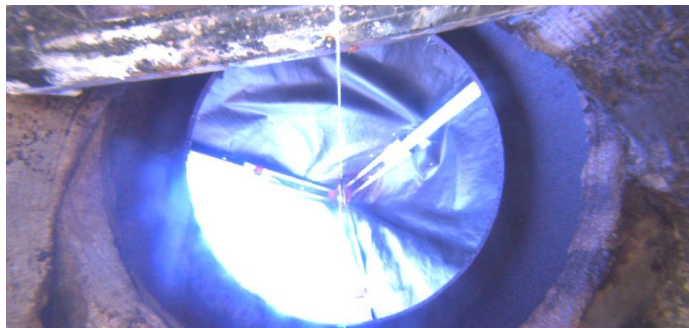
Code: **MGP**
Description: **General Photo**

Distance (ft): **2.1**
Structural Grade: **0**
O&M Grade: **0**
Clock Start/From:
Clock To:
1st Value:
2nd Value:
Value Percent:
Step: **NO**
Remarks:

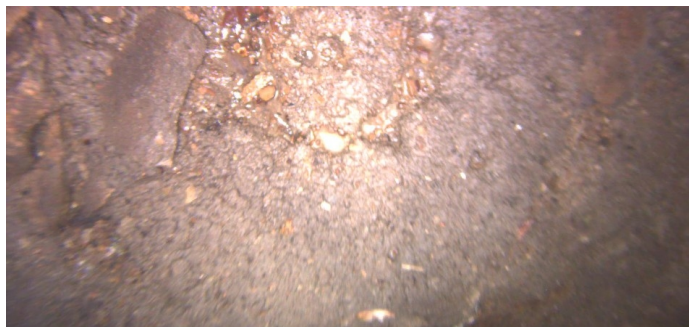
Code: **MGO**
Description: **General Observation**

Distance (ft): **3.6**
Structural Grade: **0**
O&M Grade: **0**
Clock Start/From:
Clock To:
1st Value:
2nd Value:
Value Percent:
Step: **NO**
Remarks: **Ins. Comp.**
