Manhole Inspection Report

Date:	04/19/2018	Weather:		Coding:	RZMACP
MH#:	M-708-151	Owner:	NA	Len. Surveyed:	5.2
P.O.#:		Surveyor:	John Kuglmaier	Rim to Invert:	5.7
Customer:		Cert. #:	U-1215-07002349	Wall Material:	Concrete (reinforced)

Street:	Grand Isle Ct. 181' Northeast of Lake	Project:	Hobart, IN
City:	Hobart, IN	GPS Northing:	2905842.838
Location:		GPS Easting:	2905842.838
Drain Area:	Southwest	GPS Accuracy:	Sub-Meter
Cover Shape:	Circular	Evidence of Surcharge:	No
Cover Size:	22.5	Potential for Runoff:	None
Comments:

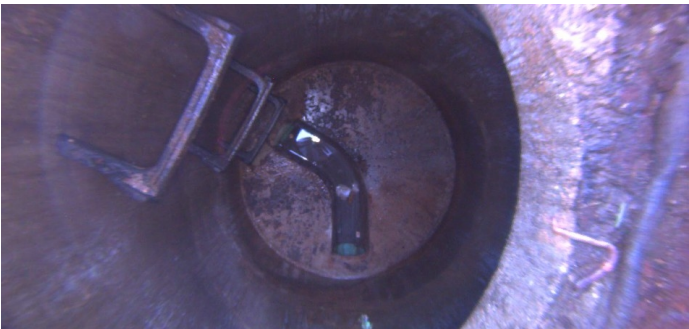
Code:
MGP

Description:
General Photo

Distance (ft):
.0

Structural Grade:
0

O&M Grade:
0

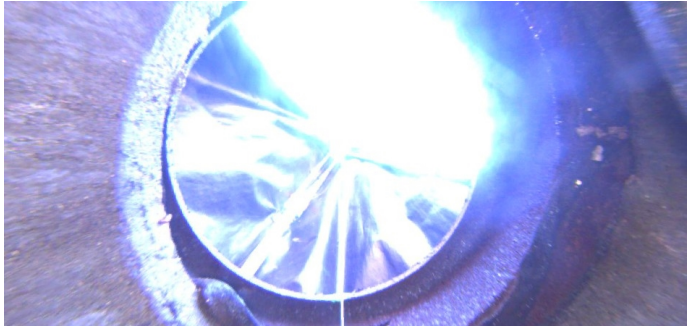
Code:	MGP
Description:	General Photo
Distance (ft):	2.1
Structural Grade:	0
O&M Grade:	0
Clock Start/From:	
Clock To:	
1st Value:	
2nd Value:	
Value Percent:	
Step:	NO
Remarks:

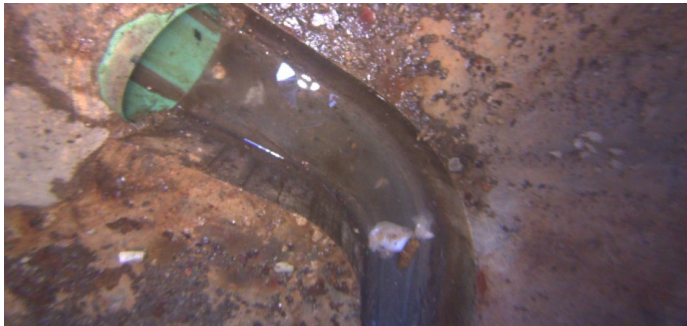
Code:	MGO
Description:	General Observation
Distance (ft):	4.2
Structural Grade:	0
O&M Grade:	0
Clock Start/From:	
Clock To:	
1st Value:	
2nd Value:	
Value Percent:	
Step:	NO
Remarks:	Ins. Comp.
