Manhole Inspection Report

Date:	04/19/2018	Weather:		Coding:	RZMACP
MH#:	M-708-152	Owner:	NA	Len. Surveyed:	4.5
P.O.#:		Surveyor:	John Kuglmaier	Rim to Invert:	5.0
Customer:		Cert. #:	U-1215-07002349	Wall Material:	Concrete (reinforced)

Street:	Grand Isle Ct. North End.	Project:	Hobart, IN
City:	Hobart, IN	GPS Northing:	2905840.851
Location:		GPS Easting:	2905840.851
Drain Area:	Southwest	GPS Accuracy:	Sub-Meter
Cover Shape:	Circular	Evidence of Surcharge:	No
Cover Size:	22.5	Potential for Runoff:	None
Comments:

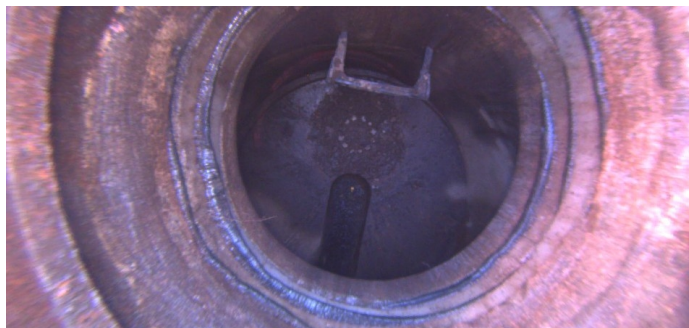
Code: **MGP**
Description: **General Photo**

Distance (ft): **.0**
Structural Grade: **0**
O&M Grade: **0**
Clock Start/From:
Clock To:
1st Value:
2nd Value:
Value Percent:
Step: **NO**
Remarks:

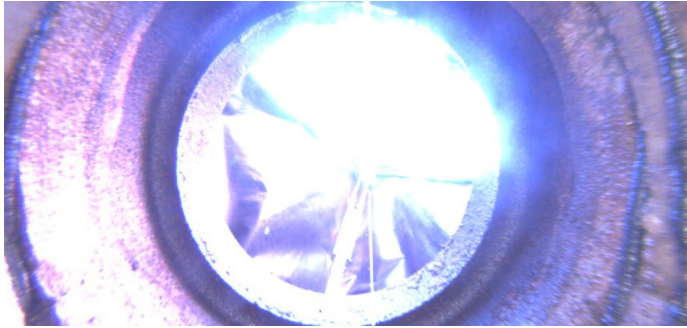
Code: **MGP**
Description: **General Photo**

Distance (ft): **2.5**
Structural Grade: **0**
O&M Grade: **0**
Clock Start/From:
Clock To:
1st Value:
2nd Value:
Value Percent:
Step: **NO**
Remarks:

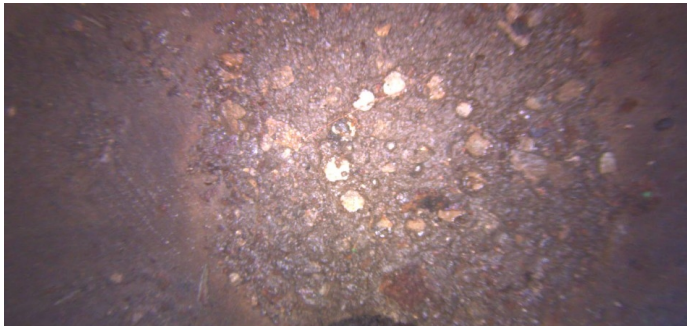
Code: **MGO**
Description: **General Observation**

Distance (ft): **3.8**
Structural Grade: **0**
O&M Grade: **0**
Clock Start/From:
Clock To:
1st Value:
2nd Value:
Value Percent:
Step: **NO**
Remarks: **Ins. Comp.**
