Manhole Inspection Report

Date:	04/10/2018	Weather:		Coding:	RZMACP
MH#:	M-708-165	Owner:	NA	Len. Surveyed:	4.5
P.O.#:		Surveyor:	John Kuglmaier	Rim to Invert:	4.9
Customer:		Cert. #:	U-1215-07002349	Wall Material:	Concrete (reinforced)

Street:	Lincoln St. 315' South of Bracken Par	Project:	Hobart, IN
City:	Hobart, IN	GPS Northing:	2906501.372
Location:		GPS Easting:	2906501.372
Drain Area:	Southwest	GPS Accuracy:	Sub-Meter
Cover Shape:	Circular	Evidence of Surcharge:	No
Cover Size:	22.5	Potential for Runoff:	None
Comments:

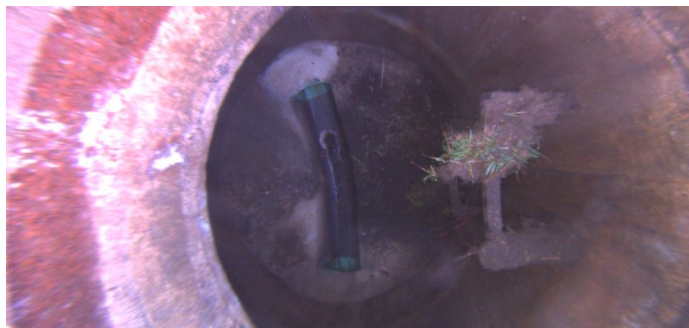
Code: **MGP**
Description: **General Photo**

Distance (ft): **.0**
Structural Grade: **0**
O&M Grade: **0**
Clock Start/From:
Clock To:
1st Value:
2nd Value:
Value Percent:
Step: **NO**
Remarks:

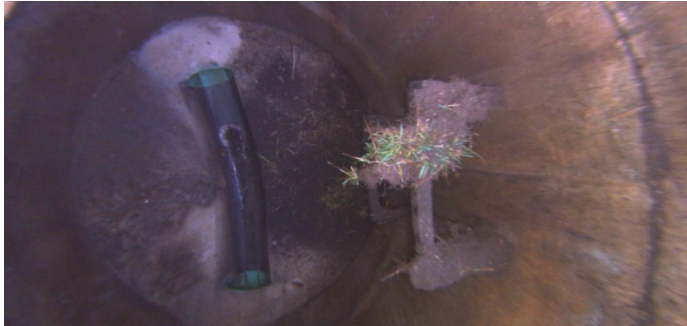
Code: **OBZ**
Description: **Obstacle Other**

Distance (ft): **.5**
Structural Grade: **0**
O&M Grade: **2**
Clock Start/From: **2**
Clock To: **4**
1st Value:
2nd Value:
Value Percent: **5.000**
Step: **YES**
Remarks: **Grass / Mud**

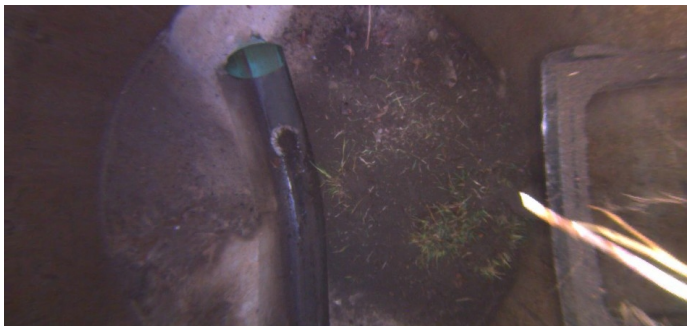
Code: **DAZ**
Description: **Deposits Attached Other**

Distance (ft): **2.1**
Structural Grade: **0**
O&M Grade: **2**
Clock Start/From: **1**
Clock To: **5**
1st Value:
2nd Value:
Value Percent: **5.000**
Step: **NO**
Remarks: **Mixed materials**

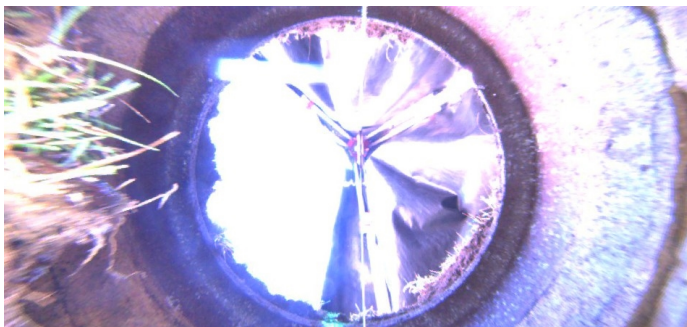
Code: **MGP**
Description: **General Photo**

Distance (ft): **2.3**
Structural Grade: **0**
O&M Grade: **0**
Clock Start/From:
Clock To:
1st Value:
2nd Value:
Value Percent:
Step: **NO**
Remarks:

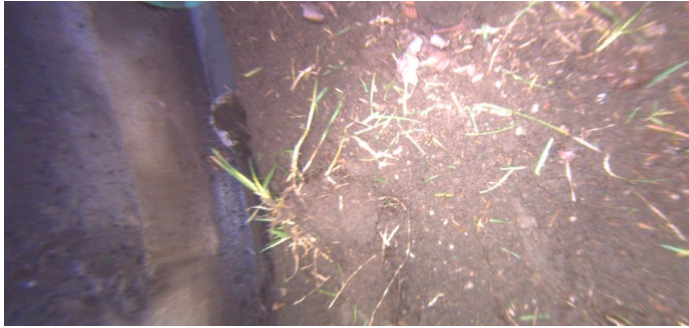
Code:	MGO
Description:	General Observation
Distance (ft):	3.9
Structural Grade:	0
O&M Grade:	0
Clock Start/From:	
Clock To:	
1st Value:	
2nd Value:	
Value Percent:	
Step:	NO
Remarks:	Ins. Comp.
