Manhole Inspection Report

Date:	04/10/2018	Weather:		Coding:	RZMACP
MH#:	M-708-166	Owner:	NA	Len. Surveyed:	3.7
P.O.#:		Surveyor:	John Kuglmaier	Rim to Invert:	4.4
Customer:		Cert. #:	U-1215-07002349	Wall Material:	Concrete (reinforced)

Street:	Lincoln St. and Capitol Dr. to the Nor	Project:	Hobart, IN
City:	Hobart, IN	GPS Northing:	2906518.446
Location:		GPS Easting:	2906518.446
Drain Area:	Southwest	GPS Accuracy:	Sub-Meter
Cover Shape:	Circular	Evidence of Surcharge:	No
Cover Size:	22.5	Potential for Runoff:	None
Comments:

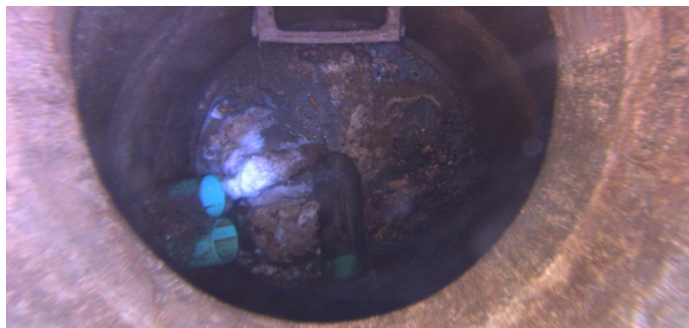
Code: **MGP**
Description: **General Photo**

Distance (ft): **.0**
Structural Grade: **0**
O&M Grade: **0**
Clock Start/From:
Clock To:
1st Value:
2nd Value:
Value Percent:
Step: **NO**
Remarks:

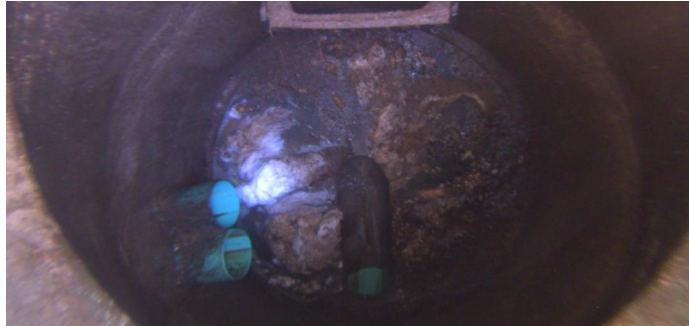
Code:	DAZ
Description:	Deposits Attached Other
Distance (ft):	.5
Structural Grade:	0
O&M Grade:	2
Clock Start/From:	12
Clock To:	12
1st Value:	
2nd Value:	
Value Percent:	10.000
Step:	NO
Remarks:	Mixed materials

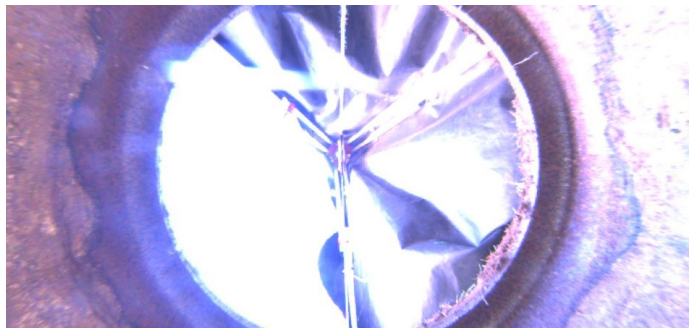
Code:	MGP
Description:	General Photo
Distance (ft):	1.7
Structural Grade:	0
O&M Grade:	0
Clock Start/From:	
Clock To:	
1st Value:	
2nd Value:	
Value Percent:	
Step:	NO
Remarks:

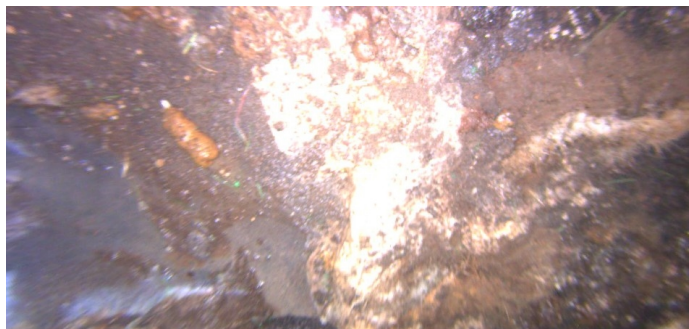
Code:	MGO
Description:	General Observation
Distance (ft):	3.0
Structural Grade:	0
O&M Grade:	0
Clock Start/From:	
Clock To:	
1st Value:	
2nd Value:	
Value Percent:	
Step:	NO
Remarks:	Ins. Comp.
