# Manhole Inspection Report

Date:	11/01/2022	Weather:		Coding:	RZMACP
MH#:	M-709-003	Owner:	NA	Len. Surveyed:	10.9
P.O.#:		Surveyor:	Jen Costello	Rim to Invert:	12.3
Customer:		Cert. #:	U-907-5518	Wall Material:	Concrete (non-reinforced)

Street:	Bracken Parkway. 342' Southeast of	Project:	Missing GPS
City:	Hobart, IN	GPS Northing:	2278731.546
Location:		GPS Easting:	2907207.238
Drain Area:	Southwest	GPS Accuracy:	Sub-Meter
Cover Shape:	Circular	Evidence of Surcharge:	No
Cover Size:	24.0	Potential for Runoff:	None
Comments:

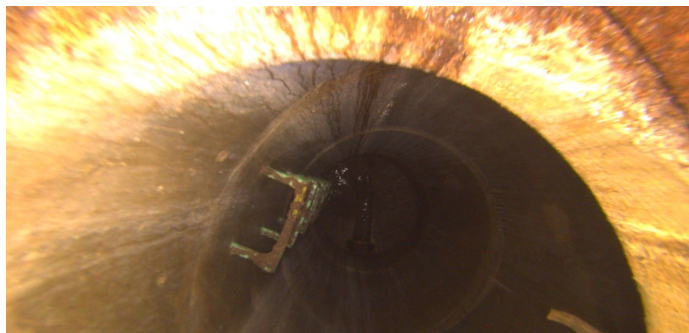
Code: **MGO**  
Description: **General Observation**

Distance (ft): **.0**  
Structural Grade: **0**  
O&M Grade: **0**  
Clock Start/From:  
Clock To:  
1st Value:  
2nd Value:  
Value Percent:  
Step: **NO**  
Remarks: **access mh**

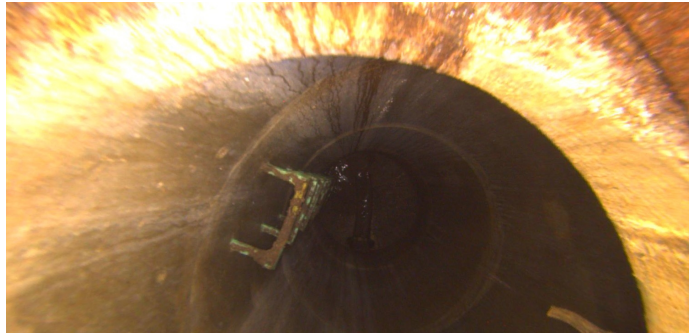
Code:	<b>SRI</b>
Description:	<b>Surface Roughness Increased</b>
Distance (ft):	<b>.0</b>
Structural Grade:	<b>1</b>
O&M Grade:	<b>0</b>
Clock Start/From:	<b>12</b>
Clock To:	<b>12</b>
1st Value:	
2nd Value:	
Value Percent:	
Step:	<b>NO</b>
Remarks:

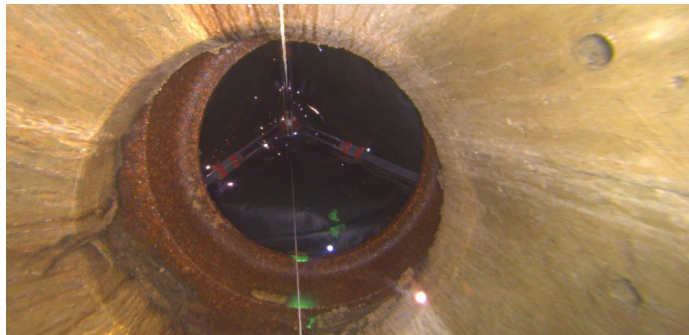
Code:	<b>MGO</b>
Description:	<b>General Observation</b>
Distance (ft):	<b>2.3</b>
Structural Grade:	<b>0</b>
O&M Grade:	<b>0</b>
Clock Start/From:	
Clock To:	
1st Value:	
2nd Value:	
Value Percent:	
Step:	<b>NO</b>
Remarks:	<b>underside of frame</b>

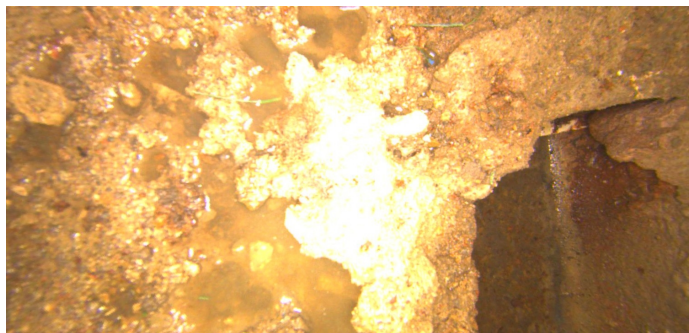
Code:	<b>DSF</b>
Description:	<b>Deposits Settled Fine</b>
Distance (ft):	<b>10.9</b>
Structural Grade:	<b>0</b>
O&M Grade:	<b>2</b>
Clock Start/From:	<b>12</b>
Clock To:	<b>12</b>
1st Value:	
2nd Value:	
Value Percent:	<b>5.000</b>
Step:	<b>NO</b>
Remarks:

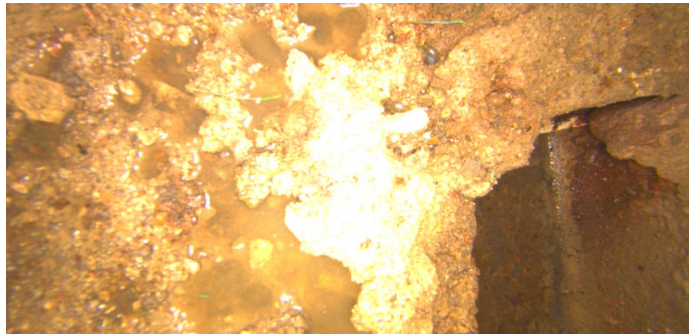
Code: **SRI**  
Description: **Surface Roughness Increased**

Distance (ft): **10.9**  
Structural Grade: **1**  
O&M Grade: **0**  
Clock Start/From: **12**  
Clock To: **12**  
1st Value:  
2nd Value:  
Value Percent:  
Step: **NO**  
Remarks:

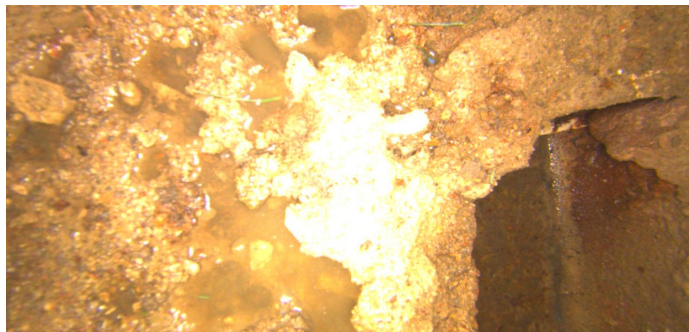
Code: **SAV**  
Description: **Surface Aggregate Visible**

Distance (ft): **10.9**  
Structural Grade: **3**  
O&M Grade: **0**  
Clock Start/From: **3**  
Clock To: **9**  
1st Value:  
2nd Value:  
Value Percent:  
Step: **NO**  
Remarks:
