# Manhole Inspection Report

Date:	04/10/2018	Weather:		Coding:	RZMACP
MH#:	M-709-009	Owner:	NA	Len. Surveyed:	15.9
P.O.#:		Surveyor:	John Kuglmaier	Rim to Invert:	17.0
Customer:		Cert. #:	U-1215-07002349	Wall Material:	Concrete (reinforced)

Street:	Bracken Parkway. 164' North of Tan	Project:	Hobart, IN
City:	Hobart, IN	GPS Northing:	2906956.755
Location:		GPS Easting:	2906956.755
Drain Area:	Southwest	GPS Accuracy:	Sub-Meter
Cover Shape:	Circular	Evidence of Surcharge:	No
Cover Size:	22.5	Potential for Runoff:	None
Comments:

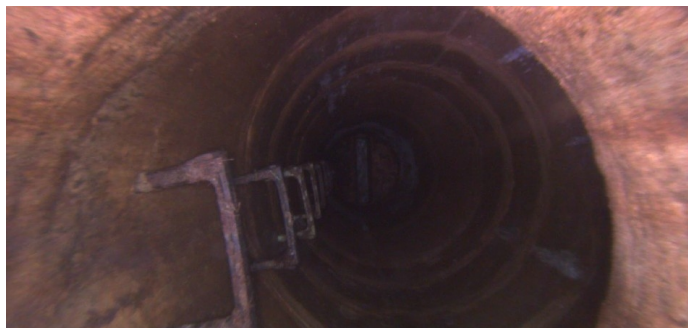
Code: **MGP**  
Description: **General Photo**

Distance (ft): **.0**  
Structural Grade: **0**  
O&M Grade: **0**  
Clock Start/From:  
Clock To:  
1st Value:  
2nd Value:  
Value Percent:  
Step: **NO**  
Remarks:

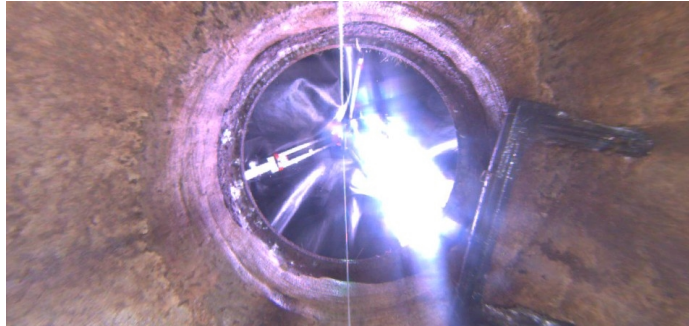
Code: **MGP**  
Description: **General Photo**

Distance (ft): **2.9**  
Structural Grade: **0**  
O&M Grade: **0**  
Clock Start/From:  
Clock To:  
1st Value:  
2nd Value:  
Value Percent:  
Step: **NO**  
Remarks:

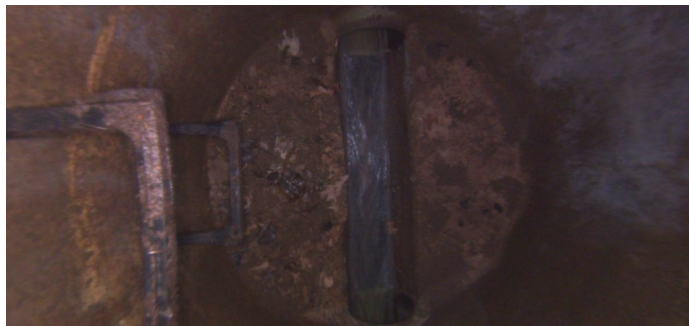
Code: **DAZ**  
Description: **Deposits Attached Other**

Distance (ft): **13.1**  
Structural Grade: **0**  
O&M Grade: **2**  
Clock Start/From: **12**  
Clock To: **12**  
1st Value:  
2nd Value:  
Value Percent: **5.000**  
Step: **NO**  
Remarks: **Mixed materials**

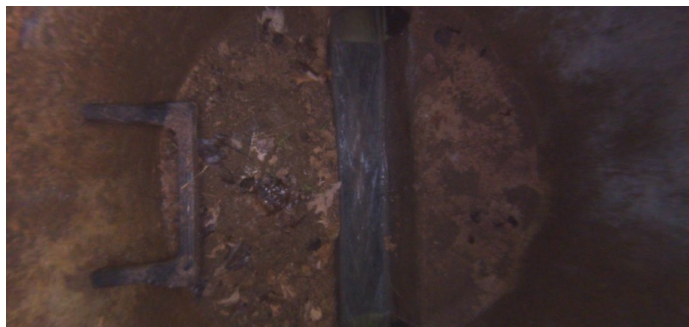
Code: **MGO**  
Description: **General Observation**

Distance (ft): **13.8**  
Structural Grade: **0**  
O&M Grade: **0**  
Clock Start/From:  
Clock To:  
1st Value:  
2nd Value:  
Value Percent:  
Step: **NO**  
Remarks: **Ins. Comp.**
