Manhole Inspection Report

Date:	04/12/2018	Weather:		Coding:	RZMACP
MH#:	M-709-012	Owner:	NA	Len. Surveyed:	12.4
P.O.#:		Surveyor:	John Kuglmaier	Rim to Invert:	12.7
Customer:		Cert. #:	U-1215-07002349	Wall Material:	Concrete (reinforced)

Street:	Avocet Circle. Dunlin Circle.	Project:	Hobart, IN
City:	Hobart, IN	GPS Northing:	2906768.201
Location:		GPS Easting:	2906768.201
Drain Area:	Southwest	GPS Accuracy:	Sub-Meter
Cover Shape:	Circular	Evidence of Surcharge:	Yes
Cover Size:	22.5	Potential for Runoff:	None
Comments:

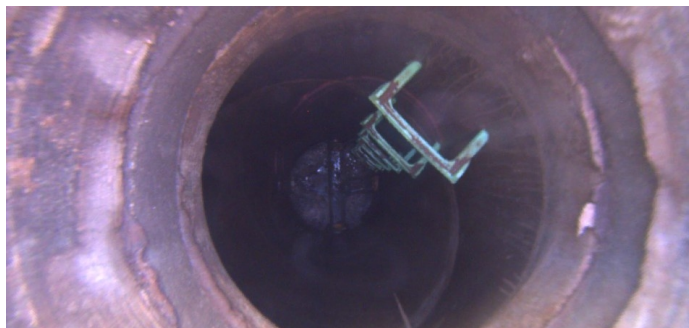
Code: **MGP**
Description: **General Photo**

Distance (ft): **.0**
Structural Grade: **0**
O&M Grade: **0**
Clock Start/From:
Clock To:
1st Value:
2nd Value:
Value Percent:
Step: **NO**
Remarks:

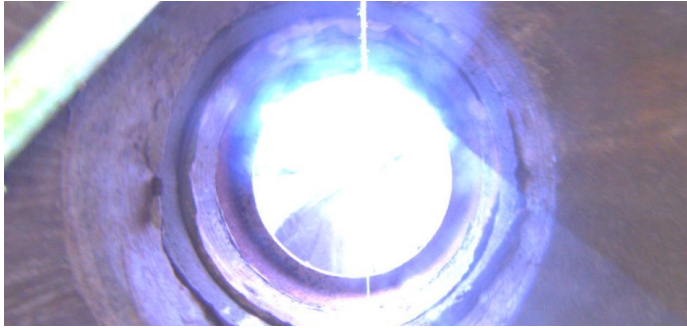
Code: **MGP**
Description: **General Photo**

Distance (ft): **2.9**
Structural Grade: **0**
O&M Grade: **0**
Clock Start/From:
Clock To:
1st Value:
2nd Value:
Value Percent:
Step: **NO**
Remarks:

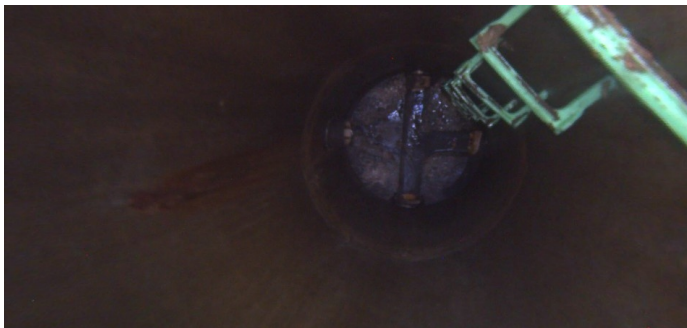
Code: **IS**
Description: **Infil Stain**

Distance (ft): **3.7**
Structural Grade: **0**
O&M Grade: **0**
Clock Start/From: **8**
Clock To:
1st Value:
2nd Value:
Value Percent:
Step: **NO**
Remarks:

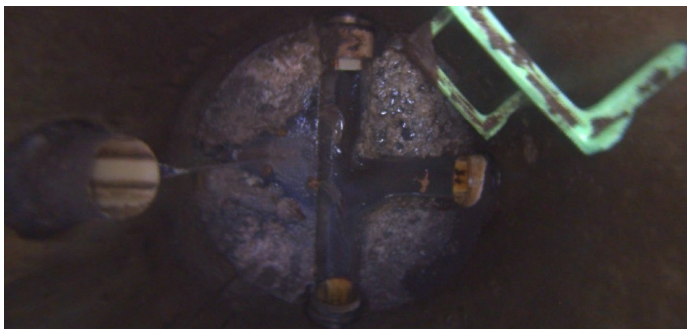
Code: **DAZ**
Description: **Deposits Attached Other**

Distance (ft): **8.9**
Structural Grade: **0**
O&M Grade: **2**
Clock Start/From: **12**
Clock To: **12**
1st Value:
2nd Value:
Value Percent: **10.000**
Step: **NO**
Remarks: **Mixed materials**

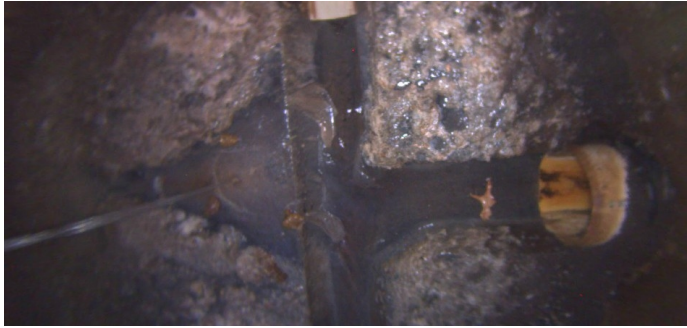
Code:	MGO
Description:	General Observation
Distance (ft):	10.6
Structural Grade:	0
O&M Grade:	0
Clock Start/From:	
Clock To:	
1st Value:	
2nd Value:	
Value Percent:	
Step:	NO
Remarks:	Ins. Comp.
