# Manhole Inspection Report

Date:	<b>04/12/2018</b>	Weather:		Coding:	<b>RZMACP</b>
MH#:	<b>M-709-015</b>	Owner:	<b>NA</b>	Len. Surveyed:	<b>9.1</b>
P.O.#:		Surveyor:	<b>John Kuglmaier</b>	Rim to Invert:	<b>9.2</b>
Customer:		Cert. #:	<b>U-1215-07002349</b>	Wall Material:	<b>Concrete (reinforced)</b>

Street:	<b>Dunlin Circle. Southwest Corner.</b>	Project:	<b>Hobart, IN</b>
City:	<b>Hobart, IN</b>	GPS Northing:	<b>2906239.581</b>
Location:		GPS Easting:	<b>2906239.581</b>
Drain Area:	<b>Southwest</b>	GPS Accuracy:	<b>Sub-Meter</b>
Cover Shape:	<b>Circular</b>	Evidence of Surcharge:	<b>No</b>
Cover Size:	<b>22.5</b>	Potential for Runoff:	<b>None</b>
Comments:

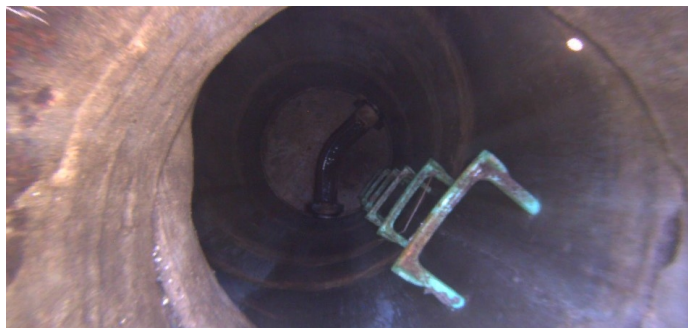
Code: **MGP**  
Description: **General Photo**

Distance (ft): **.0**  
Structural Grade: **0**  
O&M Grade: **0**  
Clock Start/From:  
Clock To:  
1st Value:  
2nd Value:  
Value Percent:  
Step: **NO**  
Remarks:

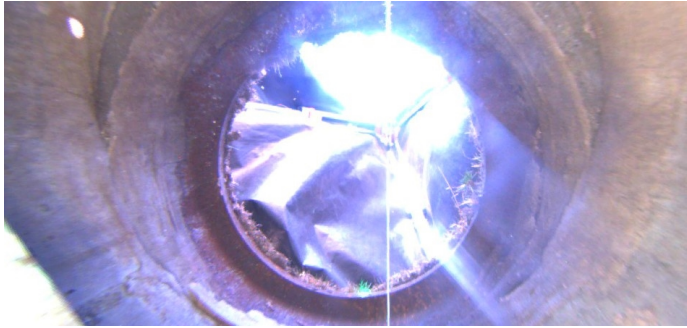
Code: **MGP**  
Description: **General Photo**

Distance (ft): **2.5**  
Structural Grade: **0**  
O&M Grade: **0**  
Clock Start/From:  
Clock To:  
1st Value:  
2nd Value:  
Value Percent:  
Step: **NO**  
Remarks:

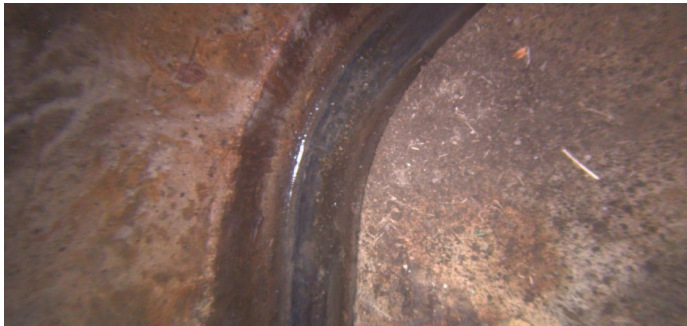
Code: **MGO**  
Description: **General Observation**

Distance (ft): **7.7**  
Structural Grade: **0**  
O&M Grade: **0**  
Clock Start/From:  
Clock To:  
1st Value:  
2nd Value:  
Value Percent:  
Step: **NO**  
Remarks: **Ins. Comp.**
