Manhole Inspection Report

Date:	04/12/2018	Weather:		Coding:	RZMACP
MH#:	M-709-017	Owner:	NA	Len. Surveyed:	8.5
P.O.#:		Surveyor:	John Kuglmaier	Rim to Invert:	9.1
Customer:		Cert. #:	U-1215-07002349	Wall Material:	Concrete (reinforced)

Street:	Dunlin Ct. Northwest Corner.	Project:	Hobart, IN
City:	Hobart, IN	GPS Northing:	2906187.73
Location:		GPS Easting:	2906187.73
Drain Area:	Southwest	GPS Accuracy:	Sub-Meter
Cover Shape:	Circular	Evidence of Surcharge:	No
Cover Size:	22.5	Potential for Runoff:	None
Comments:

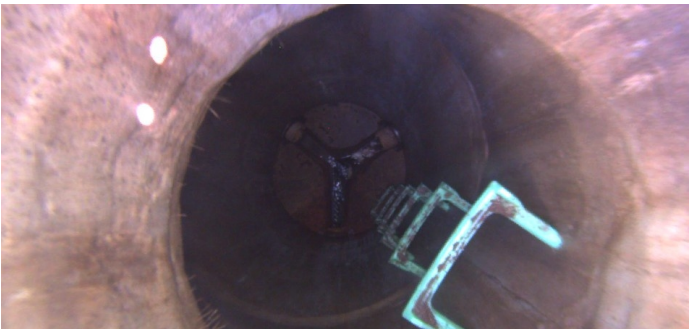
Code:
MGP

Description:
General Photo

Distance (ft):
.0

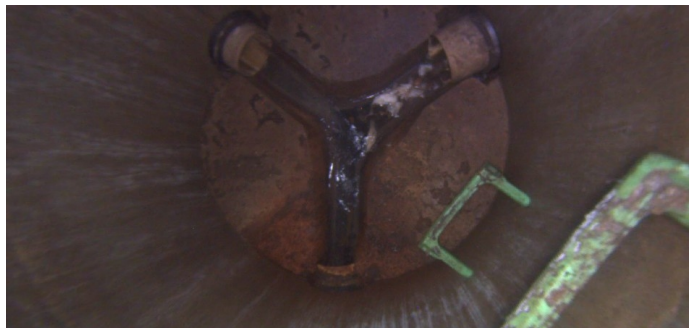
Code: **IS**
Description: **Infil Stain**

Distance (ft): **5.3**
Structural Grade: **0**
O&M Grade: **0**
Clock Start/From: **5**
Clock To: **7**
1st Value:
2nd Value:
Value Percent:
Step: **NO**
Remarks:

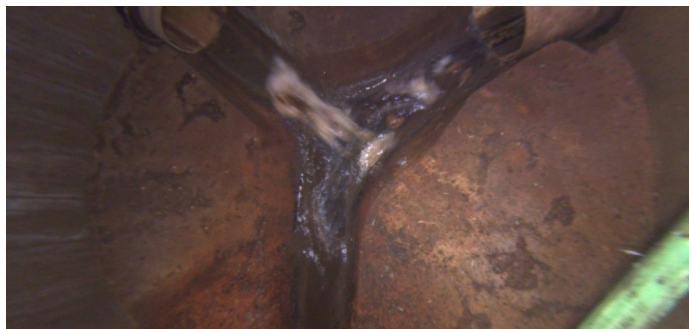
Code: **MGO**
Description: **General Observation**

Distance (ft): **7.0**
Structural Grade: **0**
O&M Grade: **0**
Clock Start/From:
Clock To:
1st Value:
2nd Value:
Value Percent:
Step: **NO**
Remarks: **Ins. Comp.**
