Manhole Inspection Report

Date:	04/12/2018	Weather:		Coding:	RZMACP
MH#:	M-709-018	Owner:	NA	Len. Surveyed:	7.5
P.O.#:		Surveyor:	John Kuglmaier	Rim to Invert:	8.2
Customer:		Cert. #:	U-1215-07002349	Wall Material:	Concrete (reinforced)

Street:	Dunlin Cir. the North Side.	Project:	Hobart, IN
City:	Hobart, IN	GPS Northing:	2906317.022
Location:		GPS Easting:	2906317.022
Drain Area:	Southwest	GPS Accuracy:	Sub-Meter
Cover Shape:	Circular	Evidence of Surcharge:	No
Cover Size:	22.5	Potential for Runoff:	None
Comments:

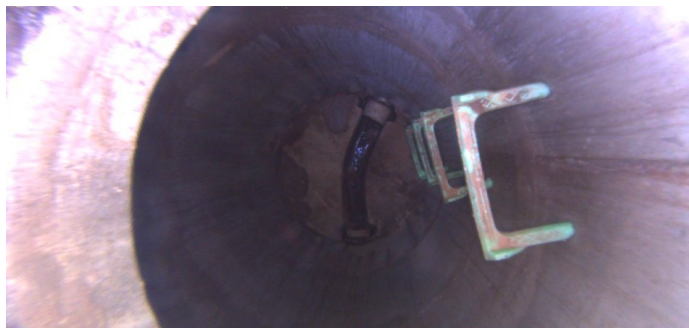
Code: **MGP**
Description: **General Photo**

Distance (ft): **.0**
Structural Grade: **0**
O&M Grade: **0**
Clock Start/From:
Clock To:
1st Value:
2nd Value:
Value Percent:
Step: **NO**
Remarks:

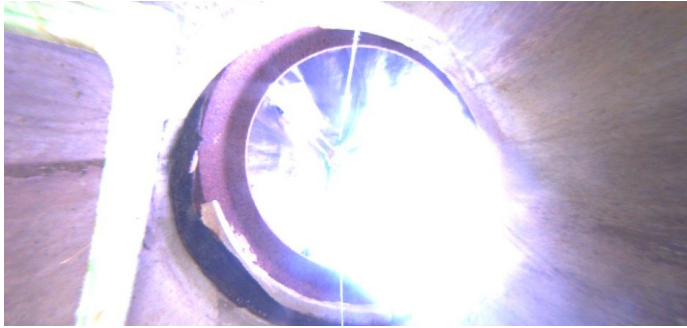
Code: **MGP**
Description: **General Photo**

Distance (ft): **2.7**
Structural Grade: **0**
O&M Grade: **0**
Clock Start/From:
Clock To:
1st Value:
2nd Value:
Value Percent:
Step: **NO**
Remarks:

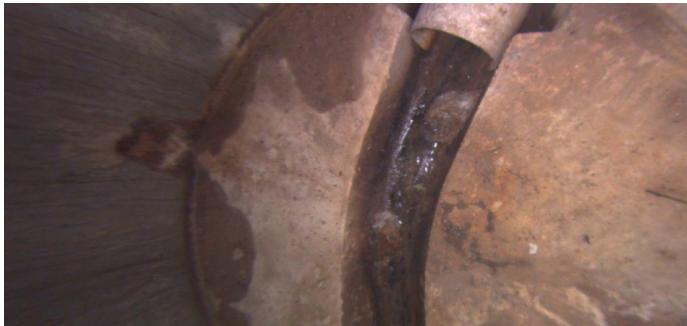
Code: **IS**
Description: **Infil Stain**

Distance (ft): **5.8**
Structural Grade: **0**
O&M Grade: **0**
Clock Start/From: **9**
Clock To:
1st Value:
2nd Value:
Value Percent:
Step: **NO**
Remarks:

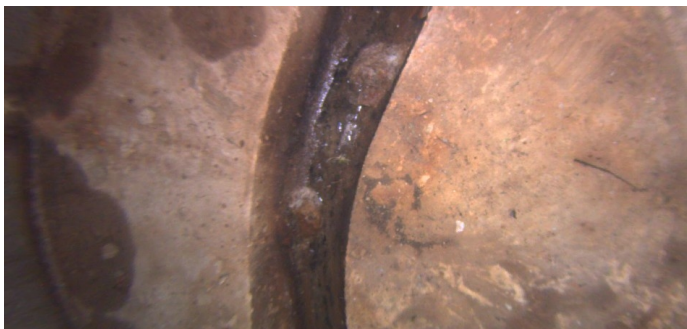
Code: **MGO**
Description: **General Observation**

Distance (ft): **6.3**
Structural Grade: **0**
O&M Grade: **0**
Clock Start/From:
Clock To:
1st Value:
2nd Value:
Value Percent:
Step: **NO**
Remarks: **Ins. Comp.**
