Manhole Inspection Report

| MH#: | M-709-019 | Owner: | NA | Len. Surveyed: | 7.5 |

| Street: | Dunlin Circle. Northeast Side. | Project: | Hobart, IN |

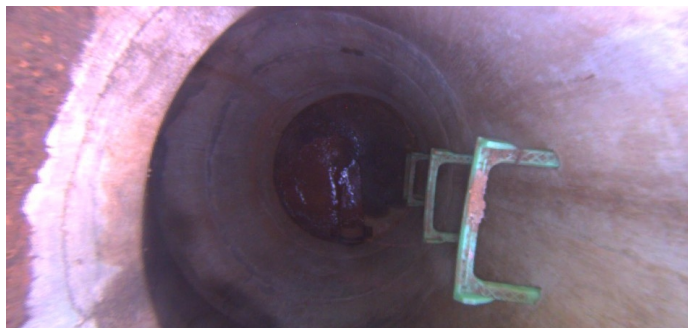
Code: **MGP**
Description: **General Photo**

Distance (ft): **.0**
Structural Grade: **0**
O&M Grade: **0**
Clock Start/From:
Clock To:
1st Value:
2nd Value:
Value Percent:
Step: **NO**
Remarks:

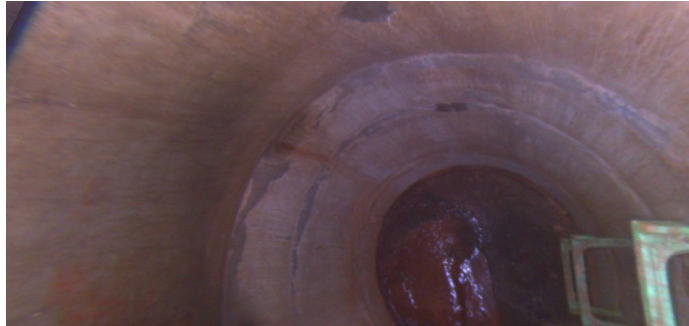
Code: **IS**
Description: **Infil Stain**

Distance (ft): **1.2**
Structural Grade: **0**
O&M Grade: **0**
Clock Start/From: **10**
Clock To:
1st Value:
2nd Value:
Value Percent:
Step: **NO**
Remarks:

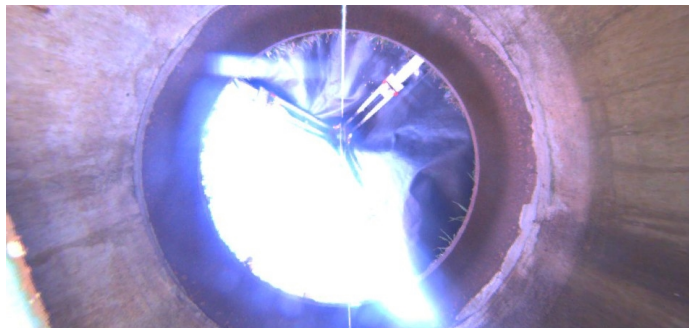
Code: **MGP**
Description: **General Photo**

Distance (ft): **2.3**
Structural Grade: **0**
O&M Grade: **0**
Clock Start/From:
Clock To:
1st Value:
2nd Value:
Value Percent:
Step: **NO**
Remarks:

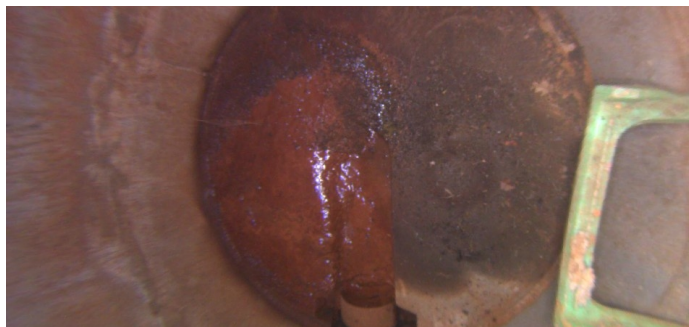
Code: **IS**
Description: **Infil Stain**

Distance (ft): **5.0**
Structural Grade: **0**
O&M Grade: **0**
Clock Start/From: **7**
Clock To: **9**
1st Value:
2nd Value:
Value Percent:
Step: **NO**
Remarks:

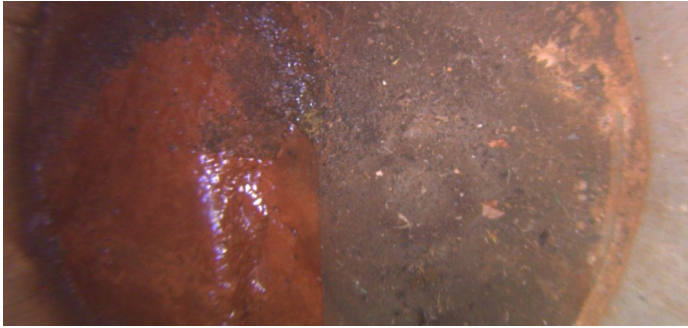
| Code: | MGO |
| Description: | General Observation |
| Distance (ft): | 6.1 |
| Remarks: | Ins. Comp. |
