Manhole Inspection Report

Date:	04/11/2018	Weather:		Coding:	RZMACP
MH#:	M-709-021	Owner:	NA	Len. Surveyed:	6.3
P.O.#:		Surveyor:	John Kuglmaier	Rim to Invert:	6.9
Customer:		Cert. #:	U-1215-07002349	Wall Material:	Concrete (reinforced)

Street:	Avocet Circle. Northwest Corner.	Project:	Hobart, IN
City:	Hobart, IN	GPS Northing:	2906144.472
Location:		GPS Easting:	2906144.472
Drain Area:	Southwest	GPS Accuracy:	Sub-Meter
Cover Shape:	Circular	Evidence of Surcharge:	No
Cover Size:	22.5	Potential for Runoff:	None
Comments:

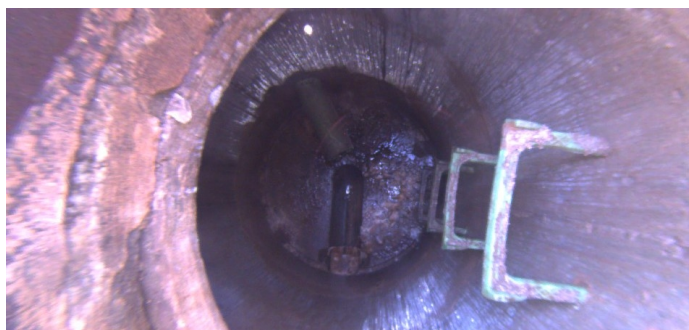
Code: **MGP**
Description: **General Photo**

Distance (ft): **.0**
Structural Grade: **0**
O&M Grade: **0**
Clock Start/From:
Clock To:
1st Value:
2nd Value:
Value Percent:
Step: **NO**
Remarks:

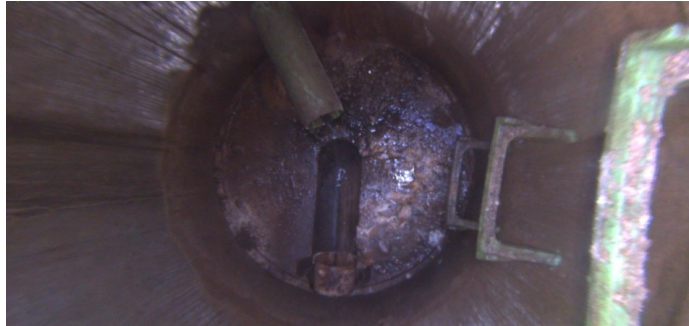
Code: **IS**
Description: **Infil Stain**

Distance (ft): **2.1**
Structural Grade: **0**
O&M Grade: **0**
Clock Start/From: **12**
Clock To: **12**
1st Value:
2nd Value:
Value Percent:
Step: **NO**
Remarks:

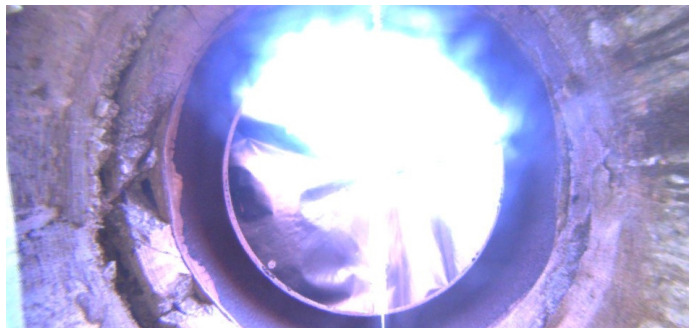
Code: **MGP**
Description: **General Photo**

Distance (ft): **2.2**
Structural Grade: **0**
O&M Grade: **0**
Clock Start/From:
Clock To:
1st Value:
2nd Value:
Value Percent:
Step: **NO**
Remarks:

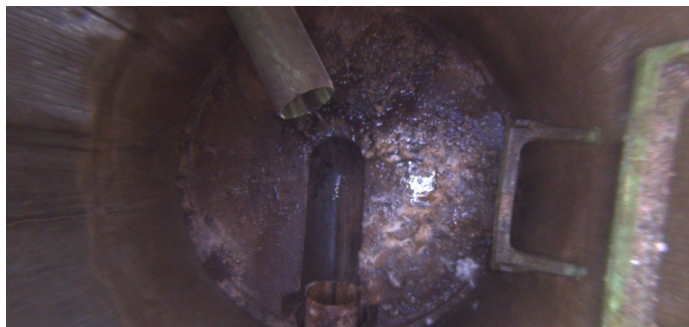
Code: **DAZ**
Description: **Deposits Attached Other**

Distance (ft): **3.1**
Structural Grade: **0**
O&M Grade: **2**
Clock Start/From: **12**
Clock To: **12**
1st Value:
2nd Value:
Value Percent: **5.000**
Step: **NO**
Remarks: **Mixed materials**

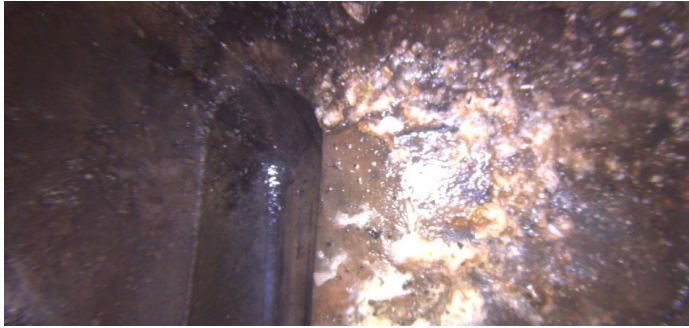
Code:	MGO
Description:	General Observation
Distance (ft):	5.1
Structural Grade:	0
O&M Grade:	0
Clock Start/From:	
Clock To:	
1st Value:	
2nd Value:	
Value Percent:	
Step:	NO
Remarks:	Ins. Comp.
