Manhole Inspection Report

Date:	04/11/2018	Weather:		Coding:	RZMACP
MH#:	M-709-023	Owner:	NA	Len. Surveyed:	6.4
P.O.#:		Surveyor:	John Kuglmaier	Rim to Invert:	7.0
Customer:		Cert. #:	U-1215-07002349	Wall Material:	Concrete (reinforced)

Street:	Avocet Circle. 1 Manhole East of Nor	Project:	Hobart, IN
City:	Hobart, IN	GPS Northing:	2906406.628
Location:		GPS Easting:	2906406.628
Drain Area:	Southwest	GPS Accuracy:	Sub-Meter
Cover Shape:	Circular	Evidence of Surcharge:	No
Cover Size:	22.5	Potential for Runoff:	None
Comments:

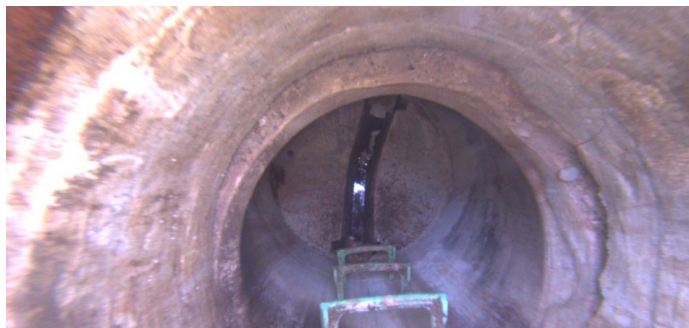
Code: **MGP**
Description: **General Photo**

Distance (ft): **.0**
Structural Grade: **0**
O&M Grade: **0**
Clock Start/From:
Clock To:
1st Value:
2nd Value:
Value Percent:
Step: **NO**
Remarks:

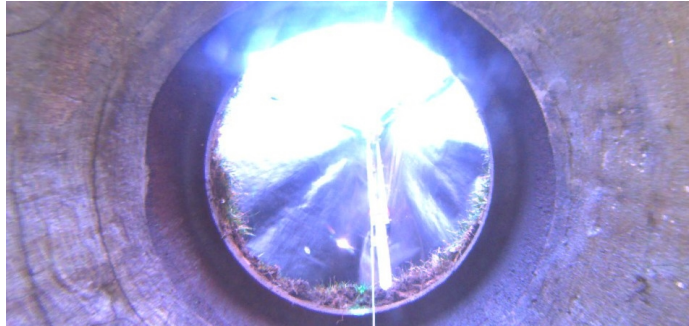
Code: **MGP**
Description: **General Photo**

Distance (ft): **2.2**
Structural Grade: **0**
O&M Grade: **0**
Clock Start/From:
Clock To:
1st Value:
2nd Value:
Value Percent:
Step: **NO**
Remarks:

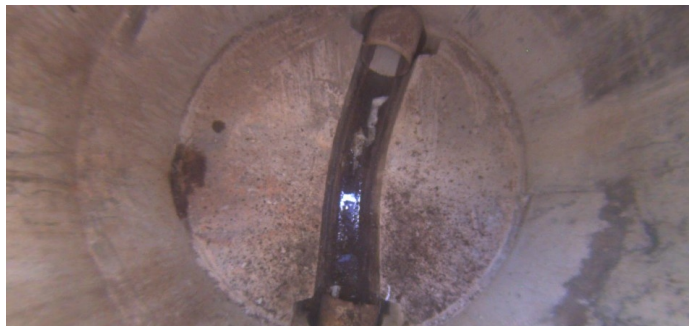
Code: **IS**
Description: **Infil Stain**

Distance (ft): **3.2**
Structural Grade: **0**
O&M Grade: **0**
Clock Start/From: **9**
Clock To:
1st Value:
2nd Value:
Value Percent:
Step: **NO**
Remarks:

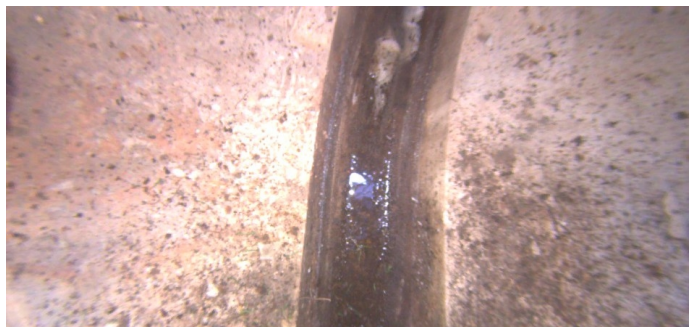
Code: **MGO**
Description: **General Observation**

Distance (ft): **5.2**
Structural Grade: **0**
O&M Grade: **0**
Clock Start/From:
Clock To:
1st Value:
2nd Value:
Value Percent:
Step: **NO**
Remarks: **Ins. Comp.**
