Manhole Inspection Report

Date:	04/12/2018	Weather:		Coding:	RZMACP
MH#:	M-709-030	Owner:	NA	Len. Surveyed:	9.1
P.O.#:		Surveyor:	John Kuglmaier	Rim to Invert:	9.8
Customer:		Cert. #:	U-1215-07002349	Wall Material:	Concrete (reinforced)

Street:	Waxwing Circle. 191' South of Dunli	Project:	Hobart, IN
City:	Hobart, IN	GPS Northing:	2906775.341
Location:		GPS Easting:	2906775.341
Drain Area:	Southwest	GPS Accuracy:	Sub-Meter
Cover Shape:	Circular	Evidence of Surcharge:	No
Cover Size:	22.5	Potential for Runoff:	None
Comments:

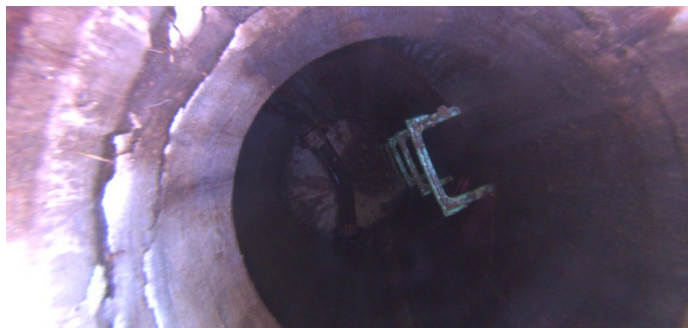
Code: **MGP**
Description: **General Photo**

Distance (ft): **.0**
Structural Grade: **0**
O&M Grade: **0**
Clock Start/From:
Clock To:
1st Value:
2nd Value:
Value Percent:
Step: **NO**
Remarks:

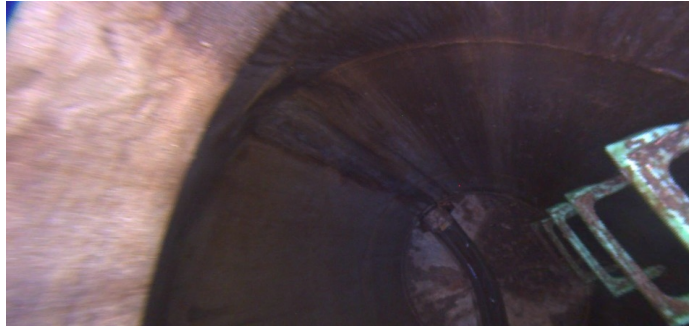
Code: **IS**
Description: **Infil Stain**

Distance (ft): **1.6**
Structural Grade: **0**
O&M Grade: **0**
Clock Start/From: **10**
Clock To:
1st Value:
2nd Value:
Value Percent:
Step: **NO**
Remarks:

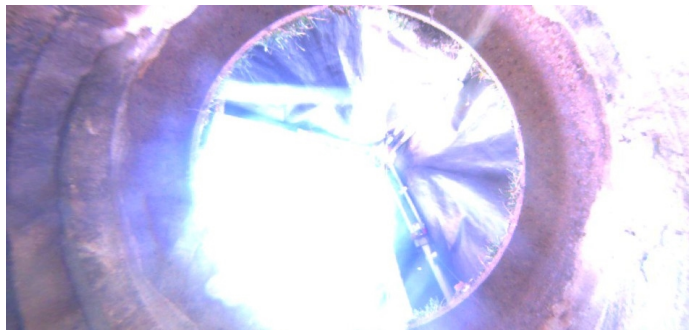
Code: **MGP**
Description: **General Photo**

Distance (ft): **2.1**
Structural Grade: **0**
O&M Grade: **0**
Clock Start/From:
Clock To:
1st Value:
2nd Value:
Value Percent:
Step: **NO**
Remarks:

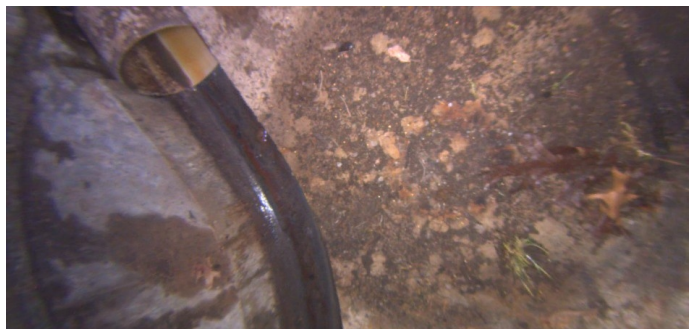
Code: **MGO**
Description: **General Observation**

Distance (ft): **8.1**
Structural Grade: **0**
O&M Grade: **0**
Clock Start/From:
Clock To:
1st Value:
2nd Value:
Value Percent:
Step: **NO**
Remarks: **Ins. Comp.**
