Manhole Inspection Report

Date:	11/01/2022	Weather:		Coding:	RZMACP
MH#:	M-709-033	Owner:	NA	Len. Surveyed:	5.7
P.O.#:		Surveyor:	Jen Costello	Rim to Invert:	6.7
Customer:		Cert. #:	U-907-5518	Wall Material:	Concrete (non-reinforced)

Street:	Waxwing Circle. Southwest Corner.	Project:	Missing GPS
City:	Hobart, IN	GPS Northing:	2278620.77
Location:		GPS Easting:	2906445.071
Drain Area:	Southwest	GPS Accuracy:	Sub-Meter
Cover Shape:	Circular	Evidence of Surcharge:	No
Cover Size:	24.0	Potential for Runoff:	None
Comments:

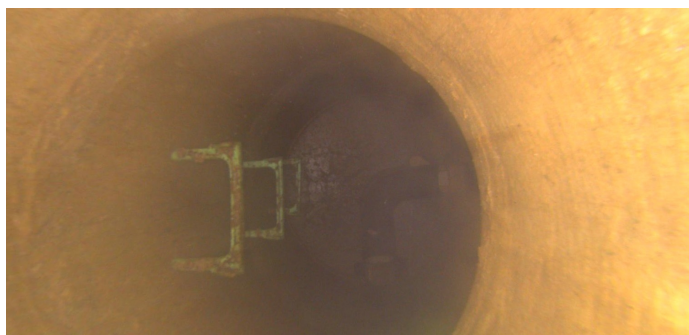
Code: **MGO**
Description: **General Observation**

Distance (ft): **.0**
Structural Grade: **0**
O&M Grade: **0**
Clock Start/From:
Clock To:
1st Value:
2nd Value:
Value Percent:
Step: **NO**
Remarks: **access mh**

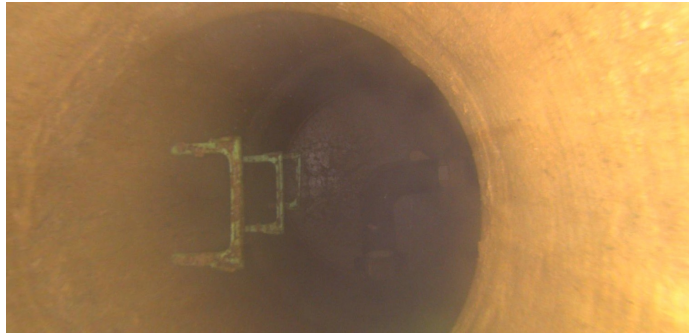
Code: **SRI**
Description: **Surface Roughness Increased**

Distance (ft): **.0**
Structural Grade: **1**
O&M Grade: **0**
Clock Start/From: **12**
Clock To: **12**
1st Value:
2nd Value:
Value Percent:
Step: **NO**
Remarks:

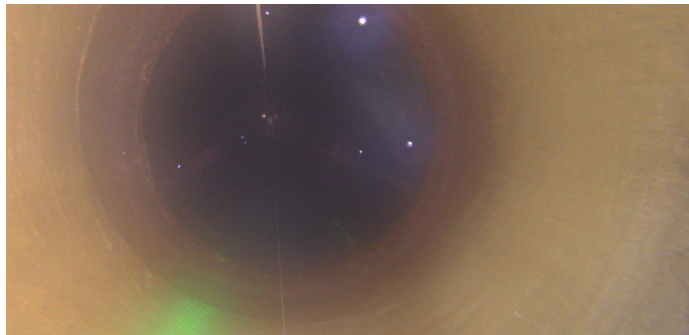
Code: **MGO**
Description: **General Observation**

Distance (ft): **1.7**
Structural Grade: **0**
O&M Grade: **0**
Clock Start/From:
Clock To:
1st Value:
2nd Value:
Value Percent:
Step: **NO**
Remarks: **underside of frame**

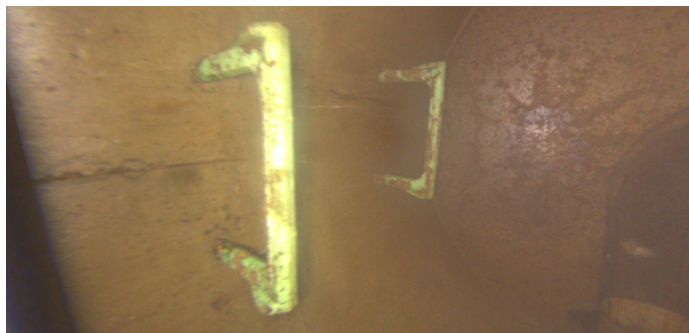
Code: **FL**
Description: **Fracture Longitudinal**

Distance (ft): **2.9**
Structural Grade: **3**
O&M Grade: **0**
Clock Start/From: **9**
Clock To:
1st Value:
2nd Value:
Value Percent:
Step: **NO**
Remarks:

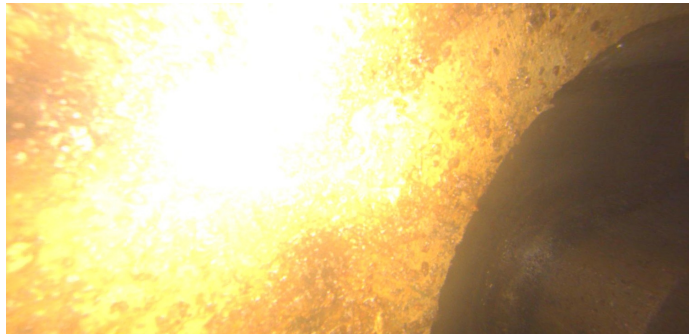
Code: **SAV**
Description: **Surface Aggregate Visible**

Distance (ft): **5.7**
Structural Grade: **3**
O&M Grade: **0**
Clock Start/From: **3**
Clock To: **9**
1st Value:
2nd Value:
Value Percent:
Step: **NO**
Remarks:

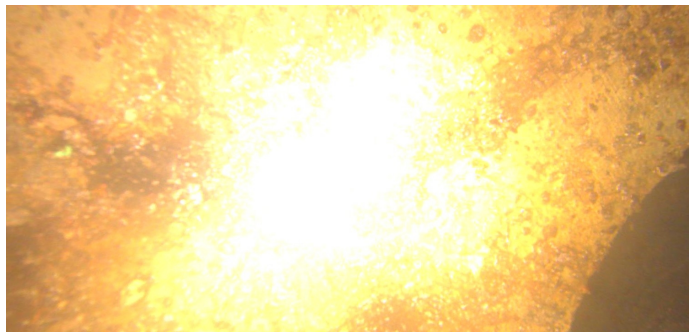
Code: **DSF**
Description: **Deposits Settled Fine**

Distance (ft): **5.7**
Structural Grade: **0**
O&M Grade: **2**
Clock Start/From: **12**
Clock To: **12**
1st Value:
2nd Value:
Value Percent: **5.000**
Step: **NO**
Remarks:

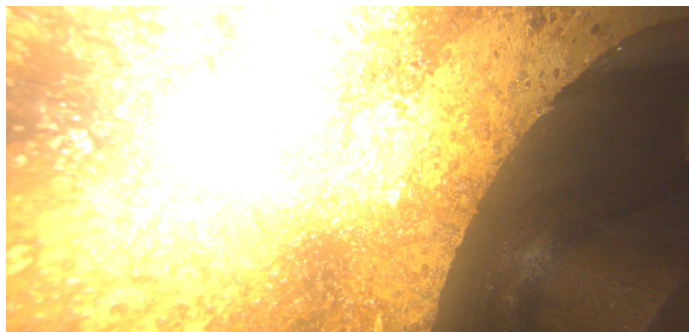
Code: **SRI**
Description: **Surface Roughness Increased**

Distance (ft): **5.7**
Structural Grade: **1**
O&M Grade: **0**
Clock Start/From: **12**
Clock To: **12**
1st Value:
2nd Value:
Value Percent:
Step: **NO**
Remarks:

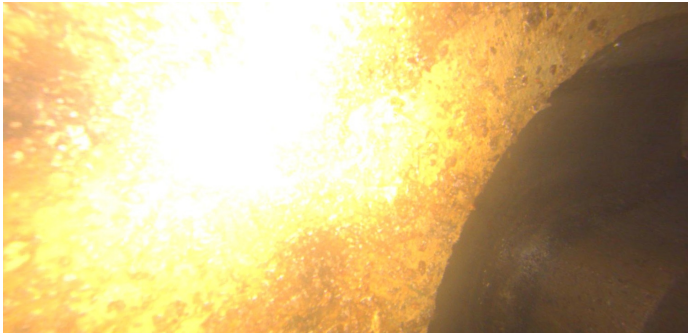
Code:	MGO
Description:	General Observation
Distance (ft):	5.7
Structural Grade:	0
O&M Grade:	0
Clock Start/From:	
Clock To:	
1st Value:	
2nd Value:	
Value Percent:	
Step:	NO
Remarks:	end of survey
