# Manhole Inspection Report

Date:	<b>04/11/2018</b>	Weather:		Coding:	<b>RZMACP</b>
MH#:	<b>M-709-035</b>	Owner:	<b>NA</b>	Len. Surveyed:	<b>10.4</b>
P.O.#:		Surveyor:	<b>John Kuglmaier</b>	Rim to Invert:	<b>10.9</b>
Customer:		Cert. #:	<b>U-1215-07002349</b>	Wall Material:	<b>Concrete (reinforced)</b>

Street:	<b>Tanager St. 298' East of Bracken Par</b>	Project:	<b>Hobart, IN</b>
City:	<b>Hobart, IN</b>	GPS Northing:	<b>2907289.891</b>
Location:		GPS Easting:	<b>2907289.891</b>
Drain Area:	<b>Southwest</b>	GPS Accuracy:	<b>Sub-Meter</b>
Cover Shape:	<b>Circular</b>	Evidence of Surcharge:	<b>No</b>
Cover Size:	<b>22.5</b>	Potential for Runoff:	<b>None</b>
Comments:

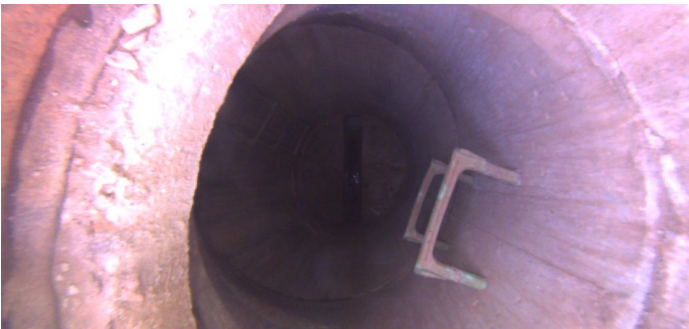
Code: **MGP**  
 Description: **General Photo**

Distance (ft): **.0**  
 Structural Grade: **0**  
 O&M Grade: **0**  
 Clock Start/From:  
 Clock To:  
 1st Value:  
 2nd Value:  
 Value Percent:  
 Step: **NO**  
 Remarks:

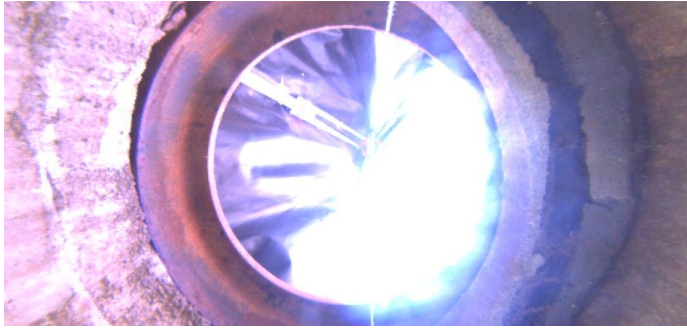
Code:	<b>MGP</b>
Description:	<b>General Photo</b>
Distance (ft):	<b>2.1</b>
Structural Grade:	<b>0</b>
O&M Grade:	<b>0</b>
Clock Start/From:	
Clock To:	
1st Value:	
2nd Value:	
Value Percent:	
Step:	<b>NO</b>
Remarks:

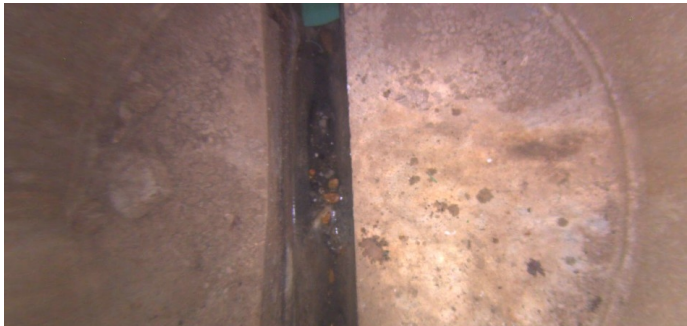
Code:	<b>MGO</b>
Description:	<b>General Observation</b>
Distance (ft):	<b>8.6</b>
Structural Grade:	<b>0</b>
O&M Grade:	<b>0</b>
Clock Start/From:	
Clock To:	
1st Value:	
2nd Value:	
Value Percent:	
Step:	<b>NO</b>
Remarks:	<b>Ins. Comp.</b>
