Manhole Inspection Report

Date:	03/22/2018	Weather:		Coding:	RZMACP
MH#:	M-802-001	Owner:	NA	Len. Surveyed:	4.3
P.O.#:		Surveyor:	John Kuglmaier	Rim to Invert:	5.5
Customer:		Cert. #:	U-1215-07002349	Wall Material:	Concrete (reinforced)

Street:	197' North of Hwy 6. and West of H	Project:	Hobart, IN
City:	Hobart, IN	GPS Northing:	0.0
Location:		GPS Easting:	0.0
Drain Area:	Northeast	GPS Accuracy:	Nearest Meter
Cover Shape:	Circular	Evidence of Surcharge:	Yes
Cover Size:	23.0	Potential for Runoff:	None
Comments:

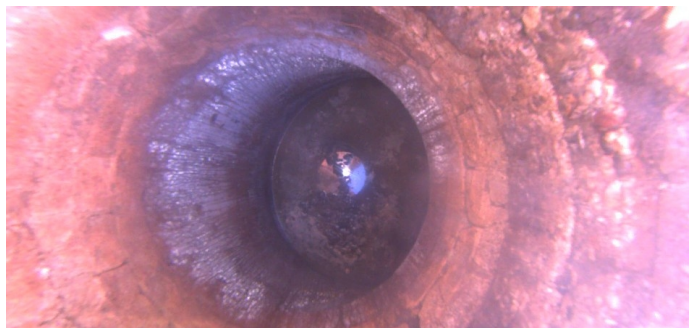
Code: **MGP**
Description: **General Photo**

Distance (ft): **.0**
Structural Grade: **0**
O&M Grade: **0**
Clock Start/From:
Clock To:
1st Value:
2nd Value:
Value Percent:
Step: **NO**
Remarks:

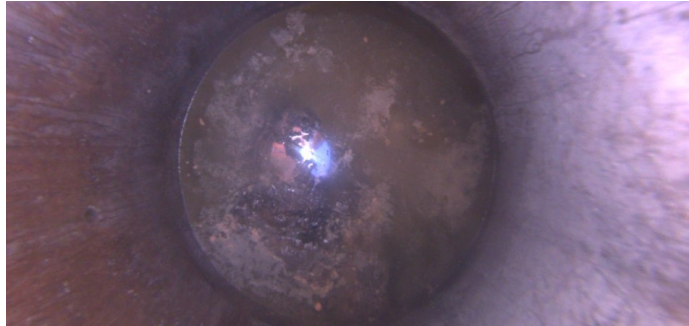
Code: **MGO**
Description: **General Observation**

Distance (ft): **2.1**
Structural Grade: **0**
O&M Grade: **0**
Clock Start/From:
Clock To:
1st Value:
2nd Value:
Value Percent:
Step: **NO**
Remarks: **Surcharge**

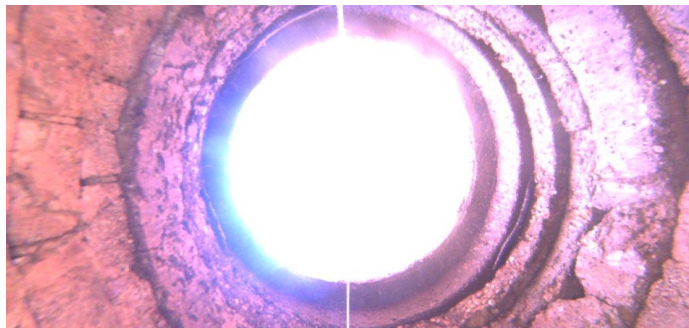
Code: **MGP**
Description: **General Photo**

Distance (ft): **2.3**
Structural Grade: **0**
O&M Grade: **0**
Clock Start/From:
Clock To:
1st Value:
2nd Value:
Value Percent:
Step: **NO**
Remarks:

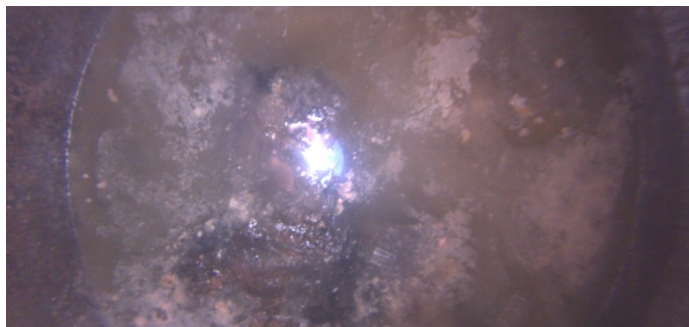
Code: **MGO**
Description: **General Observation**

Distance (ft): **3.6**
Structural Grade: **0**
O&M Grade: **0**
Clock Start/From:
Clock To:
1st Value:
2nd Value:
Value Percent:
Step: **NO**
Remarks: **Ins. Comp.**
