Manhole Inspection Report

Date:	03/22/2018	Weather:		Coding:	RZMACP
MH#:	M-802-002	Owner:	NA	Len. Surveyed:	4.8
P.O.#:		Surveyor:	John Kuglmaier	Rim to Invert:	6.0
Customer:		Cert. #:	U-1215-07002349	Wall Material:	Concrete (reinforced)

Street:	363' North of Hwy 6. and West of H	Project:	Hobart, IN
City:	Hobart, IN	GPS Northing:	0.0
Location:		GPS Easting:	0.0
Drain Area:	Northeast	GPS Accuracy:	Nearest Meter
Cover Shape:	Circular	Evidence of Surcharge:	Yes
Cover Size:	23.0	Potential for Runoff:	None
Comments:

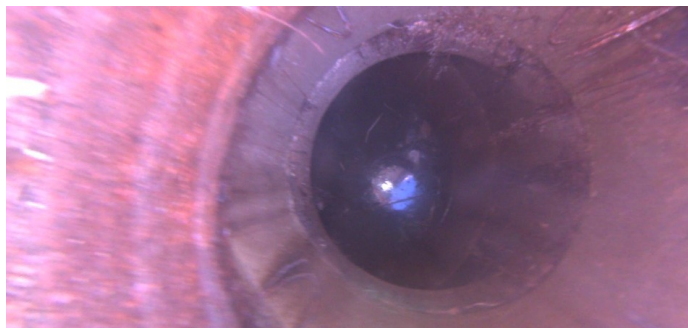
Code: **MGP**
Description: **General Photo**

Distance (ft): **.0**
Structural Grade: **0**
O&M Grade: **0**
Clock Start/From:
Clock To:
1st Value:
2nd Value:
Value Percent:
Step: **NO**
Remarks:

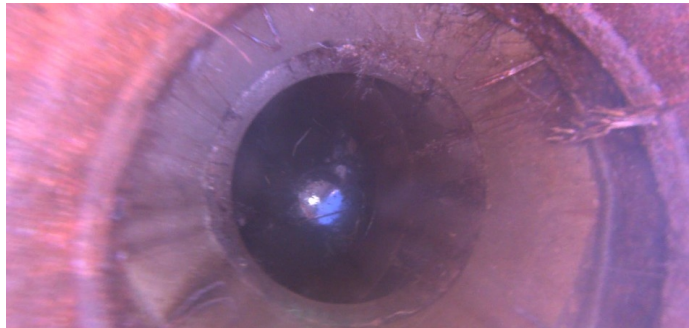
Code: **RFJ**
Description: **Roots Fine Joint**

Distance (ft): **.0**
Structural Grade: **0**
O&M Grade: **1**
Clock Start/From: **8**
Clock To: **2**
1st Value:
2nd Value:
Value Percent:
Step: **NO**
Remarks:

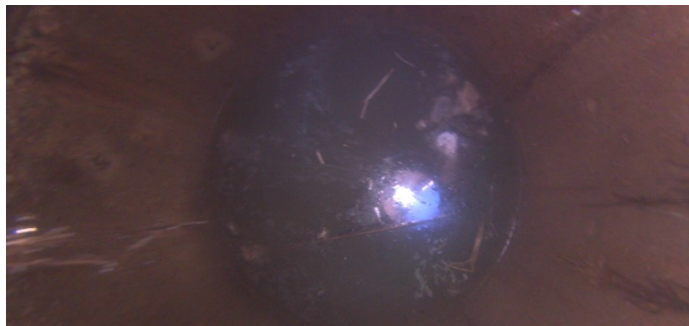
Code: **MGO**
Description: **General Observation**

Distance (ft): **2.5**
Structural Grade: **0**
O&M Grade: **0**
Clock Start/From:
Clock To:
1st Value:
2nd Value:
Value Percent:
Step: **NO**
Remarks: **Surcharge**

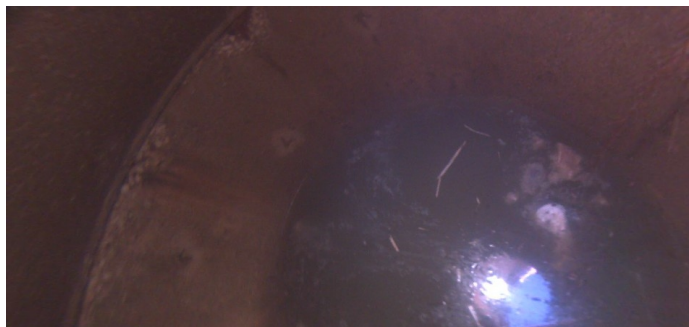
Code: **IS**
Description: **Infil Stain**

Distance (ft): **2.7**
Structural Grade: **0**
O&M Grade: **0**
Clock Start/From: **10**
Clock To:
1st Value:
2nd Value:
Value Percent:
Step: **NO**
Remarks:

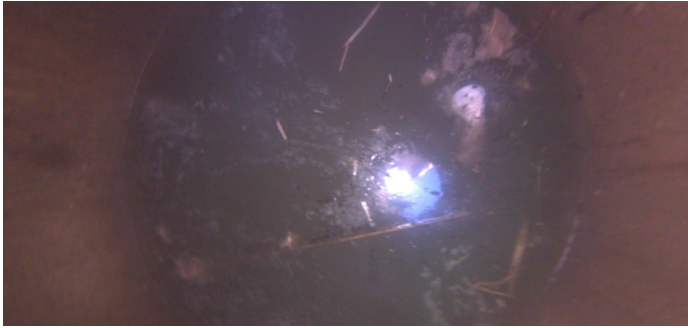
Code:	MSA
Description:	Abandoned Survey
Distance (ft):	3.4
Structural Grade:	0
O&M Grade:	0
Clock Start/From:	
Clock To:	
1st Value:	
2nd Value:	
Value Percent:	
Step:	NO
Remarks:	Surcharge
