Manhole Inspection Report

Street:	North of Hwy 6. and 291' West of H	Project:	Hobart, IN
City:	Hobart, IN	GPS Northing:	0.0
Location:		GPS Easting:	0.0
Drain Area:	Northeast	GPS Accuracy:	Nearest Meter
Cover Shape:	Circular	Evidence of Surcharge:	No
Cover Size:	23.0	Potential for Runoff:	None
Comments:

M-802-003

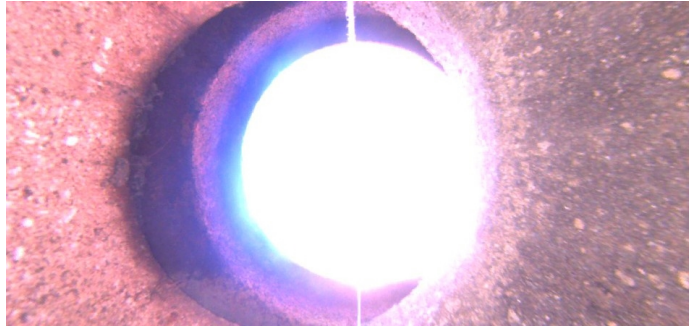
Code:	MGP
Description:	General Photo

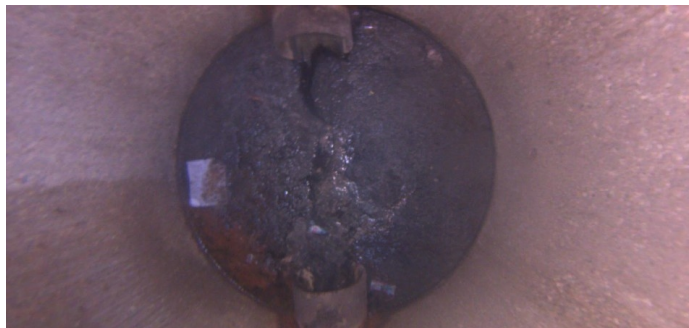
Code: **MGP**
Description: **General Photo**

Distance (ft): **2.3**
Structural Grade: **0**
O&M Grade: **0**
Clock Start/From:
Clock To:
1st Value:
2nd Value:
Value Percent:
Step: **NO**
Remarks:

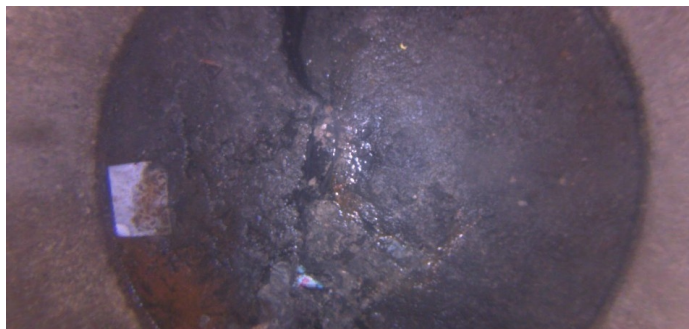
Code: **DAZ**
Description: **Deposits Attached Other**

Distance (ft): **4.9**
Structural Grade: **0**
O&M Grade: **2**
Clock Start/From: **12**
Clock To: **12**
1st Value:
2nd Value:
Value Percent: **10.000**
Step: **NO**
Remarks: **Mixed materials**
