Manhole Inspection Report

Date:	04/12/2018	Weather:		Coding:	RZMACP
MH#:	M-802-006	Owner:	NA	Len. Surveyed:	6.8
P.O.#:		Surveyor:	John Kuglmaier	Rim to Invert:	8.0
Customer:		Cert. #:	U-1215-07002349	Wall Material:	Concrete (reinforced)

Street:	Wisconsin St. 29' North of 40th Plac	Project:	Hobart, IN
City:	Hobart, IN	GPS Northing:	2909628.27
Location:		GPS Easting:	2909628.27
Drain Area:	Northwest	GPS Accuracy:	Sub-Meter
Cover Shape:	Circular	Evidence of Surcharge:	No
Cover Size:	23.0	Potential for Runoff:	None
Comments:

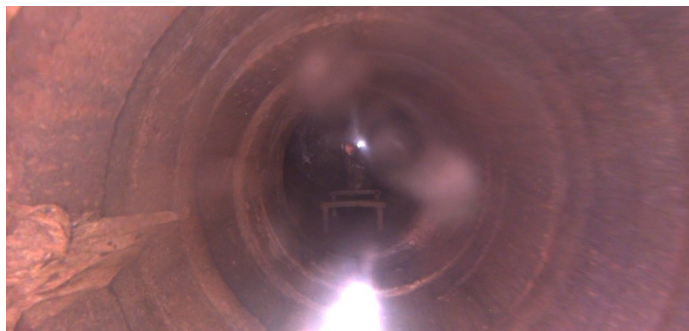
Code: **MGP**
Description: **General Photo**

Distance (ft): **.0**
Structural Grade: **0**
O&M Grade: **0**
Clock Start/From:
Clock To:
1st Value:
2nd Value:
Value Percent:
Step: **NO**
Remarks:

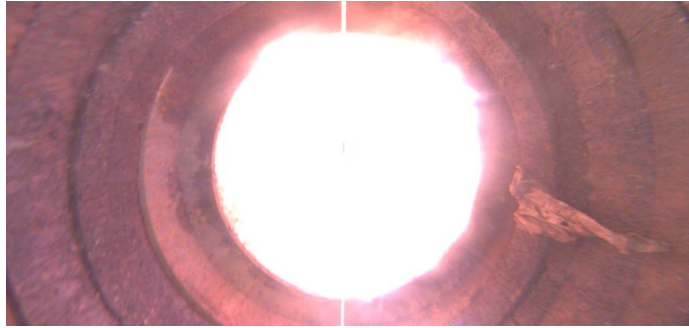
Code: **MGP**
Description: **General Photo**

Distance (ft): **2.2**
Structural Grade: **0**
O&M Grade: **0**
Clock Start/From:
Clock To:
1st Value:
2nd Value:
Value Percent:
Step: **NO**
Remarks:

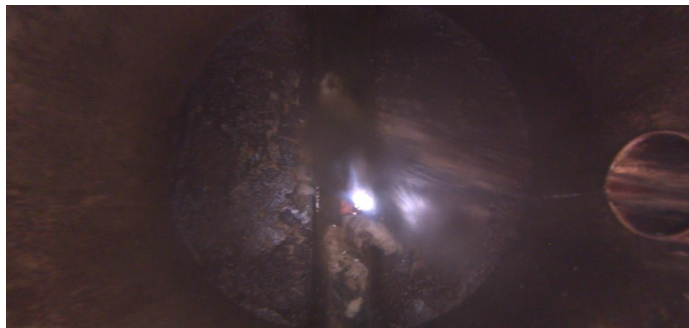
Code: **DAZ**
Description: **Deposits Attached Other**

Distance (ft): **4.6**
Structural Grade: **0**
O&M Grade: **2**
Clock Start/From: **12**
Clock To: **12**
1st Value:
2nd Value:
Value Percent: **5.000**
Step: **NO**
Remarks: **Mixed materials**

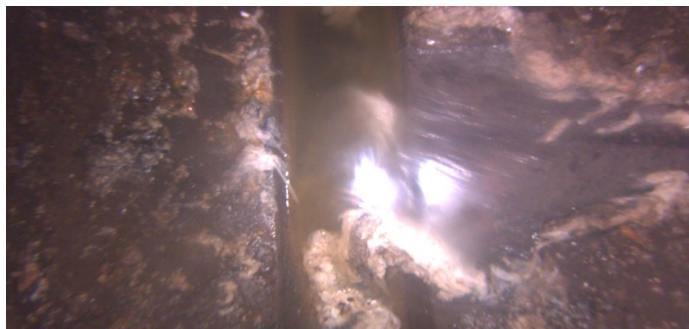
Code: **MGO**
Description: **General Observation**

Distance (ft): **6.2**
Structural Grade: **0**
O&M Grade: **0**
Clock Start/From:
Clock To:
1st Value:
2nd Value:
Value Percent:
Step: **NO**
Remarks: **Ins. Comp.**
