# Manhole Inspection Report

Date:	<b>03/22/2018</b>	Weather:		Coding:	<b>RZMACP</b>
MH#:	<b>M-802-007</b>	Owner:	<b>NA</b>	Len. Surveyed:	<b>8.1</b>
P.O.#:		Surveyor:	<b>John Kuglmaier</b>	Rim to Invert:	<b>9.3</b>
Customer:		Cert. #:	<b>U-1215-07002349</b>	Wall Material:	<b>Concrete (reinforced)</b>

Street:	<b>Hwy 51. 465' South of 34th Ln.</b>	Project:	<b>Hobart, IN</b>
City:	<b>Hobart, IN</b>	GPS Northing:	<b>0.0</b>
Location:		GPS Easting:	<b>0.0</b>
Drain Area:	<b>Northeast</b>	GPS Accuracy:	<b>Nearest Meter</b>
Cover Shape:	<b>Circular</b>	Evidence of Surcharge:	<b>Yes</b>
Cover Size:	<b>23.0</b>	Potential for Runoff:	<b>None</b>
Comments:

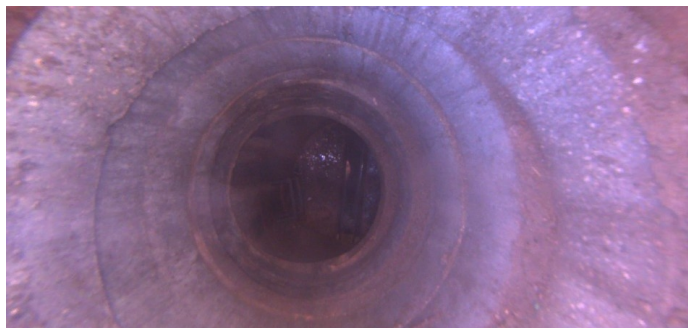
Code: **MGP**  
Description: **General Photo**

Distance (ft): **.0**  
Structural Grade: **0**  
O&M Grade: **0**  
Clock Start/From:  
Clock To:  
1st Value:  
2nd Value:  
Value Percent:  
Step: **NO**  
Remarks:

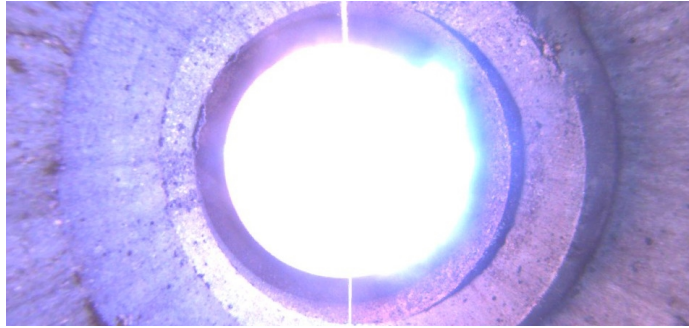
Code: **MGP**  
Description: **General Photo**

Distance (ft): **2.3**  
Structural Grade: **0**  
O&M Grade: **0**  
Clock Start/From:  
Clock To:  
1st Value:  
2nd Value:  
Value Percent:  
Step: **NO**  
Remarks:

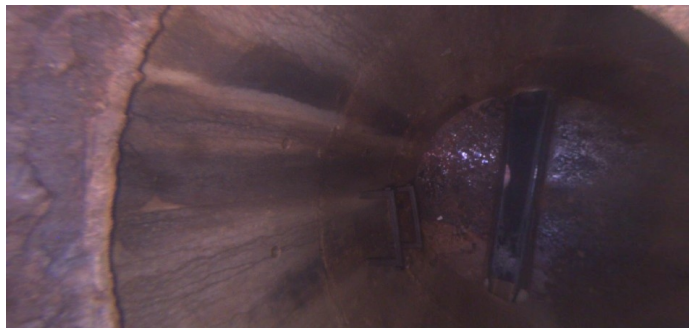
Code: **IS**  
Description: **Infil Stain**

Distance (ft): **2.7**  
Structural Grade: **0**  
O&M Grade: **0**  
Clock Start/From: **8**  
Clock To: **10**  
1st Value:  
2nd Value:  
Value Percent:  
Step: **NO**  
Remarks:

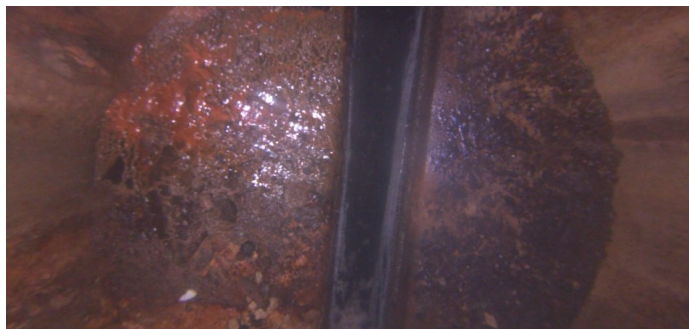
Code: **MGO**  
Description: **General Observation**

Distance (ft): **6.6**  
Structural Grade: **0**  
O&M Grade: **0**  
Clock Start/From:  
Clock To:  
1st Value:  
2nd Value:  
Value Percent:  
Step: **NO**  
Remarks: **Ins. Comp.**
