Manhole Inspection Report

Date:	03/22/2018	Weather:		Coding:	RZMACP
MH#:	M-802-008	Owner:	NA	Len. Surveyed:	9.1
P.O.#:		Surveyor:	John Kuglmaier	Rim to Invert:	10.0
Customer:		Cert. #:	U-1215-07002349	Wall Material:	Concrete (reinforced)

Street:	South of 34th Ln. 271' West of Hwy	Project:	Hobart, IN
City:	Hobart, IN	GPS Northing:	0.0
Location:		GPS Easting:	0.0
Drain Area:	Northeast	GPS Accuracy:	Nearest Meter
Cover Shape:	Circular	Evidence of Surcharge:	Yes
Cover Size:	23.0	Potential for Runoff:	None
Comments:

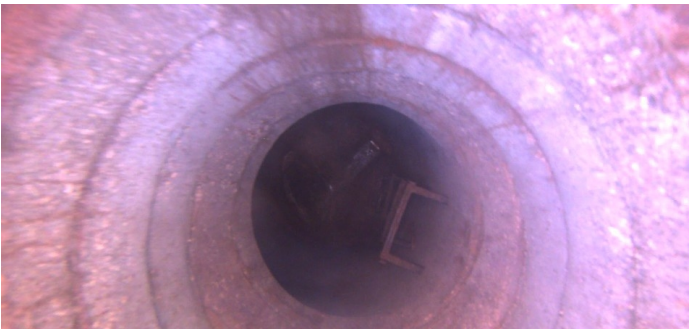
Code: **MGP**
 Description: **General Photo**

Distance (ft): **.0**
 Structural Grade: **0**
 O&M Grade: **0**
 Clock Start/From:
 Clock To:
 1st Value:
 2nd Value:
 Value Percent:
 Step: **NO**
 Remarks:

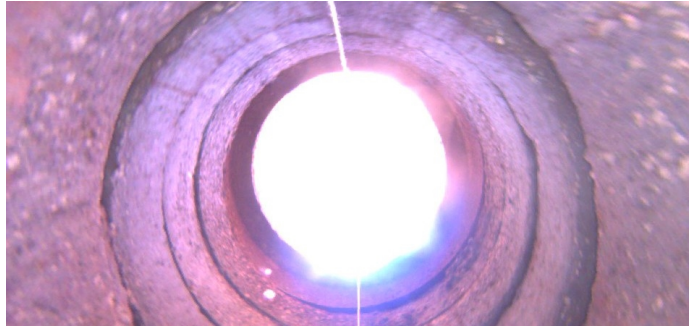
Code: **MGP**
Description: **General Photo**

Distance (ft): **2.8**
Structural Grade: **0**
O&M Grade: **0**
Clock Start/From:
Clock To:
1st Value:
2nd Value:
Value Percent:
Step: **NO**
Remarks:

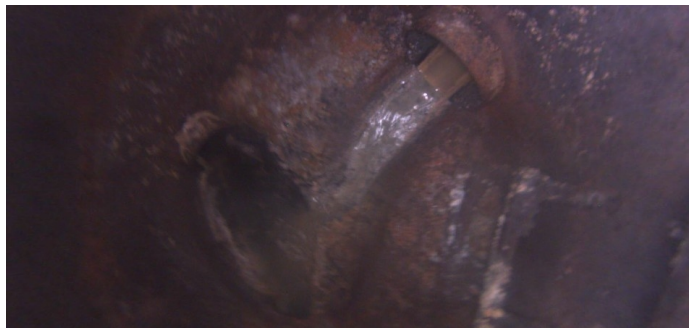
Code: **DAZ**
Description: **Deposits Attached Other**

Distance (ft): **6.1**
Structural Grade: **0**
O&M Grade: **2**
Clock Start/From: **12**
Clock To: **12**
1st Value:
2nd Value:
Value Percent: **5.000**
Step: **NO**
Remarks: **Mixed materials**

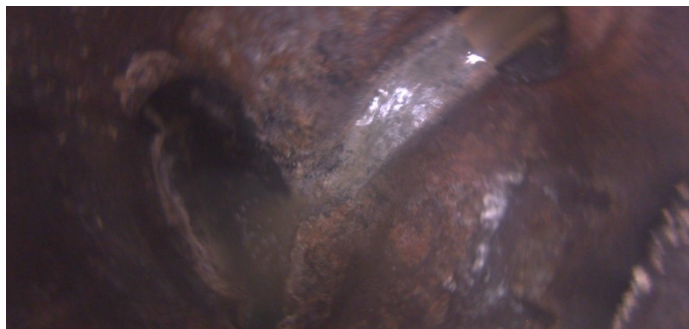
Code: **MGO**
Description: **General Observation**

Distance (ft): **6.8**
Structural Grade: **0**
O&M Grade: **0**
Clock Start/From:
Clock To:
1st Value:
2nd Value:
Value Percent:
Step: **NO**
Remarks: **Ins. Comp.**
