Manhole Inspection Report

Date:	03/22/2018	Weather:		Coding:	RZMACP
MH#:	M-802-010	Owner:	NA	Len. Surveyed:	4.3
P.O.#:		Surveyor:	John Kuglmaier	Rim to Invert:	5.6
Customer:		Cert. #:	U-1215-07002349	Wall Material:	Concrete (reinforced)

Street:	813' North of Hwy 6. and West of H	Project:	Hobart, IN
City:	Hobart, IN	GPS Northing:	0.0
Location:		GPS Easting:	0.0
Drain Area:	Northeast	GPS Accuracy:	Nearest Meter
Cover Shape:	Circular	Evidence of Surcharge:	Yes
Cover Size:	23.0	Potential for Runoff:	None
Comments:

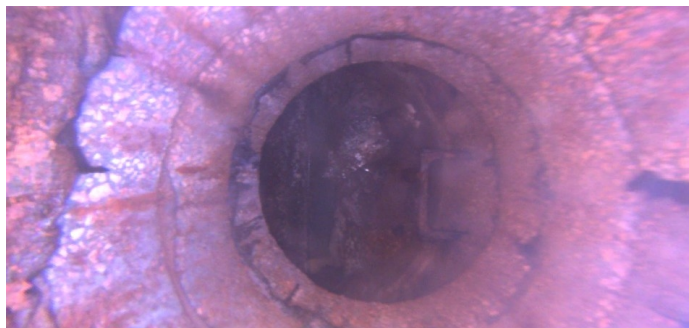
Code: **MGP**
Description: **General Photo**

Distance (ft): **.0**
Structural Grade: **0**
O&M Grade: **0**
Clock Start/From:
Clock To:
1st Value:
2nd Value:
Value Percent:
Step: **NO**
Remarks:

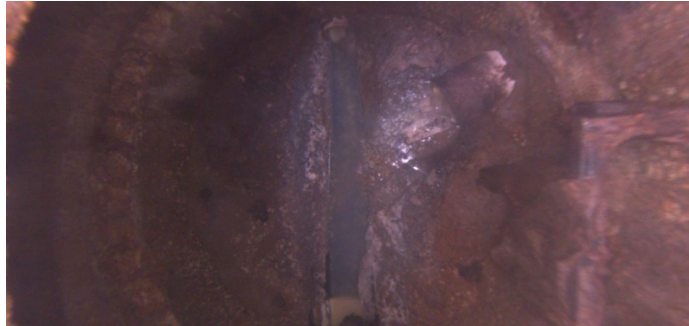
Code: **DAZ**
Description: **Deposits Attached Other**

Distance (ft): **2.0**
Structural Grade: **0**
O&M Grade: **2**
Clock Start/From: **12**
Clock To: **12**
1st Value:
2nd Value:
Value Percent: **5.000**
Step: **NO**
Remarks: **Mixed materials**

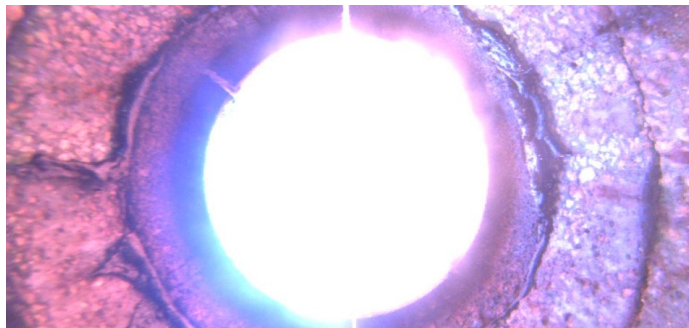
Code: **MGP**
Description: **General Photo**

Distance (ft): **2.2**
Structural Grade: **0**
O&M Grade: **0**
Clock Start/From:
Clock To:
1st Value:
2nd Value:
Value Percent:
Step: **NO**
Remarks:

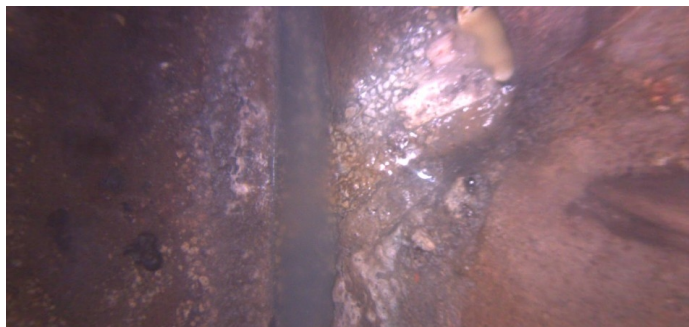
Code: **MGO**
Description: **General Observation**

Distance (ft): **3.5**
Structural Grade: **0**
O&M Grade: **0**
Clock Start/From:
Clock To:
1st Value:
2nd Value:
Value Percent:
Step: **NO**
Remarks: **Ins. Comp.**
