Manhole Inspection Report

Date:	03/22/2018	Weather:		Coding:	RZMACP
MH#:	M-802-012	Owner:	NA	Len. Surveyed:	5.5
P.O.#:		Surveyor:	John Kuglmaier	Rim to Invert:	6.9
Customer:		Cert. #:	U-1215-07002349	Wall Material:	Concrete (reinforced)

Street:	North of Hwy 6. and 508' West of H	Project:	Hobart, IN
City:	Hobart, IN	GPS Northing:	0.0
Location:		GPS Easting:	0.0
Drain Area:	Northeast	GPS Accuracy:	Nearest Meter
Cover Shape:	Circular	Evidence of Surcharge:	Yes
Cover Size:	23.0	Potential for Runoff:	None
Comments:

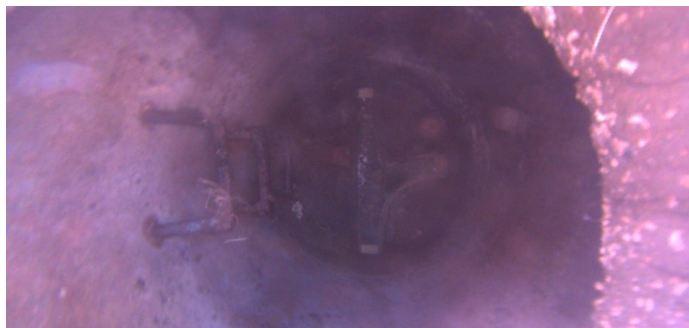
Code: **MGP**
Description: **General Photo**

Distance (ft): **.0**
Structural Grade: **0**
O&M Grade: **0**
Clock Start/From:
Clock To:
1st Value:
2nd Value:
Value Percent:
Step: **NO**
Remarks:

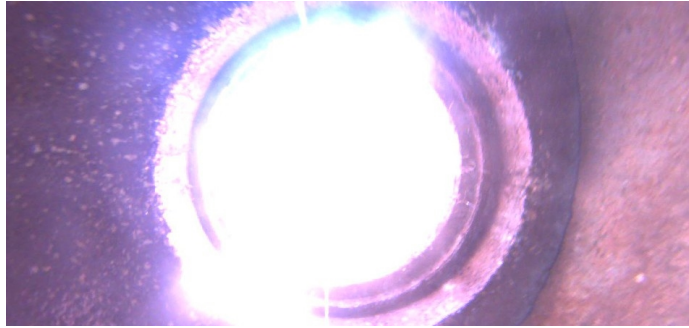
Code: **MGP**
Description: **General Photo**

Distance (ft): **2.4**
Structural Grade: **0**
O&M Grade: **0**
Clock Start/From:
Clock To:
1st Value:
2nd Value:
Value Percent:
Step: **NO**
Remarks:

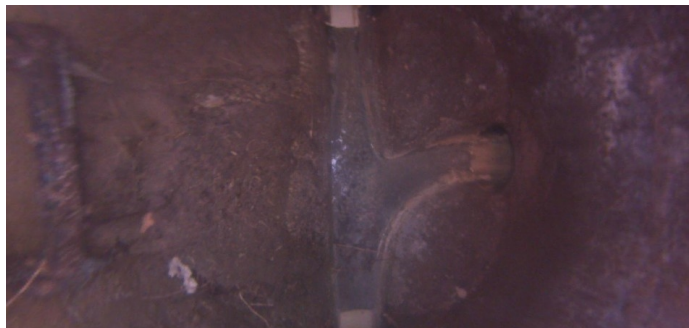
Code: **DSF**
Description: **Deposits Settled Fine**

Distance (ft): **3.3**
Structural Grade: **0**
O&M Grade: **3**
Clock Start/From: **12**
Clock To: **12**
1st Value:
2nd Value:
Value Percent: **15.000**
Step: **NO**
Remarks:

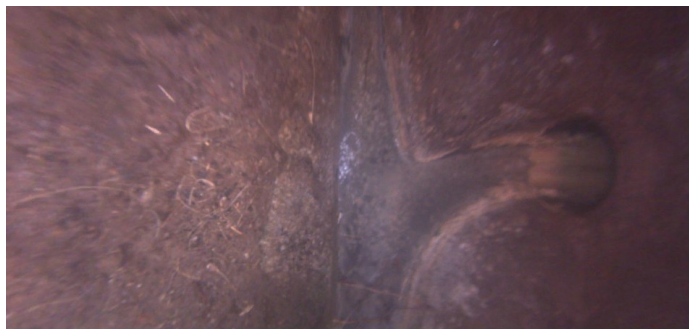
Code: **MGO**
Description: **General Observation**

Distance (ft): **4.3**
Structural Grade: **0**
O&M Grade: **0**
Clock Start/From:
Clock To:
1st Value:
2nd Value:
Value Percent:
Step: **NO**
Remarks: **Ins. Comp.**
