Manhole Inspection Report

| MH#: | M-802-013 | Owner: | NA | Len. Surveyed: | 3.3 |

| Street: | 177' North of Hwy 6. 97' West of No | Project: | Hobart, IN |

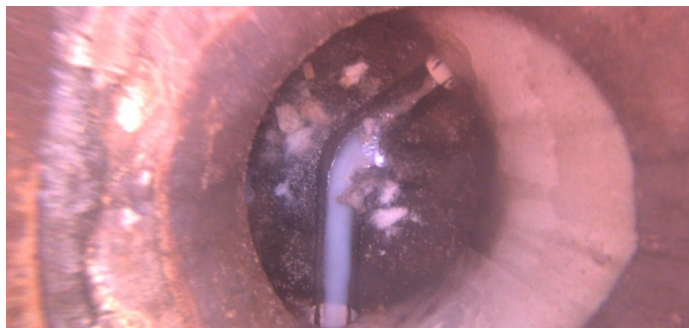
Code: **MGP**
Description: **General Photo**

Distance (ft): **.0**
Structural Grade: **0**
O&M Grade: **0**
Clock Start/From:
Clock To:
1st Value:
2nd Value:
Value Percent:
Step: **NO**
Remarks:

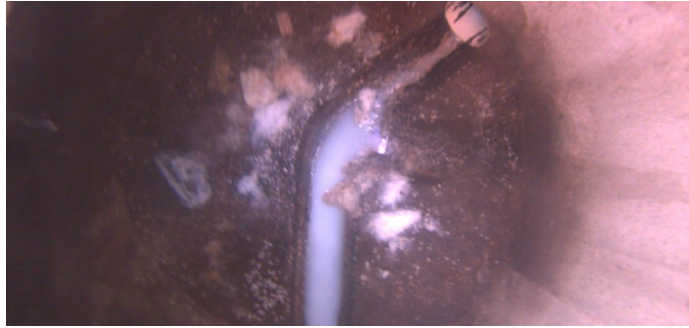
| Code: | DAZ |
| Description: | Deposits Attached Other |
| Distance (ft): | 1.1 |
| O&M Grade: | 2 |
| Value Percent: | 5.000 |
| Remarks: | Mixed materials |

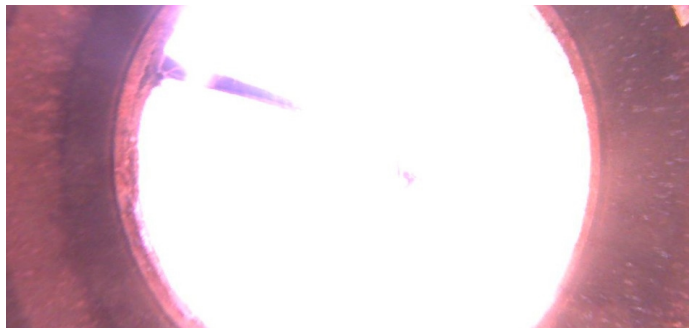
| Code: | MGP |
| Description: | General Photo |
| Distance (ft): | 1.3 |

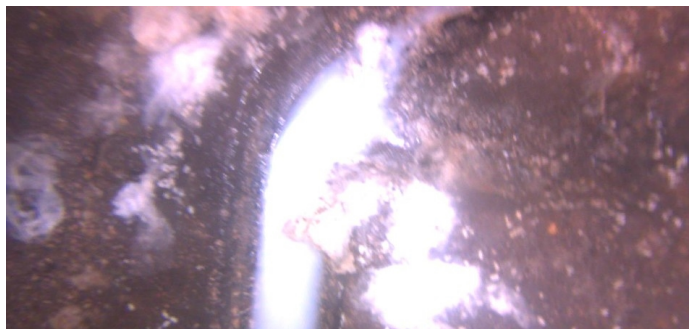
| Code: | MGO |
| Description: | General Observation |
| Distance (ft): | 2.5 |
| Remarks: | Ins. Comp. |
