Manhole Inspection Report

| MH#: | M-802-014 | Owner: | NA | Len. Surveyed: | 2.1 |

| Street: | 177' North of Hwy 6. 97' West of No | Project: | Hobart, IN |

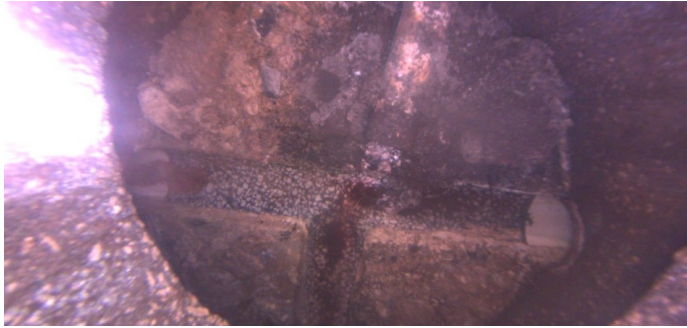
| Code: | DAZ |
| Description: | Deposits Attached Other |
| Distance (ft): | .6 |
| O&M Grade: | 2 |
| Value Percent: | 10.000 |
| Remarks: | Mixed materials |

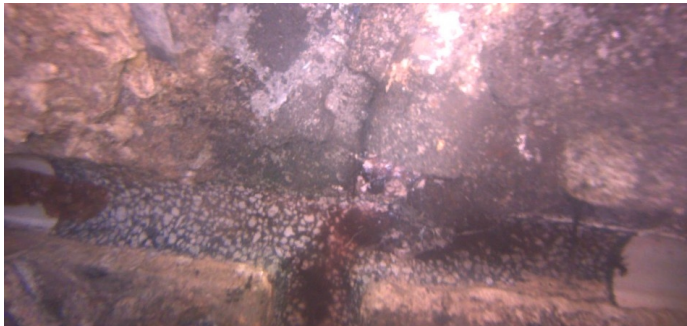
| Code: | MGO |
| Description: | General Observation |
| Distance (ft): | 1.7 |
| Remarks: | Ins. Comp. |
