Manhole Inspection Report

Date:	03/21/2018	Weather:		Coding:	RZMACP
MH#:	M-802-015	Owner:	NA	Len. Surveyed:	5.3
P.O.#:		Surveyor:	John Kuglmaier	Rim to Invert:	7.5
Customer:		Cert. #:	U-1215-07002349	Wall Material:	Concrete (reinforced)

Street:	177' North of Hwy 6. 97' West of No	Project:	Hobart, IN
City:	Hobart, IN	GPS Northing:	0.0
Location:		GPS Easting:	0.0
Drain Area:	Northeast	GPS Accuracy:	Nearest Meter
Cover Shape:	Circular	Evidence of Surcharge:	No
Cover Size:	23.0	Potential for Runoff:	None
Comments:

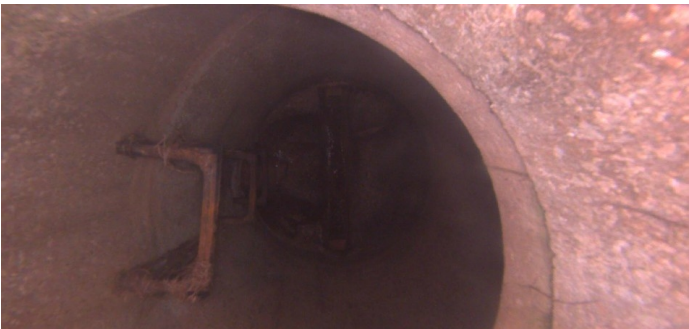
Code: **MGP**
 Description: **General Photo**

Distance (ft): **.0**
 Structural Grade: **0**
 O&M Grade: **0**
 Clock Start/From:
 Clock To:
 1st Value:
 2nd Value:
 Value Percent:
 Step: **NO**
 Remarks:

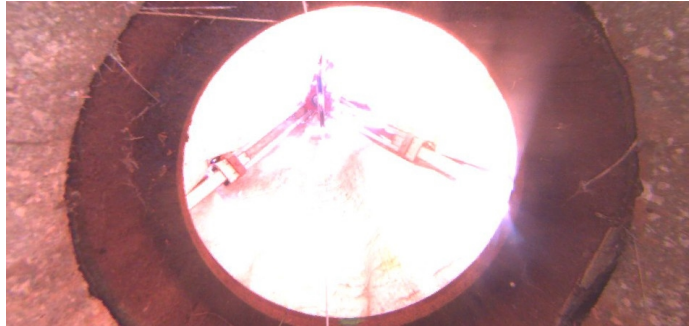
Code: **MGP**
Description: **General Photo**

Distance (ft): **1.2**
Structural Grade: **0**
O&M Grade: **0**
Clock Start/From:
Clock To:
1st Value:
2nd Value:
Value Percent:
Step: **NO**
Remarks:

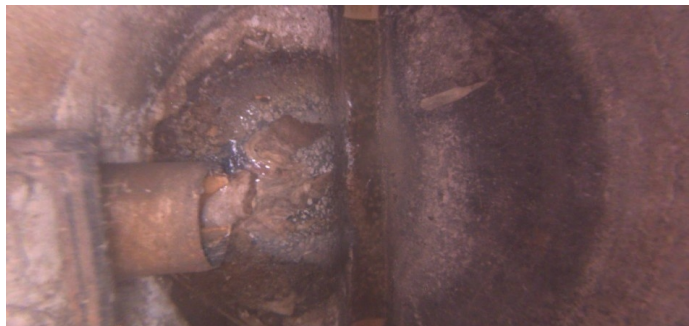
Code: **DAZ**
Description: **Deposits Attached Other**

Distance (ft): **3.9**
Structural Grade: **0**
O&M Grade: **2**
Clock Start/From: **12**
Clock To: **12**
1st Value:
2nd Value:
Value Percent: **10.000**
Step: **NO**
Remarks: **Mixed materials**

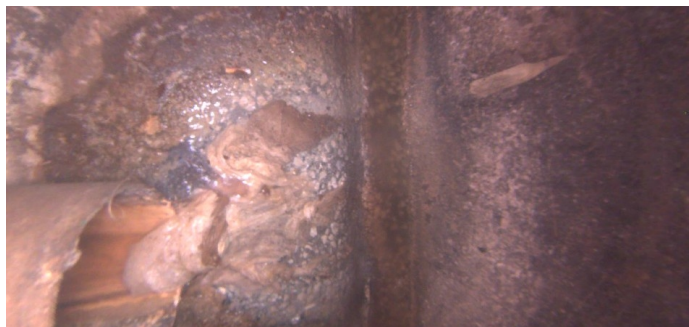
Code: **MGO**
Description: **General Observation**

Distance (ft): **4.7**
Structural Grade: **0**
O&M Grade: **0**
Clock Start/From:
Clock To:
1st Value:
2nd Value:
Value Percent:
Step: **NO**
Remarks: **Ins. Comp.**
