Manhole Inspection Report

Date:	03/21/2018	Weather:		Coding:	RZMACP
MH#:	M-802-016	Owner:	NA	Len. Surveyed:	1.9
P.O.#:		Surveyor:	John Kuglmaier	Rim to Invert:	3.0
Customer:		Cert. #:	U-1215-07002349	Wall Material:	Concrete (reinforced)

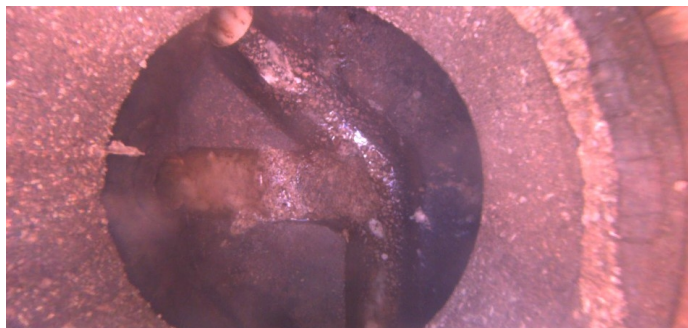
Code: **MGP**
Description: **General Photo**

Distance (ft): **.0**
Structural Grade: **0**
O&M Grade: **0**
Clock Start/From:
Clock To:
1st Value:
2nd Value:
Value Percent:
Step: **NO**
Remarks:

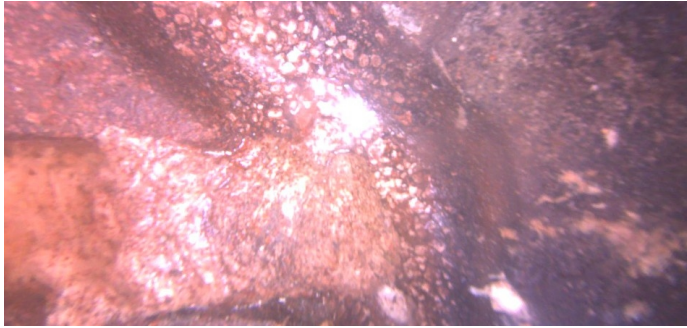
Code:	MGO
Description:	General Observation
Distance (ft):	1.5
Structural Grade:	0
O&M Grade:	0
Clock Start/From:	
Clock To:	
1st Value:	
2nd Value:	
Value Percent:	
Step:	NO
Remarks:	Ins. Comp.
