Manhole Inspection Report

| MH#: | M-802-018 | Owner: | NA | Len. Surveyed: | 4.2 |

| Street: | 290' West of North Ridge Dr. North | Project: | Hobart, IN |

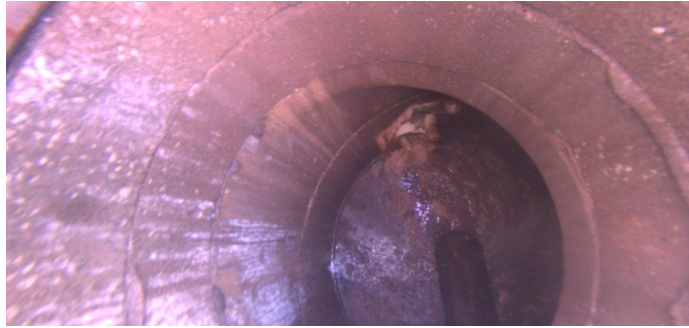
Code: **IS**
Description: **Infil Stain**

Distance (ft): **.6**
Structural Grade: **0**
O&M Grade: **0**
Clock Start/From: **10**
Clock To: **11**
1st Value:
2nd Value:
Value Percent:
Step: **NO**
Remarks:

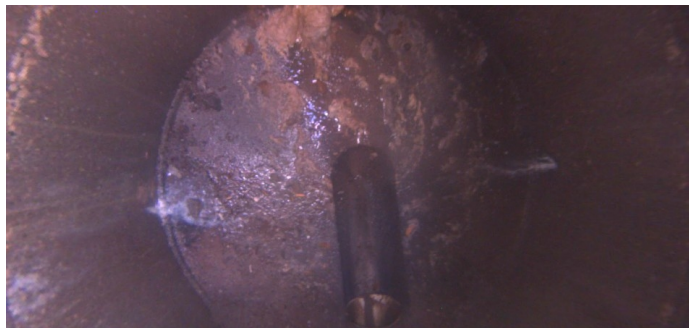
Code: **DAZ**
Description: **Deposits Attached Other**

Distance (ft): **2.1**
Structural Grade: **0**
O&M Grade: **2**
Clock Start/From: **12**
Clock To: **12**
1st Value:
2nd Value:
Value Percent: **5.000**
Step: **NO**
Remarks: **Mixed materials**

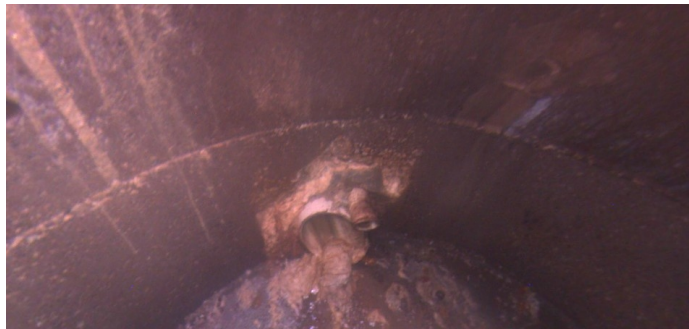
Code: **IS**
Description: **Infil Stain**

Distance (ft): **2.5**
Structural Grade: **0**
O&M Grade: **0**
Clock Start/From: **1**
Clock To:
1st Value:
2nd Value:
Value Percent:
Step: **NO**
Remarks:

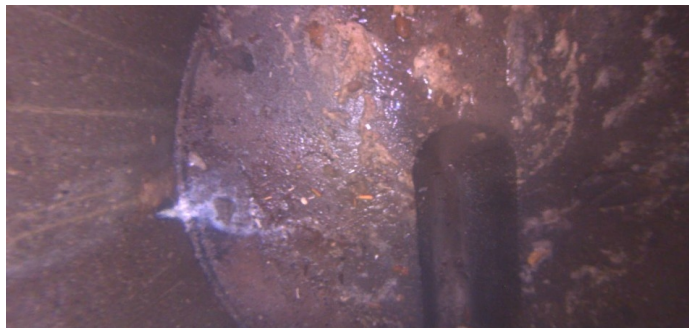
Code: **IS**
Description: **Infil Stain**

Distance (ft): **3.1**
Structural Grade: **0**
O&M Grade: **0**
Clock Start/From: **8**
Clock To:
1st Value:
2nd Value:
Value Percent:
Step: **NO**
Remarks:

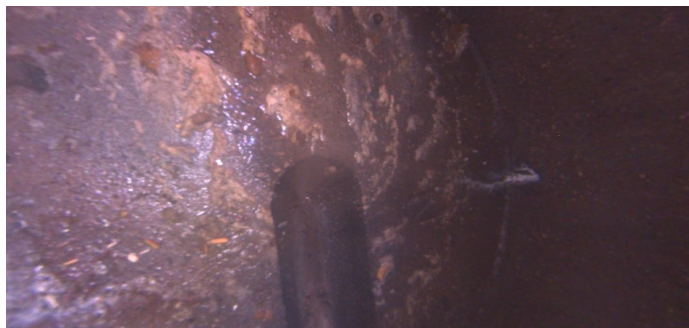
Code: **IS**
Description: **Infil Stain**

Distance (ft): **3.1**
Structural Grade: **0**
O&M Grade: **0**
Clock Start/From: **3**
Clock To:
1st Value:
2nd Value:
Value Percent:
Step: **NO**
Remarks:
