Manhole Inspection Report

Date:	03/22/2018	Weather:		Coding:	RZMACP
MH#:	M-802-020	Owner:	NA	Len. Surveyed:	6.3
P.O.#:		Surveyor:	John Kuglmaier	Rim to Invert:	7.7
Customer:		Cert. #:	U-1215-07002349	Wall Material:	Concrete (reinforced)

Street:	South of 34th Ln. 271' West of Hwy	Project:	Hobart, IN
City:	Hobart, IN	GPS Northing:	0.0
Location:		GPS Easting:	0.0
Drain Area:	Northeast	GPS Accuracy:	Nearest Meter
Cover Shape:	Circular	Evidence of Surcharge:	No
Cover Size:	23.0	Potential for Runoff:	None
Comments:

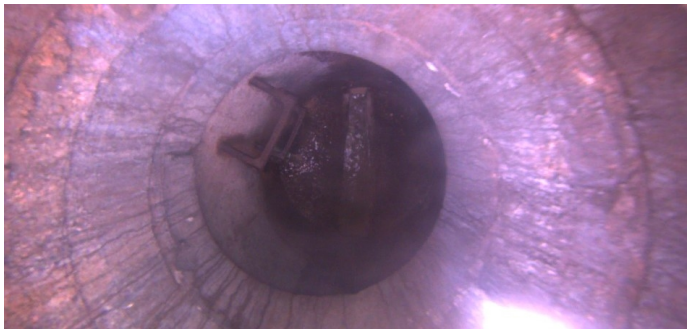
Code:	MGP
Description:	General Photo

Distance (ft):	.0
Structural Grade:	0
O&M Grade:	0
Clock Start/From:	
Clock To:	
1st Value:	
2nd Value:	
Value Percent:	
Step:	NO
Remarks:

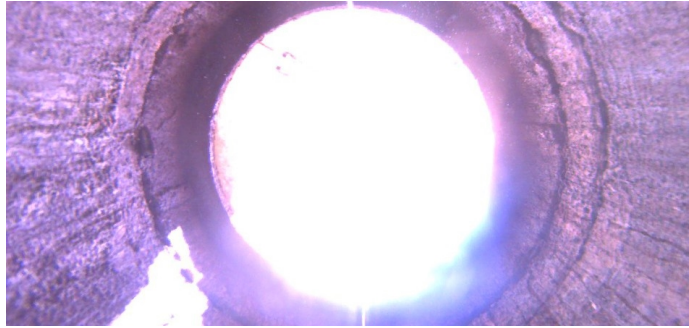
Code: **MGP**
Description: **General Photo**

Distance (ft): **2.2**
Structural Grade: **0**
O&M Grade: **0**
Clock Start/From:
Clock To:
1st Value:
2nd Value:
Value Percent:
Step: **NO**
Remarks:

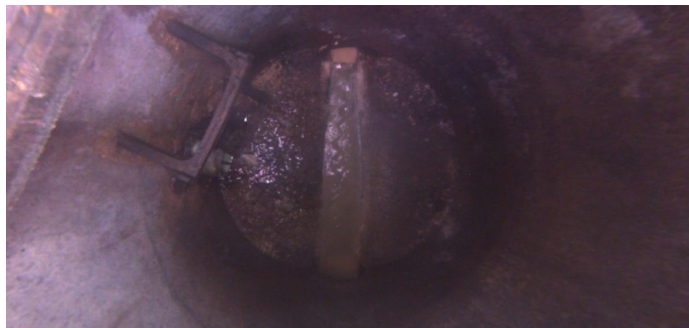
Code: **IS**
Description: **Infil Stain**

Distance (ft): **2.6**
Structural Grade: **0**
O&M Grade: **0**
Clock Start/From: **12**
Clock To: **12**
1st Value:
2nd Value:
Value Percent:
Step: **NO**
Remarks:

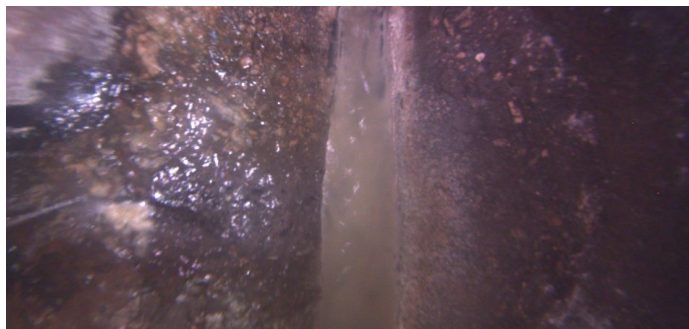
Code: **MGO**
Description: **General Observation**

Distance (ft): **5.1**
Structural Grade: **0**
O&M Grade: **0**
Clock Start/From:
Clock To:
1st Value:
2nd Value:
Value Percent:
Step: **NO**
Remarks: **Ins. Comp.**
