Manhole Inspection Report

Date:	03/22/2018	Weather:		Coding:	RZMACP
MH#:	M-802-021	Owner:	NA	Len. Surveyed:	4.2
P.O.#:		Surveyor:	John Kuglmaier	Rim to Invert:	5.0
Customer:		Cert. #:	U-1215-07002349	Wall Material:	Concrete (reinforced)

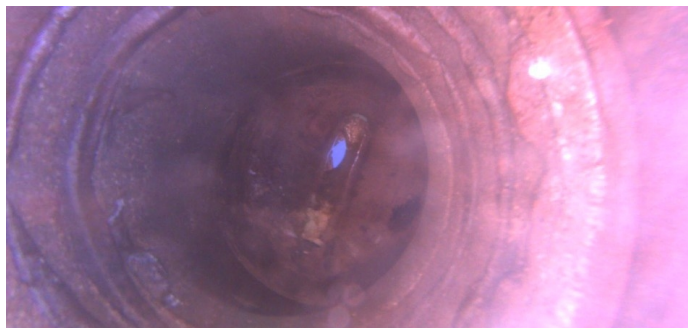
Code: **MGP**
Description: **General Photo**

Distance (ft): **.0**
Structural Grade: **0**
O&M Grade: **0**
Clock Start/From:
Clock To:
1st Value:
2nd Value:
Value Percent:
Step: **NO**
Remarks:

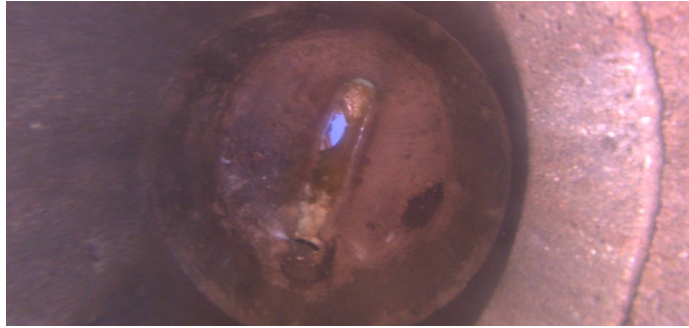
Code: **IS**
Description: **Infil Stain**

Distance (ft): **1.1**
Structural Grade: **0**
O&M Grade: **0**
Clock Start/From: **12**
Clock To: **12**
1st Value:
2nd Value:
Value Percent:
Step: **NO**
Remarks:

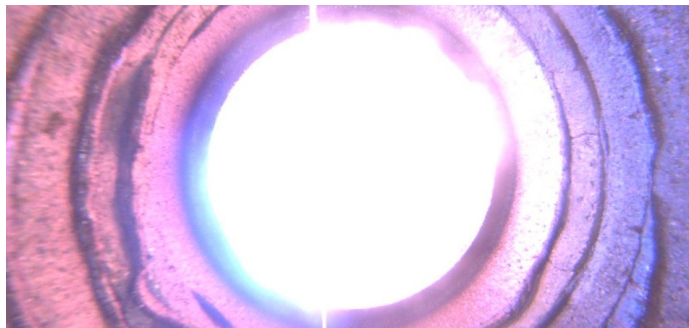
Code: **MGP**
Description: **General Photo**

Distance (ft): **2.1**
Structural Grade: **0**
O&M Grade: **0**
Clock Start/From:
Clock To:
1st Value:
2nd Value:
Value Percent:
Step: **NO**
Remarks:

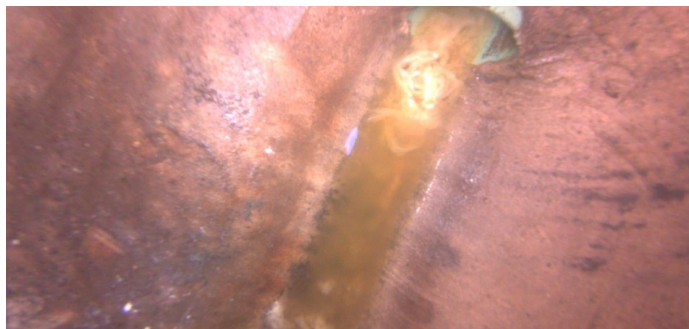
Code: **MGO**
Description: **General Observation**

Distance (ft): **3.7**
Structural Grade: **0**
O&M Grade: **0**
Clock Start/From:
Clock To:
1st Value:
2nd Value:
Value Percent:
Step: **NO**
Remarks: **Ins. Comp.**
