Manhole Inspection Report

Date:	03/21/2018	Weather:		Coding:	RZMACP
MH#:	M-802-024	Owner:	NA	Len. Surveyed:	2.1
P.O.#:		Surveyor:	John Kuglmaier	Rim to Invert:	3.0
Customer:		Cert. #:	U-1215-07002349	Wall Material:	Concrete (reinforced)

Street:	177' North of Hwy 6. 97' West of No	Project:	Hobart, IN
City:	Hobart, IN	GPS Northing:	0.0
Location:		GPS Easting:	0.0
Drain Area:	Northeast	GPS Accuracy:	Nearest Meter
Cover Shape:	Circular	Evidence of Surcharge:	No
Cover Size:	23.0	Potential for Runoff:	None
Comments:

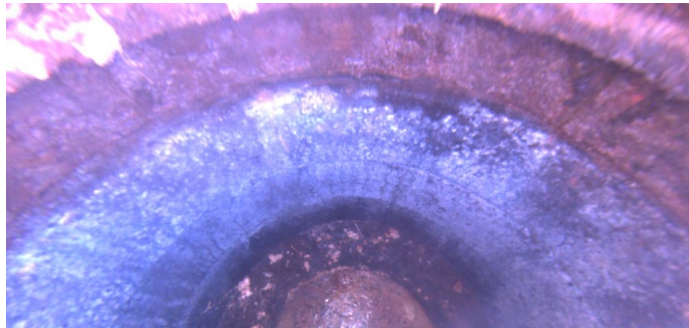
Code: **DAGS**
Description: **Deposits Attached Grease**

Distance (ft): **.0**
Structural Grade: **0**
O&M Grade: **2**
Clock Start/From: **12**
Clock To: **12**
1st Value:
2nd Value:
Value Percent: **5.000**
Step: **NO**
Remarks:

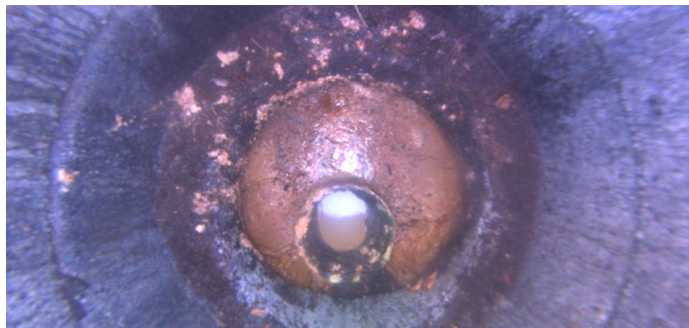
Code: **DSF**
Description: **Deposits Settled Fine**

Distance (ft): **.9**
Structural Grade: **0**
O&M Grade: **2**
Clock Start/From: **12**
Clock To: **12**
1st Value:
2nd Value:
Value Percent: **5.000**
Step: **NO**
Remarks:

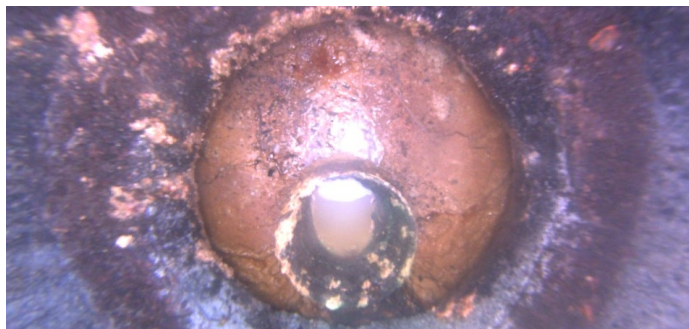
Code: **MGO**
Description: **General Observation**

Distance (ft): **1.4**
Structural Grade: **0**
O&M Grade: **0**
Clock Start/From:
Clock To:
1st Value:
2nd Value:
Value Percent:
Step: **NO**
Remarks: **Tee connection**

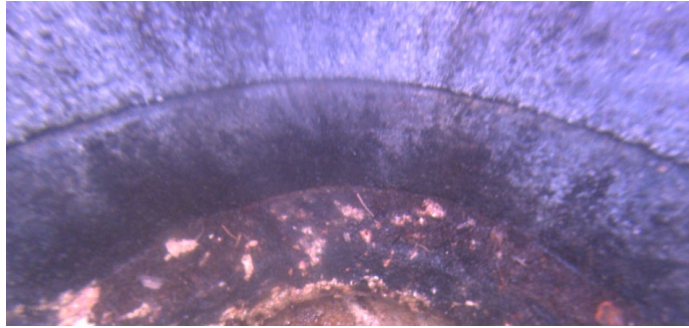
Code:	DAGS
Description:	Deposits Attached Grease
Distance (ft):	1.5
Structural Grade:	0
O&M Grade:	2
Clock Start/From:	12
Clock To:	12
1st Value:	
2nd Value:	
Value Percent:	5.000
Step:	NO
Remarks:

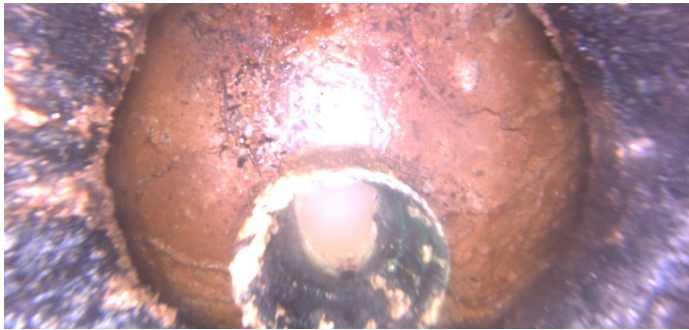
Code:	MSA
Description:	Abandoned Survey
Distance (ft):	1.7
Structural Grade:	0
O&M Grade:	0
Clock Start/From:	
Clock To:	
1st Value:	
2nd Value:	
Value Percent:	
Step:	NO
Remarks:	MH not fully open
