# Manhole Inspection Report

Date:	<b>03/22/2018</b>	Weather:		Coding:	<b>RZMACP</b>
MH#:	<b>M-802-026</b>	Owner:	<b>NA</b>	Len. Surveyed:	<b>2.4</b>
P.O.#:		Surveyor:	<b>John Kuglmaier</b>	Rim to Invert:	<b>3.3</b>
Customer:		Cert. #:	<b>U-1215-07002349</b>	Wall Material:	<b>Concrete (reinforced)</b>

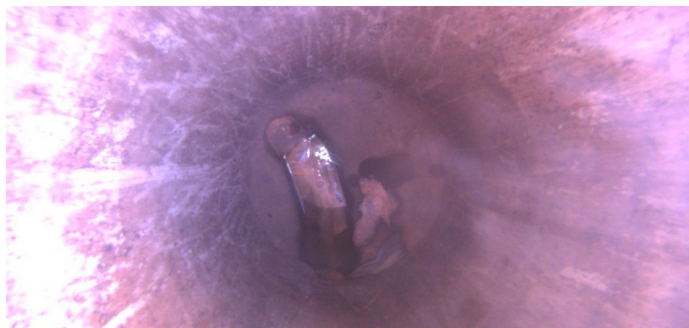
Code: **MGP**  
Description: **General Photo**

Distance (ft): **.0**  
Structural Grade: **0**  
O&M Grade: **0**  
Clock Start/From:  
Clock To:  
1st Value:  
2nd Value:  
Value Percent:  
Step: **NO**  
Remarks:

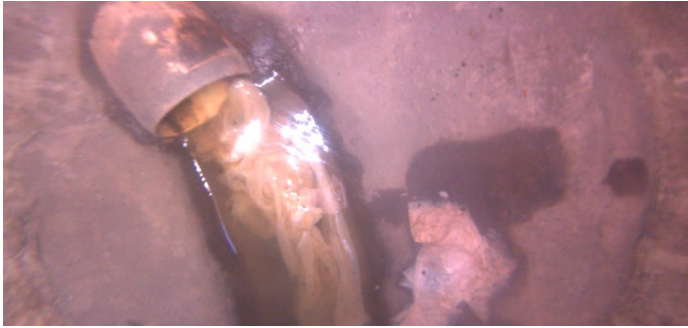
Code:	MGO
Description:	General Observation
Distance (ft):	1.9
Structural Grade:	0
O&M Grade:	0
Clock Start/From:	
Clock To:	
1st Value:	
2nd Value:	
Value Percent:	
Step:	NO
Remarks:	Ins. Comp.
