Manhole Inspection Report

Date:	03/28/2018	Weather:		Coding:	RZMACP
MH#:	M-803-001	Owner:	NA	Len. Surveyed:	14.8
P.O.#:		Surveyor:	John Kuglmaier	Rim to Invert:	16.3
Customer:		Cert. #:	U-1215-07002349	Wall Material:	Concrete (reinforced)

Street:	High St. 180' West of Hwy 51.	Project:	Hobart, IN
City:	Hobart, IN	GPS Northing:	0.0
Location:		GPS Easting:	0.0
Drain Area:	Northeast	GPS Accuracy:	Nearest Meter
Cover Shape:	Circular	Evidence of Surcharge:	Yes
Cover Size:	23.0	Potential for Runoff:	None
Comments:

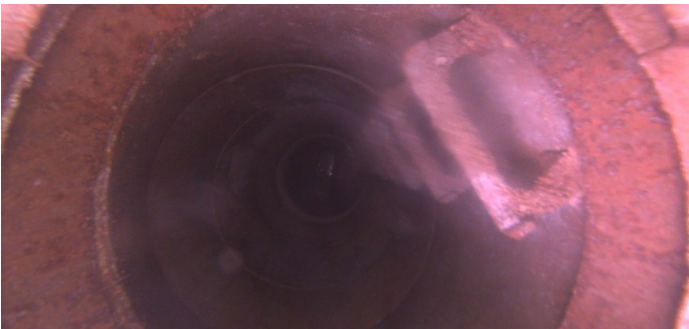
Code: **MGP**
 Description: **General Photo**

Distance (ft): **.0**
 Structural Grade: **0**
 O&M Grade: **0**
 Clock Start/From:
 Clock To:
 1st Value:
 2nd Value:
 Value Percent:
 Step: **NO**
 Remarks:

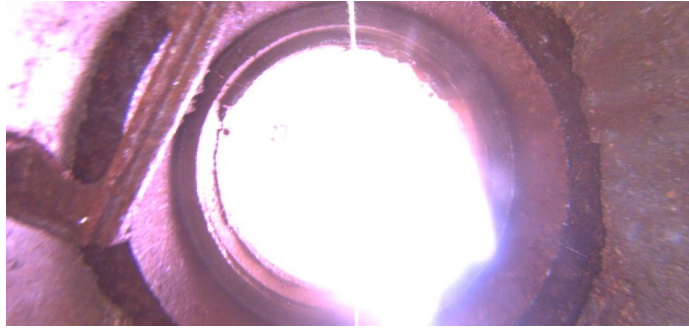
Code: **MGP**
Description: **General Photo**

Distance (ft): **2.4**
Structural Grade: **0**
O&M Grade: **0**
Clock Start/From:
Clock To:
1st Value:
2nd Value:
Value Percent:
Step: **NO**
Remarks:

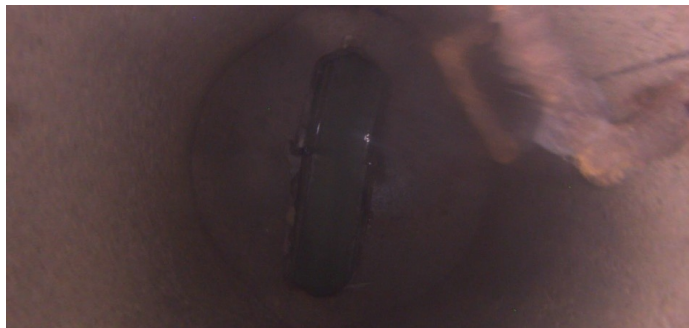
Code: **DSF**
Description: **Deposits Settled Fine**

Distance (ft): **11.7**
Structural Grade: **0**
O&M Grade: **2**
Clock Start/From: **12**
Clock To: **12**
1st Value:
2nd Value:
Value Percent: **5.000**
Step: **NO**
Remarks:

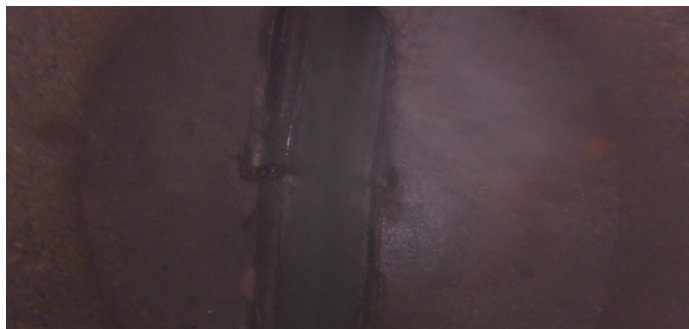
Code: **MGO**
Description: **General Observation**

Distance (ft): **13.3**
Structural Grade: **0**
O&M Grade: **0**
Clock Start/From:
Clock To:
1st Value:
2nd Value:
Value Percent:
Step: **NO**
Remarks: **Ins. Comp.**
