Manhole Inspection Report

Date:	03/28/2018	Weather:		Coding:	RZMACP
MH#:	M-803-003	Owner:	NA	Len. Surveyed:	13.3
P.O.#:		Surveyor:	John Kuglmaier	Rim to Invert:	14.7
Customer:		Cert. #:	U-1215-07002349	Wall Material:	Concrete (reinforced)

Street:	164' South of North St. 163' West of	Project:	Hobart, IN
City:	Hobart, IN	GPS Northing:	0.0
Location:		GPS Easting:	0.0
Drain Area:	Northeast	GPS Accuracy:	Nearest Meter
Cover Shape:	Circular	Evidence of Surcharge:	Yes
Cover Size:	23.0	Potential for Runoff:	None
Comments:

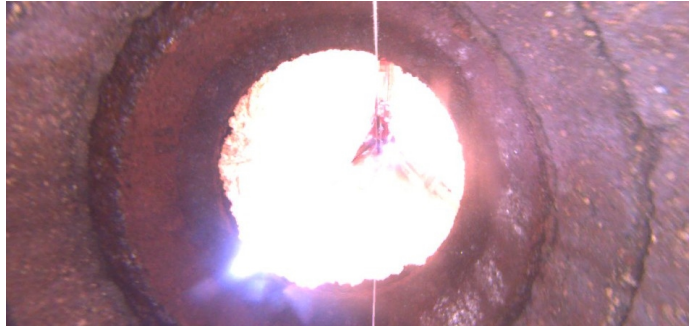
Code: **MGP**
Description: **General Photo**

Distance (ft): **2.0**
Structural Grade: **0**
O&M Grade: **0**
Clock Start/From:
Clock To:
1st Value:
2nd Value:
Value Percent:
Step: **NO**
Remarks:

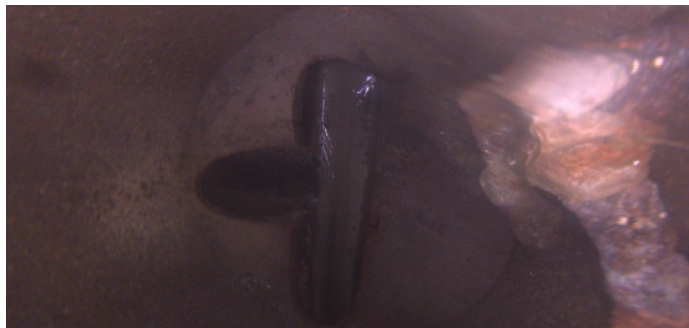
Code: **DSF**
Description: **Deposits Settled Fine**

Distance (ft): **10.4**
Structural Grade: **0**
O&M Grade: **2**
Clock Start/From: **12**
Clock To: **12**
1st Value:
2nd Value:
Value Percent: **5.000**
Step: **NO**
Remarks:

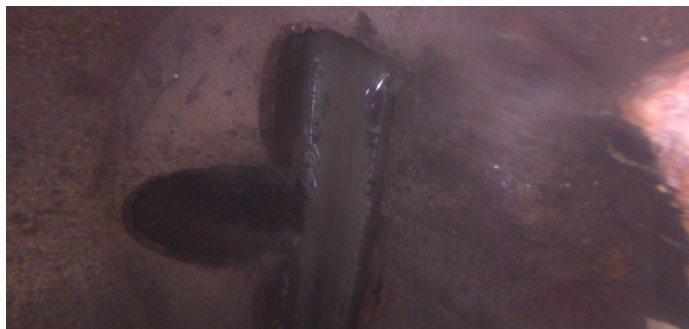
Code: **MGO**
Description: **General Observation**

Distance (ft): **11.7**
Structural Grade: **0**
O&M Grade: **0**
Clock Start/From:
Clock To:
1st Value:
2nd Value:
Value Percent:
Step: **NO**
Remarks: **Ins. Comp.**
