Manhole Inspection Report

Date:	03/27/2018	Weather:		Coding:	RZMACP
MH#:	M-803-006	Owner:	NA	Len. Surveyed:	7.2
P.O.#:		Surveyor:	John Kuglmaier	Rim to Invert:	8.3
Customer:		Cert. #:	U-1215-07002349	Wall Material:	Concrete (reinforced)

Street:	65' North of High St. 163' East of Lib	Project:	Hobart, IN
City:	Hobart, IN	GPS Northing:	0.0
Location:		GPS Easting:	0.0
Drain Area:	Northeast	GPS Accuracy:	Nearest Meter
Cover Shape:	Circular	Evidence of Surcharge:	No
Cover Size:	23.0	Potential for Runoff:	None
Comments:

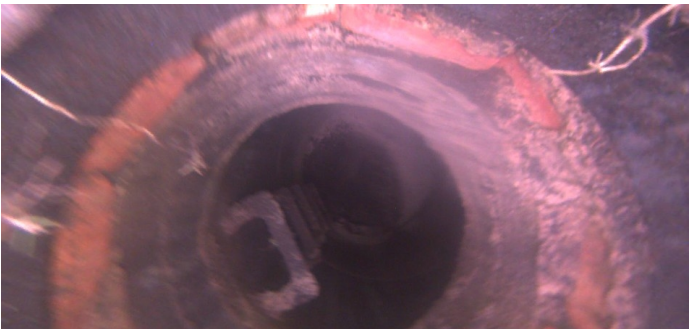
Code:
MGP

Description:
General Photo

Distance (ft):
.0

Structural Grade:
0

O&M Grade:
0

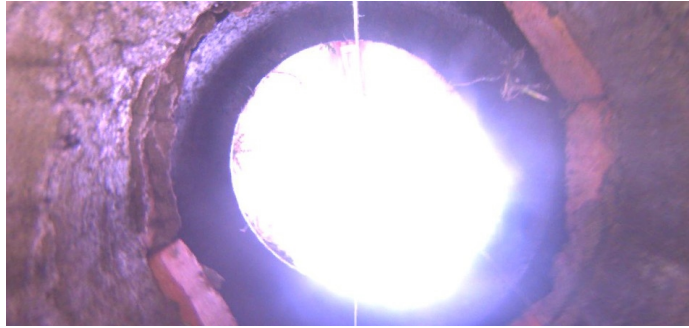
Code:	MGP
Description:	General Photo
Distance (ft):	2.5
Structural Grade:	0
O&M Grade:	0
Clock Start/From:	
Clock To:	
1st Value:	
2nd Value:	
Value Percent:	
Step:	NO
Remarks:

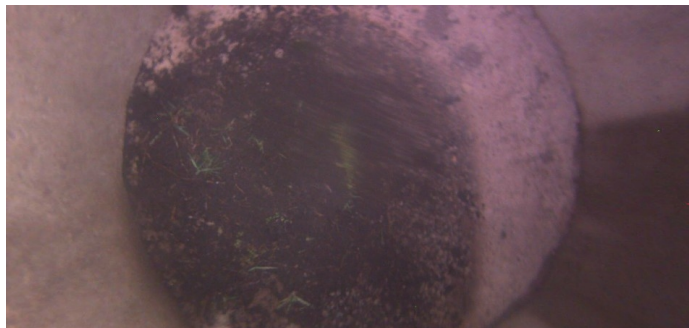
Code:	MGO
Description:	General Observation
Distance (ft):	6.2
Structural Grade:	0
O&M Grade:	0
Clock Start/From:	
Clock To:	
1st Value:	
2nd Value:	
Value Percent:	
Step:	NO
Remarks:	Ins. Comp.
