Manhole Inspection Report

Date:	03/28/2018	Weather:		Coding:	RZMACP
MH#:	M-803-007	Owner:	NA	Len. Surveyed:	13.5
P.O.#:		Surveyor:	John Kuglmaier	Rim to Invert:	15.6
Customer:		Cert. #:	U-1215-07002349	Wall Material:	Concrete (reinforced)

Street:	North St. 165' East of Lawrence St.	Project:	Hobart, IN
City:	Hobart, IN	GPS Northing:	0.0
Location:		GPS Easting:	0.0
Drain Area:	Northeast	GPS Accuracy:	Nearest Meter
Cover Shape:	Circular	Evidence of Surcharge:	Yes
Cover Size:	23.0	Potential for Runoff:	None
Comments:

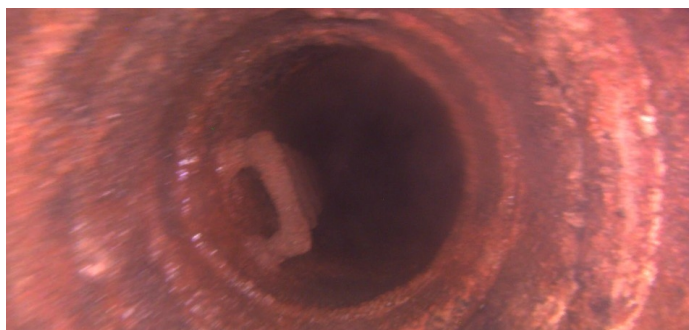
Code: **MGP**
Description: **General Photo**

Distance (ft): **.0**
Structural Grade: **0**
O&M Grade: **0**
Clock Start/From:
Clock To:
1st Value:
2nd Value:
Value Percent:
Step: **NO**
Remarks:

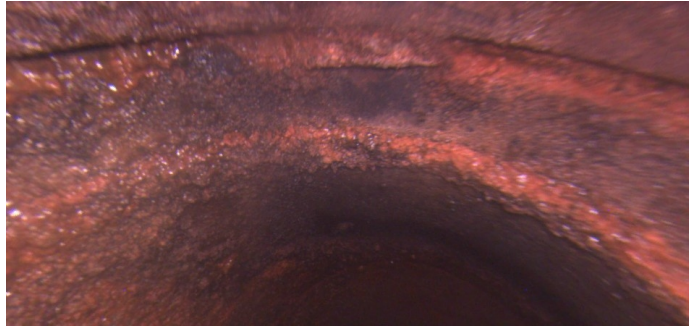
Code: **DAZ**
Description: **Deposits Attached Other**

Distance (ft): **1.3**
Structural Grade: **0**
O&M Grade: **2**
Clock Start/From: **12**
Clock To: **12**
1st Value:
2nd Value:
Value Percent: **5.000**
Step: **NO**
Remarks: **Mixed materials**

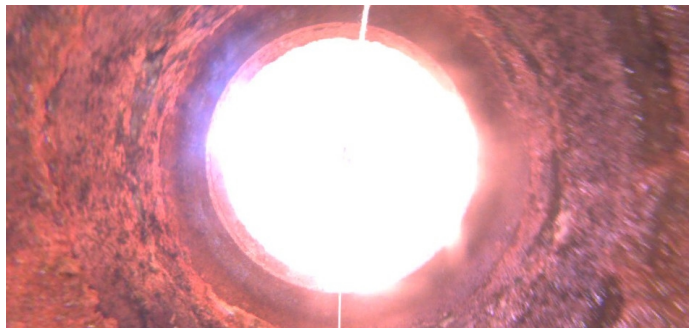
Code: **MGP**
Description: **General Photo**

Distance (ft): **2.3**
Structural Grade: **0**
O&M Grade: **0**
Clock Start/From:
Clock To:
1st Value:
2nd Value:
Value Percent:
Step: **NO**
Remarks:

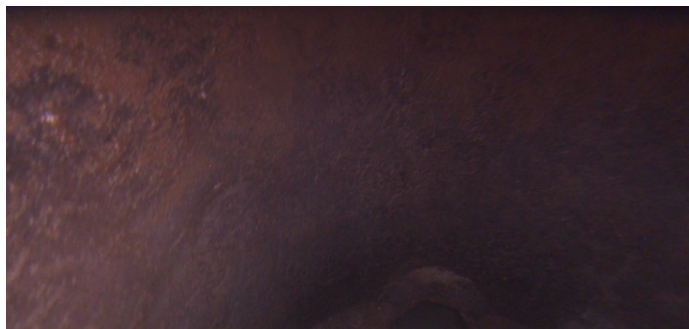
Code: **DAZ**
Description: **Deposits Attached Other**

Distance (ft): **11.4**
Structural Grade: **0**
O&M Grade: **2**
Clock Start/From: **12**
Clock To: **12**
1st Value:
2nd Value:
Value Percent: **5.000**
Step: **NO**
Remarks: **Mixed materials**

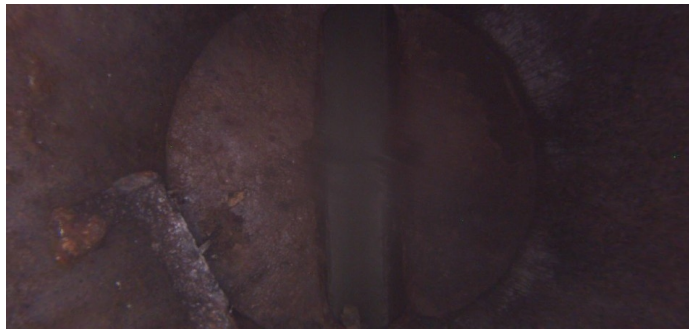
Code:	DAZ
Description:	Deposits Attached Other
Distance (ft):	11.5
Structural Grade:	0
O&M Grade:	2
Clock Start/From:	12
Clock To:	12
1st Value:	
2nd Value:	
Value Percent:	10.000
Step:	NO
Remarks:	Mixed materials

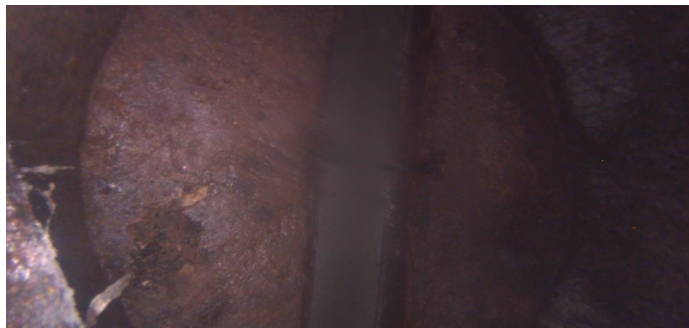
Code:	MGO
Description:	General Observation
Distance (ft):	12.5
Structural Grade:	0
O&M Grade:	0
Clock Start/From:	
Clock To:	
1st Value:	
2nd Value:	
Value Percent:	
Step:	NO
Remarks:	Ins. Comp.
