Manhole Inspection Report

Date:	03/28/2018	Weather:		Coding:	RZMACP
MH#:	M-803-009	Owner:	NA	Len. Surveyed:	13.4
P.O.#:		Surveyor:	John Kuglmaier	Rim to Invert:	14.9
Customer:		Cert. #:	U-1215-07002349	Wall Material:	Concrete (reinforced)

Street:	434' North of North St. 164' East of L	Project:	Hobart, IN
City:	Hobart, IN	GPS Northing:	0.0
Location:		GPS Easting:	0.0
Drain Area:	Northeast	GPS Accuracy:	Nearest Meter
Cover Shape:	Circular	Evidence of Surcharge:	Yes
Cover Size:	23.0	Potential for Runoff:	None
Comments:

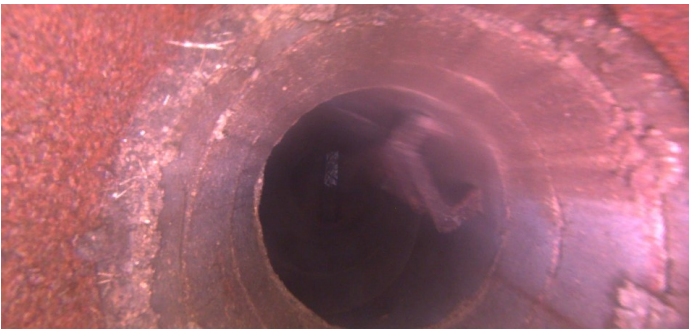
Code:

MGP

Description:

General Photo

Distance (ft):

.0

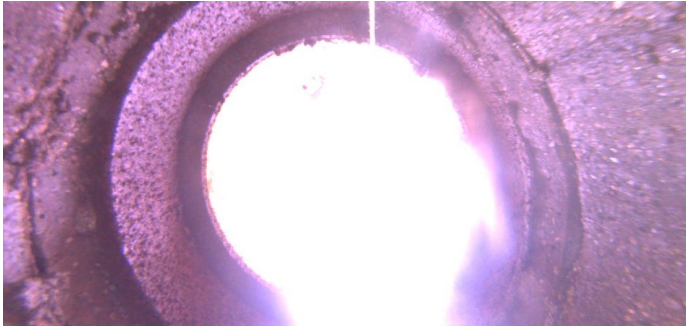
Code: **MGP**
Description: **General Photo**

Distance (ft): **2.1**
Structural Grade: **0**
O&M Grade: **0**
Clock Start/From:
Clock To:
1st Value:
2nd Value:
Value Percent:
Step: **NO**
Remarks:

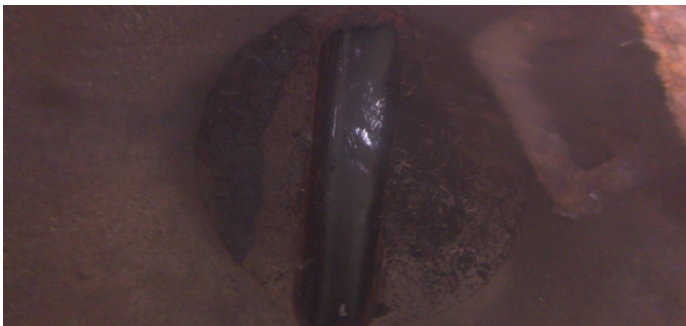
Code: **DSF**
Description: **Deposits Settled Fine**

Distance (ft): **10.8**
Structural Grade: **0**
O&M Grade: **2**
Clock Start/From: **12**
Clock To: **12**
1st Value:
2nd Value:
Value Percent: **10.000**
Step: **NO**
Remarks:

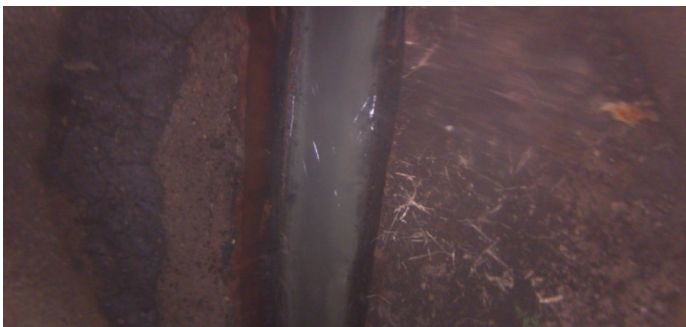
Code: **MGO**
Description: **General Observation**

Distance (ft): **12.5**
Structural Grade: **0**
O&M Grade: **0**
Clock Start/From:
Clock To:
1st Value:
2nd Value:
Value Percent:
Step: **NO**
Remarks: **Ins. Comp.**
