Manhole Inspection Report

Date:	04/12/2018	Weather:		Coding:	RZMACP
MH#:	M-803-013	Owner:	NA	Len. Surveyed:	9.8
P.O.#:		Surveyor:	John Kuglmaier	Rim to Invert:	11.9
Customer:		Cert. #:	U-1215-07002349	Wall Material:	Concrete (reinforced)

Street:	Wisconsin St. 29' North of 40th Plac	Project:	Hobart, IN
City:	Hobart, IN	GPS Northing:	2909718.837
Location:		GPS Easting:	2909718.837
Drain Area:	Northwest	GPS Accuracy:	Sub-Meter
Cover Shape:	Circular	Evidence of Surcharge:	Yes
Cover Size:	23.0	Potential for Runoff:	None
Comments:

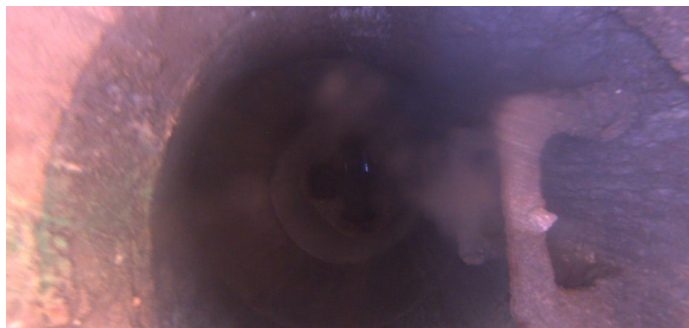
Code: **MGP**
Description: **General Photo**

Distance (ft): **.0**
Structural Grade: **0**
O&M Grade: **0**
Clock Start/From:
Clock To:
1st Value:
2nd Value:
Value Percent:
Step: **NO**
Remarks:

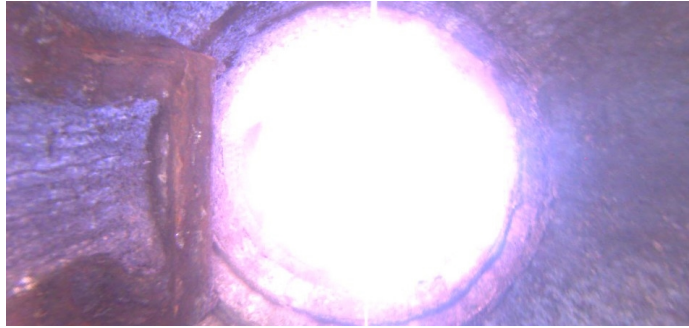
Code: **MGP**
Description: **General Photo**

Distance (ft): **2.5**
Structural Grade: **0**
O&M Grade: **0**
Clock Start/From:
Clock To:
1st Value:
2nd Value:
Value Percent:
Step: **NO**
Remarks:

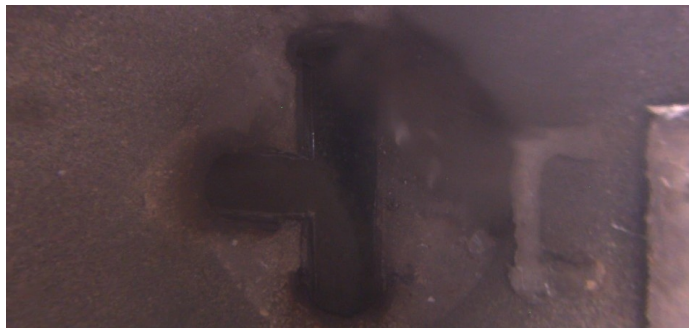
Code: **DSF**
Description: **Deposits Settled Fine**

Distance (ft): **7.2**
Structural Grade: **0**
O&M Grade: **2**
Clock Start/From: **12**
Clock To: **12**
1st Value:
2nd Value:
Value Percent: **10.000**
Step: **NO**
Remarks:

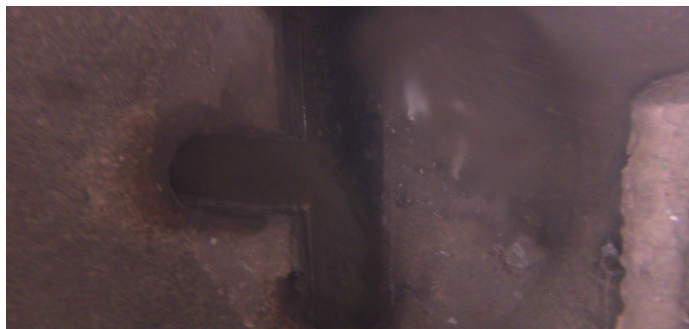
Code: **MGO**
Description: **General Observation**

Distance (ft): **8.2**
Structural Grade: **0**
O&M Grade: **0**
Clock Start/From:
Clock To:
1st Value:
2nd Value:
Value Percent:
Step: **NO**
Remarks: **Ins. Comp.**
