Manhole Inspection Report

Date:	03/27/2018	Weather:		Coding:	RZMACP
MH#:	M-803-015	Owner:	NA	Len. Surveyed:	9.3
P.O.#:		Surveyor:	John Kuglmaier	Rim to Invert:	10.7
Customer:		Cert. #:	U-1215-07002349	Wall Material:	Concrete (reinforced)

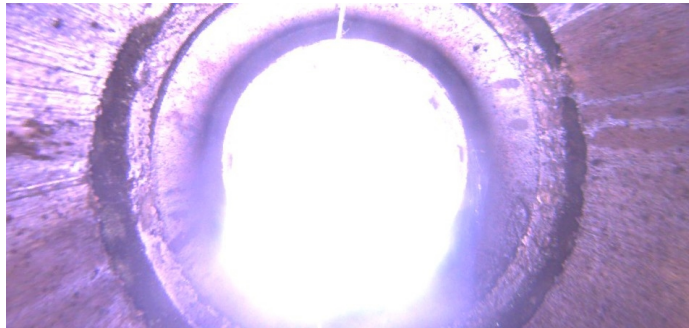
Code: **MGP**
Description: **General Photo**

Distance (ft): **2.6**
Structural Grade: **0**
O&M Grade: **0**
Clock Start/From:
Clock To:
1st Value:
2nd Value:
Value Percent:
Step: **NO**
Remarks:

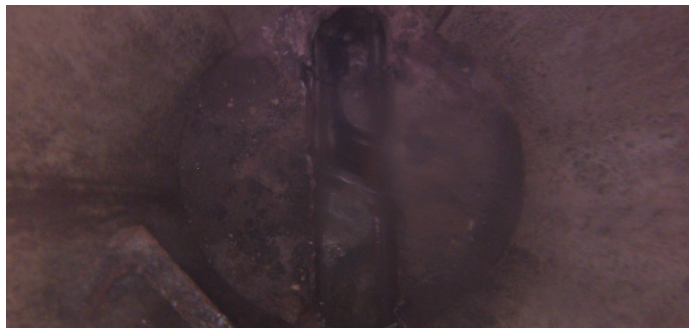
Code: **DSF**
Description: **Deposits Settled Fine**

Distance (ft): **6.8**
Structural Grade: **0**
O&M Grade: **2**
Clock Start/From: **12**
Clock To: **12**
1st Value:
2nd Value:
Value Percent: **5.000**
Step: **NO**
Remarks:

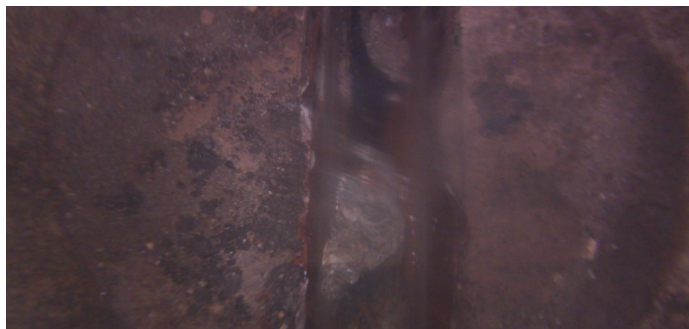
Code: **MGO**
Description: **General Observation**

Distance (ft): **8.0**
Structural Grade: **0**
O&M Grade: **0**
Clock Start/From:
Clock To:
1st Value:
2nd Value:
Value Percent:
Step: **NO**
Remarks: **Ins. Comp.**
