Manhole Inspection Report

Date:	03/27/2018	Weather:		Coding:	RZMACP
MH#:	M-803-015	Owner:	NA	Len. Surveyed:	7.9
P.O.#:		Surveyor:	John Kuglmaier	Rim to Invert:	10.0
Customer:		Cert. #:	U-1215-07002349	Wall Material:	Concrete (reinforced)

Street:	202' North of North St. 164' West of	Project:	Hobart, IN
City:	Hobart, IN	GPS Northing:	0.0
Location:		GPS Easting:	0.0
Drain Area:	Northeast	GPS Accuracy:	Nearest Meter
Cover Shape:	Circular	Evidence of Surcharge:	No
Cover Size:	23.0	Potential for Runoff:	None
Comments:

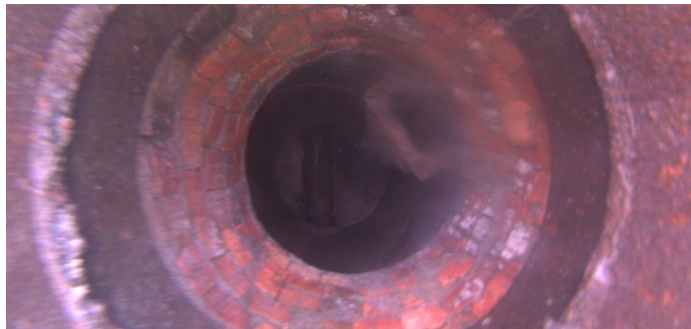
Code: **MGP**
Description: **General Photo**

Distance (ft): **.0**
Structural Grade: **0**
O&M Grade: **0**
Clock Start/From:
Clock To:
1st Value:
2nd Value:
Value Percent:
Step: **NO**
Remarks:

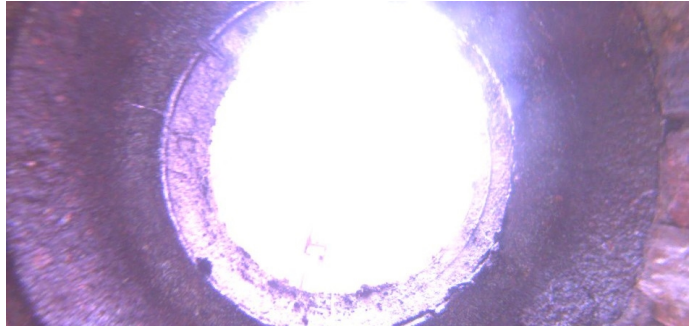
Code: **MGP**
Description: **General Photo**

Distance (ft): **2.2**
Structural Grade: **0**
O&M Grade: **0**
Clock Start/From:
Clock To:
1st Value:
2nd Value:
Value Percent:
Step: **NO**
Remarks:

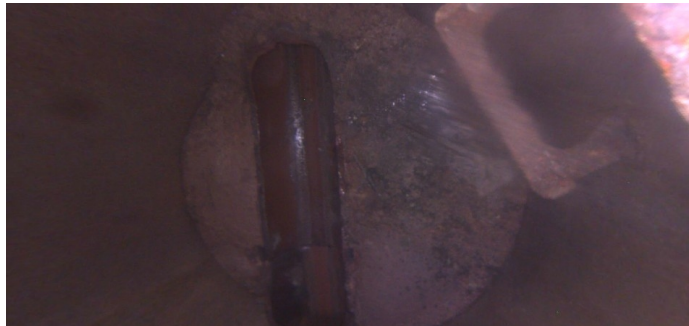
Code: **DSF**
Description: **Deposits Settled Fine**

Distance (ft): **6.3**
Structural Grade: **0**
O&M Grade: **2**
Clock Start/From: **12**
Clock To: **12**
1st Value:
2nd Value:
Value Percent: **10.000**
Step: **NO**
Remarks:

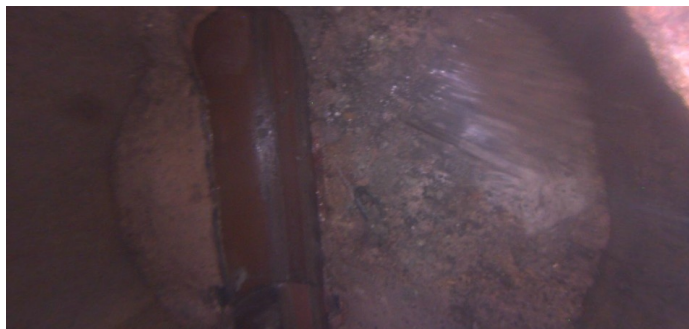
Code: **MGO**
Description: **General Observation**

Distance (ft): **7.3**
Structural Grade: **0**
O&M Grade: **0**
Clock Start/From:
Clock To:
1st Value:
2nd Value:
Value Percent:
Step: **NO**
Remarks: **Ins. Comp.**
