Manhole Inspection Report

Date:	03/27/2018	Weather:		Coding:	RZMACP
MH#:	M-803-016	Owner:	NA	Len. Surveyed:	7.2
P.O.#:		Surveyor:	John Kuglmaier	Rim to Invert:	9.0
Customer:		Cert. #:	U-1215-07002349	Wall Material:	Concrete (reinforced)

Street:	414' North of North St. 166' East of L	Project:	Hobart, IN
City:	Hobart, IN	GPS Northing:	0.0
Location:		GPS Easting:	0.0
Drain Area:	Northeast	GPS Accuracy:	Nearest Meter
Cover Shape:	Circular	Evidence of Surcharge:	Yes
Cover Size:	23.0	Potential for Runoff:	None
Comments:

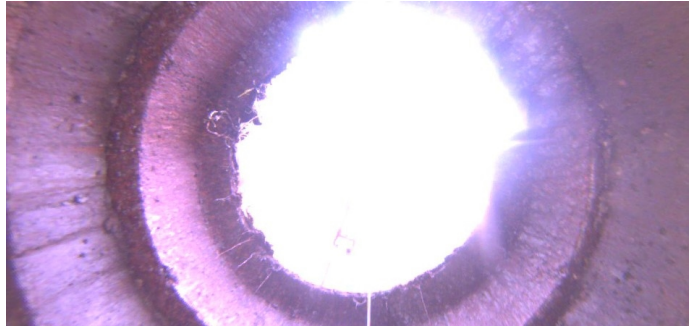
Code: **MGP**
Description: **General Photo**

Distance (ft): **1.8**
Structural Grade: **0**
O&M Grade: **0**
Clock Start/From:
Clock To:
1st Value:
2nd Value:
Value Percent:
Step: **NO**
Remarks:

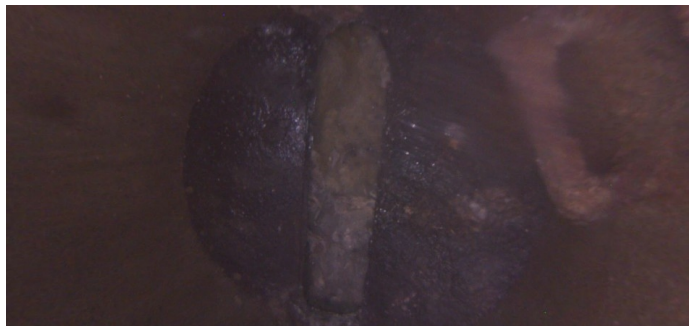
Code: **DSF**
Description: **Deposits Settled Fine**

Distance (ft): **5.2**
Structural Grade: **0**
O&M Grade: **2**
Clock Start/From: **12**
Clock To: **12**
1st Value:
2nd Value:
Value Percent: **10.000**
Step: **NO**
Remarks:

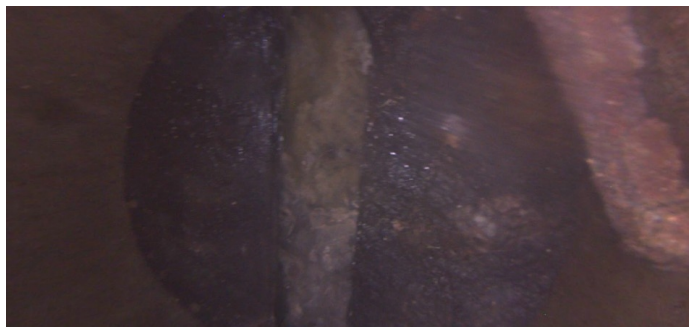
Code: **MGO**
Description: **General Observation**

Distance (ft): **5.9**
Structural Grade: **0**
O&M Grade: **0**
Clock Start/From:
Clock To:
1st Value:
2nd Value:
Value Percent:
Step: **NO**
Remarks: **Ins. Comp.**
