Manhole Inspection Report

Date:	03/27/2018	Weather:		Coding:	RZMACP
MH#:	M-803-018	Owner:	NA	Len. Surveyed:	6.3
P.O.#:		Surveyor:	John Kuglmaier	Rim to Invert:	7.9
Customer:		Cert. #:	U-1215-07002349	Wall Material:	Concrete (reinforced)

Street:	40th Ave. 162' East of Joliet St.	Project:	Hobart, IN
City:	Hobart, IN	GPS Northing:	0.0
Location:		GPS Easting:	0.0
Drain Area:	Northeast	GPS Accuracy:	Nearest Meter
Cover Shape:	Circular	Evidence of Surcharge:	Yes
Cover Size:	23.0	Potential for Runoff:	None
Comments:

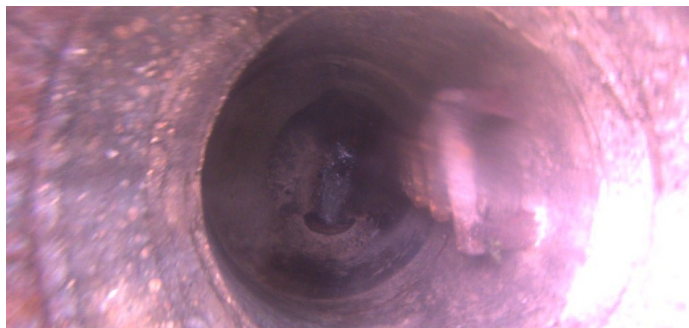
Code: **MGP**
Description: **General Photo**

Distance (ft): **.0**
Structural Grade: **0**
O&M Grade: **0**
Clock Start/From:
Clock To:
1st Value:
2nd Value:
Value Percent:
Step: **NO**
Remarks:

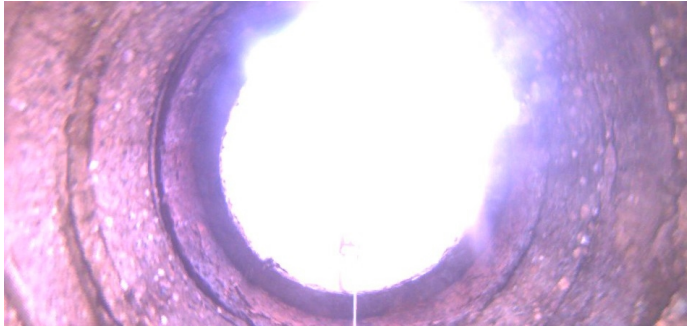
Code: **MGP**
Description: **General Photo**

Distance (ft): **2.2**
Structural Grade: **0**
O&M Grade: **0**
Clock Start/From:
Clock To:
1st Value:
2nd Value:
Value Percent:
Step: **NO**
Remarks:

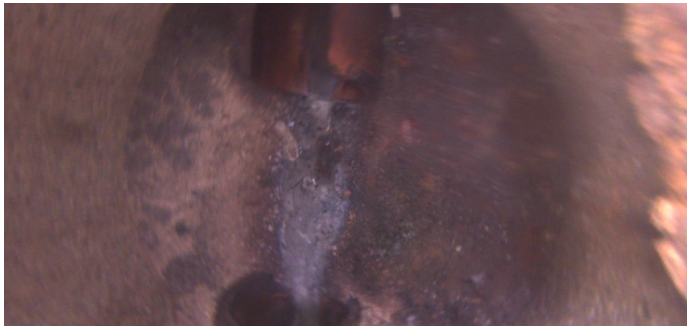
Code: **MGO**
Description: **General Observation**

Distance (ft): **5.0**
Structural Grade: **0**
O&M Grade: **0**
Clock Start/From:
Clock To:
1st Value:
2nd Value:
Value Percent:
Step: **NO**
Remarks: **Ins. Comp.**
