Manhole Inspection Report

Date:	03/27/2018	Weather:		Coding:	RZMACP
MH#:	M-803-019	Owner:	NA	Len. Surveyed:	6.9
P.O.#:		Surveyor:	John Kuglmaier	Rim to Invert:	8.9
Customer:		Cert. #:	U-1215-07002349	Wall Material:	Concrete (reinforced)

Street:	40th Ave. 162' East of Joliet St.	Project:	Hobart, IN
City:	Hobart, IN	GPS Northing:	0.0
Location:		GPS Easting:	0.0
Drain Area:	Northeast	GPS Accuracy:	Nearest Meter
Cover Shape:	Circular	Evidence of Surcharge:	Yes
Cover Size:	23.0	Potential for Runoff:	None
Comments:

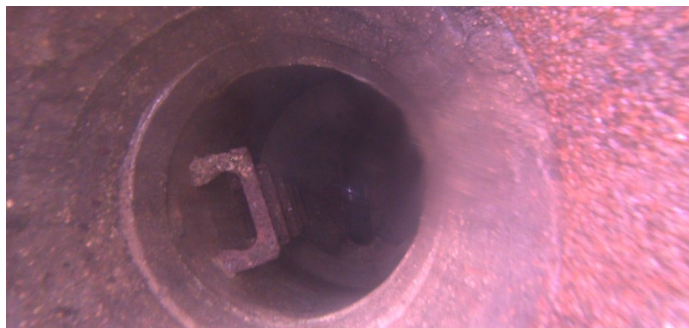
Code: **MGP**
 Description: **General Photo**

Distance (ft): **.0**
 Structural Grade: **0**
 O&M Grade: **0**
 Clock Start/From:
 Clock To:
 1st Value:
 2nd Value:
 Value Percent:
 Step: **NO**
 Remarks:

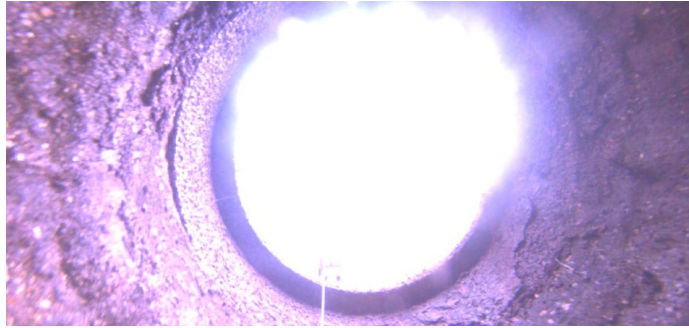
Code: **MGP**
Description: **General Photo**

Distance (ft): **2.1**
Structural Grade: **0**
O&M Grade: **0**
Clock Start/From:
Clock To:
1st Value:
2nd Value:
Value Percent:
Step: **NO**
Remarks:

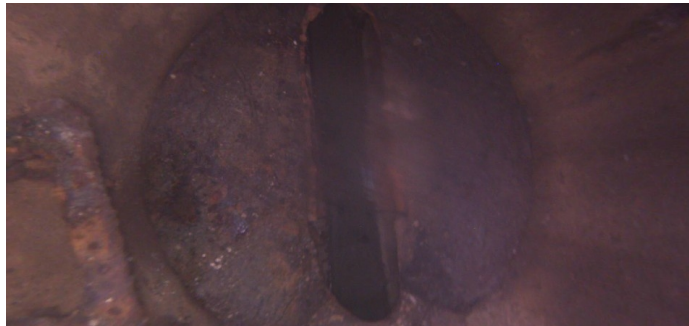
Code: **DSF**
Description: **Deposits Settled Fine**

Distance (ft): **5.0**
Structural Grade: **0**
O&M Grade: **2**
Clock Start/From: **12**
Clock To: **12**
1st Value:
2nd Value:
Value Percent: **10.000**
Step: **NO**
Remarks:

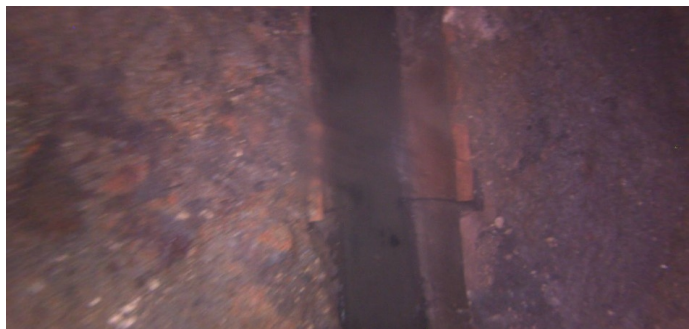
Code: **MGO**
Description: **General Observation**

Distance (ft): **6.2**
Structural Grade: **0**
O&M Grade: **0**
Clock Start/From:
Clock To:
1st Value:
2nd Value:
Value Percent:
Step: **NO**
Remarks: **Ins. Comp.**
