# Manhole Inspection Report

Date:	03/27/2018	Weather:		Coding:	RZMACP
MH#:	M-803-021	Owner:	NA	Len. Surveyed:	8.3
P.O.#:		Surveyor:	John Kuglmaier	Rim to Invert:	9.9
Customer:		Cert. #:	U-1215-07002349	Wall Material:	Concrete (reinforced)

Street:	Intersection of 40th Ave. and Joliet	Project:	Hobart, IN
City:	Hobart, IN	GPS Northing:	0.0
Location:		GPS Easting:	0.0
Drain Area:	Northeast	GPS Accuracy:	Nearest Meter
Cover Shape:	Circular	Evidence of Surcharge:	Yes
Cover Size:	23.0	Potential for Runoff:	None
Comments:

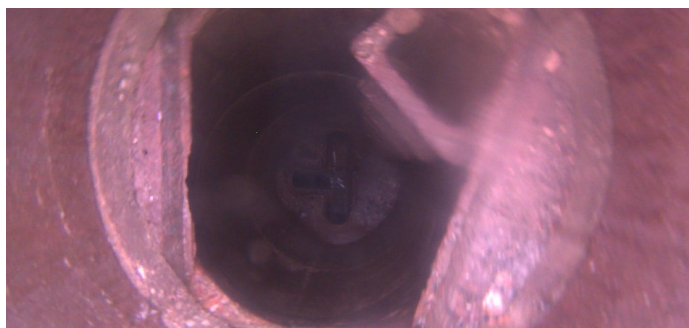
Code: **MGP**  
Description: **General Photo**

Distance (ft): **.0**  
Structural Grade: **0**  
O&M Grade: **0**  
Clock Start/From:  
Clock To:  
1st Value:  
2nd Value:  
Value Percent:  
Step: **NO**  
Remarks:

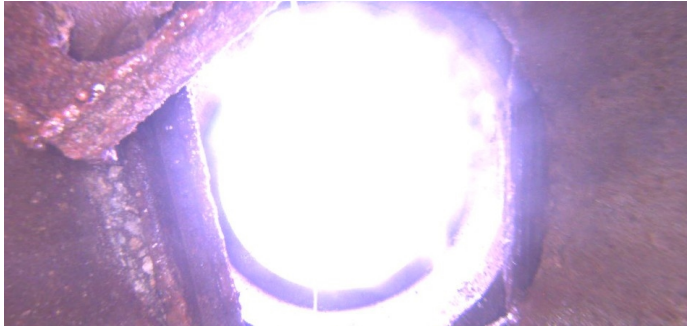
Code: **MGP**  
Description: **General Photo**

Distance (ft): **2.7**  
Structural Grade: **0**  
O&M Grade: **0**  
Clock Start/From:  
Clock To:  
1st Value:  
2nd Value:  
Value Percent:  
Step: **NO**  
Remarks:

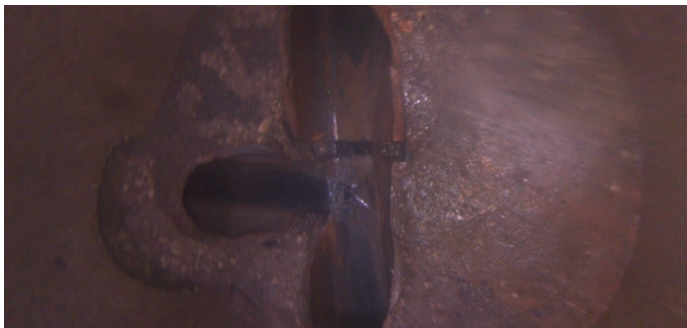
Code: **MGO**  
Description: **General Observation**

Distance (ft): **7.0**  
Structural Grade: **0**  
O&M Grade: **0**  
Clock Start/From:  
Clock To:  
1st Value:  
2nd Value:  
Value Percent:  
Step: **NO**  
Remarks: **Ins. Comp.**
