Manhole Inspection Report

Date:	03/29/2018	Weather:		Coding:	RZMACP
MH#:	M-803-022	Owner:	NA	Len. Surveyed:	6.0
P.O.#:		Surveyor:	John Kuglmaier	Rim to Invert:	7.3
Customer:		Cert. #:	U-1215-07002349	Wall Material:	Concrete (reinforced)

Street:	281' North of 40th Ave. 330' East of	Project:	Hobart, IN
City:	Hobart, IN	GPS Northing:	0.0
Location:		GPS Easting:	0.0
Drain Area:	Northeast	GPS Accuracy:	Nearest Meter
Cover Shape:	Circular	Evidence of Surcharge:	No
Cover Size:	23.0	Potential for Runoff:	None
Comments:

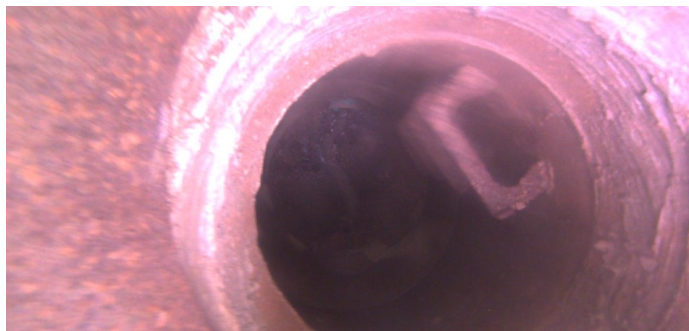
Code: **MGP**
Description: **General Photo**

Distance (ft): **.0**
Structural Grade: **0**
O&M Grade: **0**
Clock Start/From:
Clock To:
1st Value:
2nd Value:
Value Percent:
Step: **NO**
Remarks:

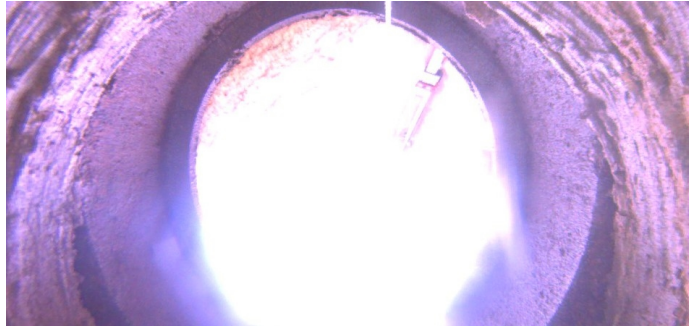
Code:	MGP
Description:	General Photo
Distance (ft):	1.9
Structural Grade:	0
O&M Grade:	0
Clock Start/From:	
Clock To:	
1st Value:	
2nd Value:	
Value Percent:	
Step:	NO
Remarks:

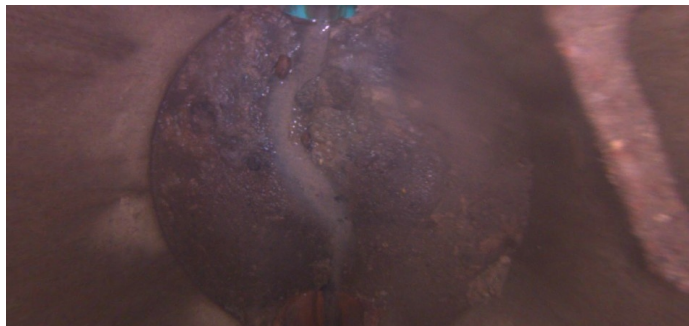
Code:	DAZ
Description:	Deposits Attached Other
Distance (ft):	4.2
Structural Grade:	0
O&M Grade:	2
Clock Start/From:	12
Clock To:	12
1st Value:	
2nd Value:	
Value Percent:	10.000
Step:	NO
Remarks:	Mixed materials

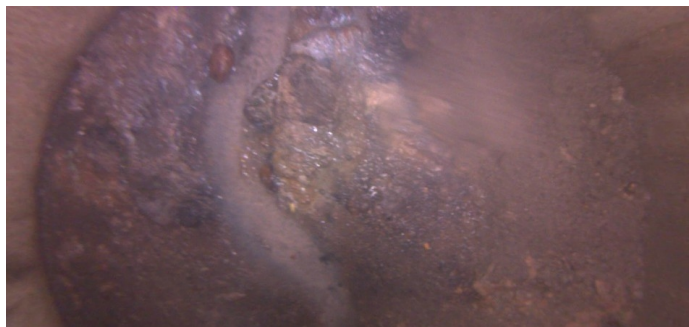
Code:	MGO
Description:	General Observation
Distance (ft):	5.2
Structural Grade:	0
O&M Grade:	0
Clock Start/From:	
Clock To:	
1st Value:	
2nd Value:	
Value Percent:	
Step:	NO
Remarks:	Ins. Comp.
