Manhole Inspection Report

| MH#: | M-803-023 | Owner: | NA | Len. Surveyed: | 8.8 |

| Street: | 40th Ave. 169' East of Ohio St. | Project: | Hobart, IN |

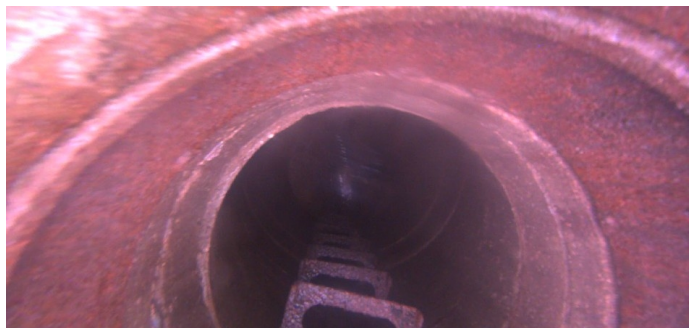
Code: **MGP**
 Description: **General Photo**

Distance (ft): **.0**
 Structural Grade: **0**
 O&M Grade: **0**
 Clock Start/From:
 Clock To:
 1st Value:
 2nd Value:
 Value Percent:
 Step: **NO**
 Remarks:

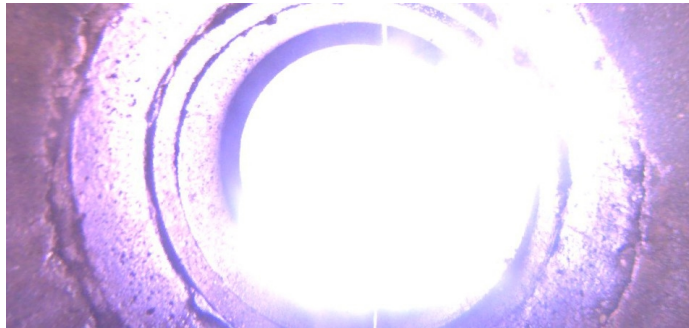
Code: **MGP**
Description: **General Photo**

Distance (ft): **2.6**
Structural Grade: **0**
O&M Grade: **0**
Clock Start/From:
Clock To:
1st Value:
2nd Value:
Value Percent:
Step: **NO**
Remarks:

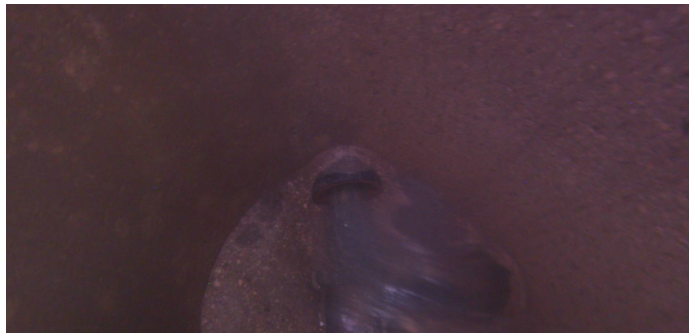
| | Position | Code | Observation | Video (sec) | Grade |
|--|---|---|---|---|---|
| | 5.5 | SAV | Surface Aggregate Visible | 49 | S 3 |

Code: **SAV**
Description: **Surface Aggregate Visible**

Distance (ft): **5.5**
Structural Grade: **3**
O&M Grade: **0**
Clock Start/From: **12**
Clock To: **12**
1st Value:
2nd Value:
Value Percent:
Step: **NO**
Remarks:

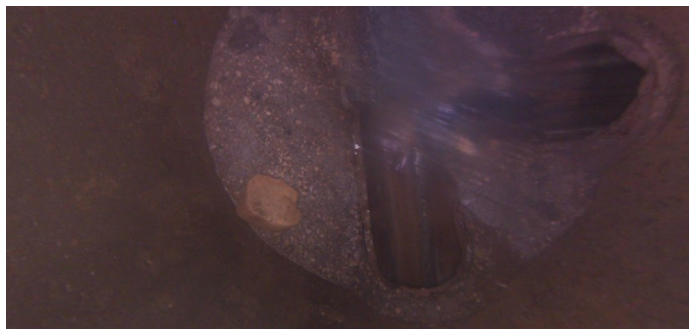
| | Position | Code | Observation | Video (sec) | Grade |
|--|---|---|---|---|---|
| | 6.9 | OBR | Obstacle Rocks | 63 | M 2 |

Code: **OBR**
Description: **Obstacle Rocks**

Distance (ft): **6.9**
Structural Grade: **0**
O&M Grade: **2**
Clock Start/From: **8**
Clock To:
1st Value:
2nd Value:
Value Percent: **5.000**
Step: **NO**
Remarks:

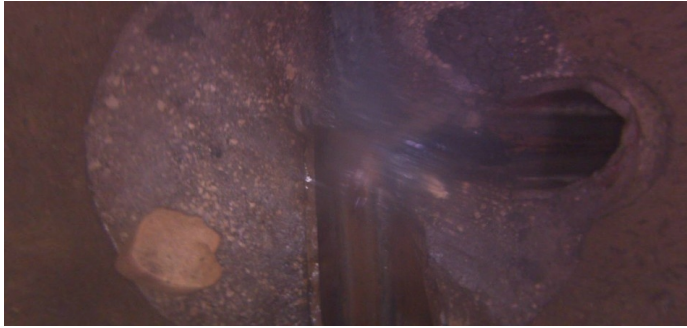
| Description: | General Observation |
| Remarks: | Ins. Comp. |
